## **Colorado Oil and Gas Conservation Commission**

# Monitor Wells Summary Report 2021

# 4M Project Monitoring Program Archuleta and La Plata Counties Colorado

May 26, 2022

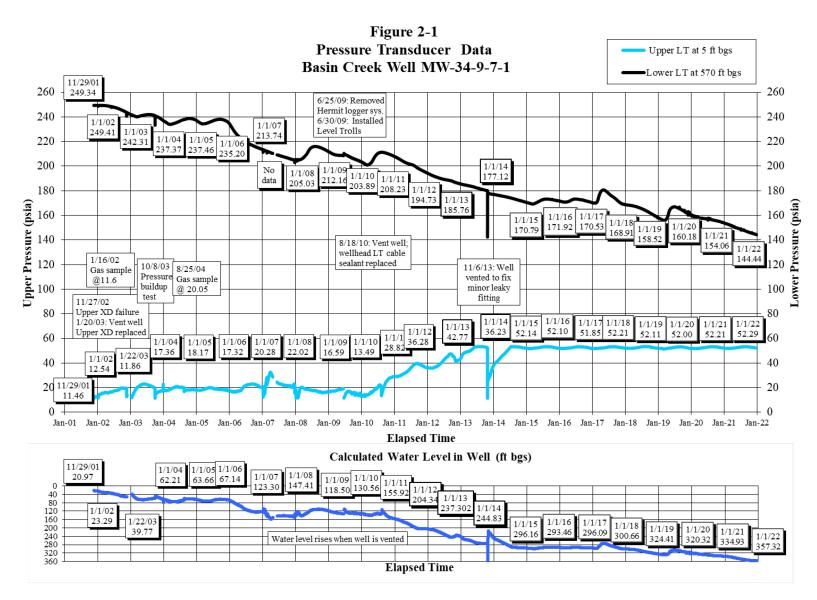
Figure 2-1
Pressure Transducer Data Basin Creek Well MW-34-9-7-1

Figure 2-1 charts the upper and lower pressure transducer data and the calculated water level in the well. Table 2-1 and Figure 2-1 show a net increase of 40.83 psi in wellhead pressure for the entire 20-year period of record from November 29, 2001 (11.46 psia) to January 1, 2022 (52.29 psia). Figure 2-1 generally shows a pattern of minor seasonal fluctuations within an overall stable trend in wellhead pressure prior to wellhead cable gland seal replacement on August 18, 2010, followed by a rise in wellhead pressure to a recorded high of 53.42 psia on September 11, 2013. A very minor leak persisted so on November 6, 2013 the well was vented to allow a safe condition to repair leaking threads at the wellhead. Recovery of the previous wellhead pressure occurred for about nine months following this wellhead venting. Since

recovery in the second half of 2014, wellhead pressure has remained relatively stable. 2019 data demonstrated a groundwater recharge response to the very wet winter of 2018-2019; this effect was greater in magnitude than a similar pressure and water level response to the wet winters of 2007-2008, 2009-2010, 2016-2017.

In contrast to the wellhead pressure patterns, Table 2-1 and Figure 2-1 show a substantial net decline of 336.35 feet in the calculated well water level and a corresponding net decline in downhole pressure of 104.90 psi for the period of record. Figure 2-1 also shows a pattern of slight seasonal fluctuations within the overall declining trend in the water level and corresponding downhole pressure for the period of record.

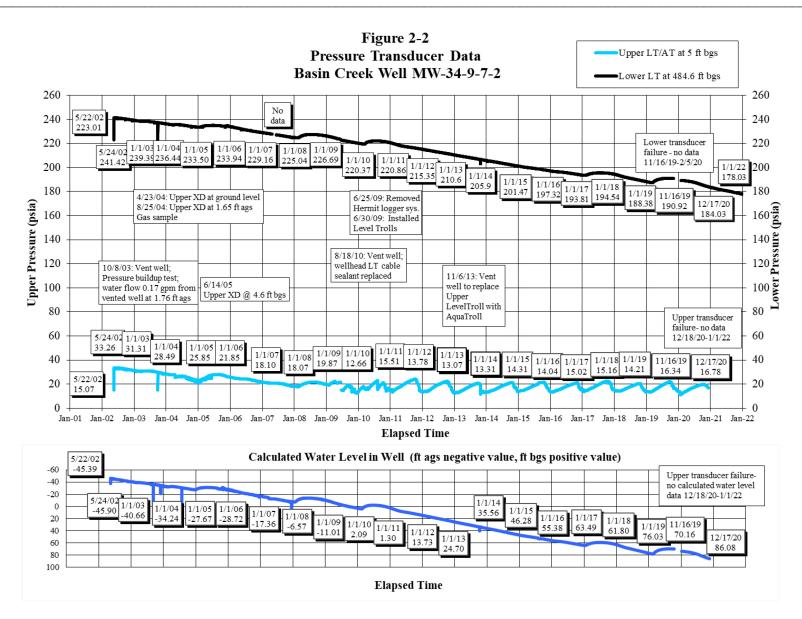
Figure 2-2
Pressure Transducer Data Basin Creek Well MW-34-9-7-2

A small amount of gas was released and artesian flow (~0.2 gpm) from the well consistently occurred each time the well was vented for maintenance during the period of record between 2002 and 2010. The pressure regime documented was relatively high pressure but low volume based on the head pressure versus artesian flow. Artesian flow from the well did not occur when the wellhead was vented on August 18, 2010 to replace the Level Troll wellhead cable Conax gland sealants. The final recorded upper transducer pressure in 2011 of 13.7 psi was very near atmospheric pressure indicating the well was essentially in hydrostatic balance. The pressure fluctuations since early 2009 suggest that ambient surface temperatures may be affecting the gas pressure as measured by the upper transducer. In order to attempt to distinguish water pressure versus gas pressure being recorded by the upper transducer, the Level Troll was replaced by an Aqua Troll, which records specific conductance (SC) in addition to pressure and temperature. The concept was that if water was present at the Aqua Troll, it would record an SC value greater than zero. If a value of zero was recorded for SC, then a pressure greater than atmospheric pressure would be gas pressure only. The Aqua Troll was installed on November 6, 2013, but it appears by this time the static water level in this well had dropped from the near-surface balance of 2009-2011. 2017 brought a change in trend of the downhole pressure; it increased slightly throughout the first half of 2017, plateaued and then continued to decrease in the linear trend followed since mid-2011. This was a similar trend as observed in 2010. 2019 data demonstrated a groundwater recharge response to the very wet winter of 2018-2019, similar to that observed after the wet winters of 2007-2008, 2009-2010, 2016-2017.

Substantial water level decline has been documented in this well, going from artesian flowing with a calculated shut-in head of approximately 53 feet above ground surface just after construction to 86.08 feet below ground surface on December 17, 2020. This calculated water level data set has been verified by a manual open-well water level measurement on November 6, 2013 of 40.20 ft bgs used as a calibration

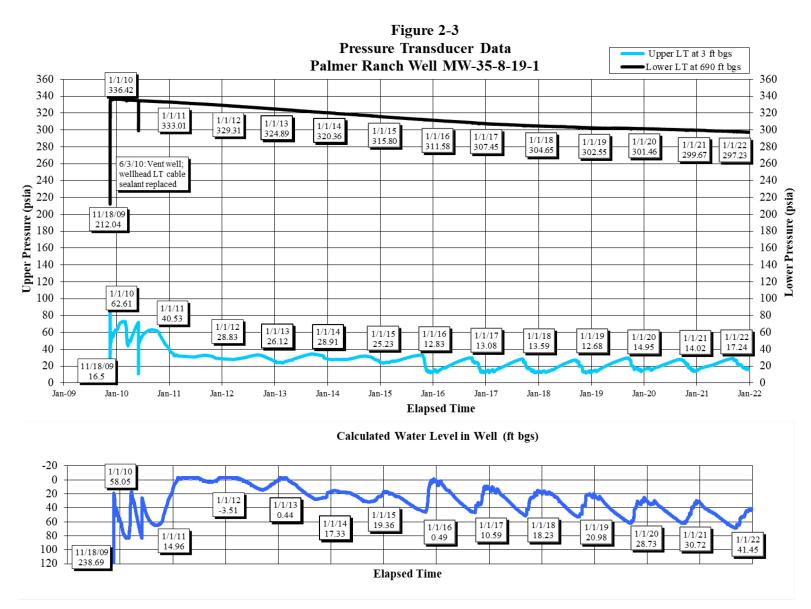
Figure 2-3
Pressure Transducer Data Palmer Ranch Well MW-35-8-19-1

In late October 2015, wellhead pressure apparently began dropping slowly from approximately 33 psi to approximately 12 psi in mid-December 2015. Wellhead pressure then was fairly stable through the winter and then slowly built up from late winter through late summer. The pressure trend appears to be similar but stronger seasonal trend that has been occurring since 2011. The trend repeated through 2021 and suggests the well has been demonstrating an apparent increased response to seasonal groundwater level

2021 4M Project Monitor Wells Summary Report – Final	COGCC
changes, increased local groundwater production effects or coal seam reservoir pressure f Florida River runs immediately adjacent to the well and flows are significantly impacted irrigation schedules, which may have both direct and indirect effects on observed Frui reservoir pressure and water levels.	d by agricultural

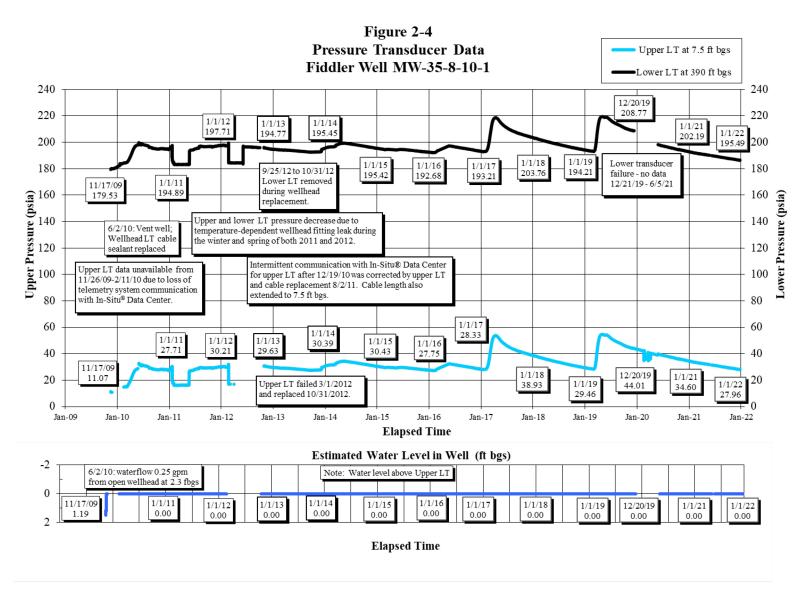
Figure 2-4
Pressure Transducer Data Fiddler MW-35-8-10-1

Monitoring data for MW 35-8-10-1 are plotted in Figure 2-4. The net change in wellhead pressure is 13.12 psi and the net change in downhole pressure is 11.19 psi for the 12-year period of record. As Figure 2-4 shows, both the wellhead pressure and downhole pressure steadily increased from installation on November 17, 2009 to early June, 2010. This well has seen moderate fluctuation in the pressure regime, however instrumentation problems and wellhead leakage occurred until 2013. These issues are discussed below.

As noted on Figure 2-4 the lower Level Troll was removed during wellhead maintenance on September 25, 2012 and reinstalled on October 31, 2012. A net water level change was not calculated because the upper transducer is below the water level in the well. Figure 2-4 documents a natural flow rate from the well at a rate of 0.25 gallons per minute (gpm) when the well was vented for maintenance on June 2, 2010. At the time of the well inspection on October 31, 2012, the flow rate was measured at 0.14 gpm. For charting purposes, the water level in the shut-in well is estimated to be at or near ground surface above the upper pressure transducer (set at 7.5 ft bgs).

Also noted on Figure 2-4, telemetry system communication with the In-Situ® Data Center for the upper transducer was lost from November 26, 2009 through February 11, 2010 due to cable connection problem and was intermittent from December 19, 2010 to January 1, 2011. The upper transducer and cable were replaced during the 2011 well inspection and the cable length was extended from 3 ft bgs to 7.5 ft bgs. Additionally, a wellhead fitting leak during the winter and spring of 2011 through the summer of 2012 caused a pressure decrease observed on both the upper and lower transducers. Related to the freeze-thaw cycles, the upper transducer failed again March 1, 2012. Inspection of the wellhead on June 6, 2012

revealed the minor water leak at an estimated flow rate of 0.1 to 0.2 gpm. Evidence of the wellhead freezing and then popping the wellhead seal is observed by the minor pressure spiking on both transducers in January 2011 and February 2012. The tubing head threading was cleaned in an attempt to achieve a pressure tight seal at the mandrel head, but both the rubber seals and threading had deteriorated significantly. Documentation was conducted for a later wellhead replacement. Souder Miller Associates supervised installation of the new wellhead on September 25, 2012, which required removal of all instrumentation from the well. Rather than reset the instrumentation at that time, it was planned to remain out of service until the well inspection conducted by COGCC, Norwest and In-Situ, Inc. on October 31, 2012. During that well inspection the upper transducer was replaced with a new 100 psia Level Troll. Also, as planned, the lower transducer and cable was reset, however the new set depth was approximately 15 feet deeper than the previous set depth, so the proper offset has been incorporated into the lower transducer data in Figure 2-4.

Since mid-2014, the Fiddler monitoring well showed a fairly steady decline in bottom-hole and wellhead pressure of approximately 6 psi through January 1, 2016. However, bottom hole and wellhead pressure measurements show a steady increase of approximately 5 psi from late February 2016 through May 2016. This could have been a response related to temporary shut-in of one or more nearby coal bed methane production wells. A similar pressure decline trend as the 2014-2015 resumed in June 2016.

2017 demonstrated a substantial pressure build-up measured on both the upper and lower transducers. It appears to represent significant groundwater recharge to at least one, if not all of the five Fruitland coal seams monitored in the Fiddler well following the wet winter of 2016-2017. This effect is observed again with similar magnitude following the very wet winter of 2018-2019.

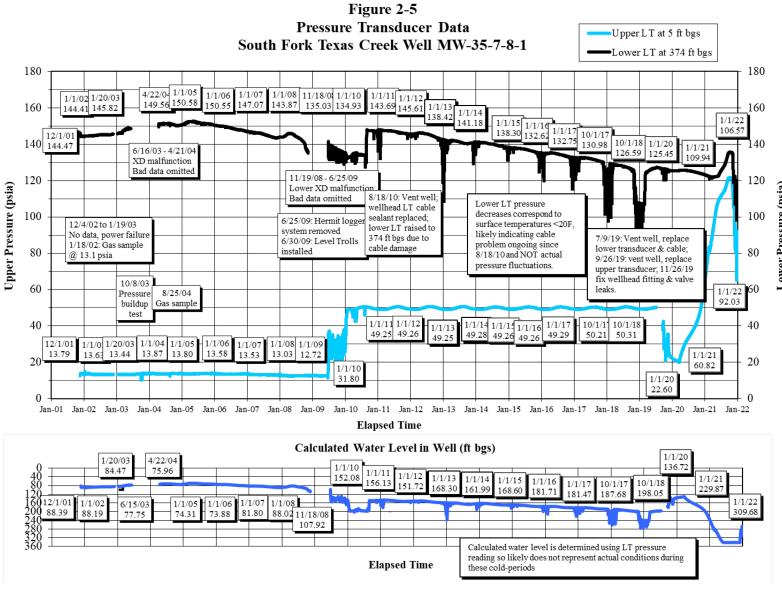
Figure 2-5
Pressure Transducer Data South Fork Texas Creek Well MW-35-7-8-1

Figure 2-5 shows a relatively stable wellhead pressure (12 to 13.5 psia) prior to installation of the Level Troll instrument on June 30, 2009. After the transducer change-out, there was a build-up in wellhead pressure from 11.52 psia on June 30, 2009 to 33.76 psia on July 3, 2009 followed by frequent fluctuations in wellhead pressure ranging between 19 psia and 38 psia through January 18, 2010. Between January 19, 2010 and January 30, 2010, the wellhead pressure rose from 38 psia to 49 psia and then remained fairly stable through June 2019. The relatively stable wellhead pressure curve prior to June 30, 2009 is inconsistent with the fluctuating and notably higher pressure measurements recorded after June 30, 2009. Likewise, the lower Level Troll has recorded frequent downhole pressure fluctuations (between 129 and 142 psia) not previously observed in well pressure data prior to June 30, 2009. The higher well pressure regime since August 2010 may indicate complete well shut-in was not achieved until after the Level Troll cable wellhead seals were replaced on August 18, 2010. Some higher magnitude pressure fluctuations in the lower transducer began occurring in December of 2012 and were continuing through the current period of record during winter (cold) periods. In the summer of 2019, the lower transducer and cable were

replaced as planned to address the cold weather pressure spikes. The upper transducer was replaced due to failure. Following those repairs and during the subsequent shut-in, the wellhead pressure declined for a period of several months until April 1<sup>st</sup> of 2020. At that time there was a significant, fairly steady wellhead pressure increase of over 100 psi through September of 2021, which may relate to decrease of groundwater production and thus an increase of reservoir gas pressure in the vicinity. In early November 2021 a drastic reversal of this trend began and has continued through January 1, 2022. This data may indicate an increase of groundwater production in the immediate vicinity. No significant pressure spikes were observed in the lower transducer data in the cold months of 2020 or 2021, indicating the cable replacement in 2019 was successful.

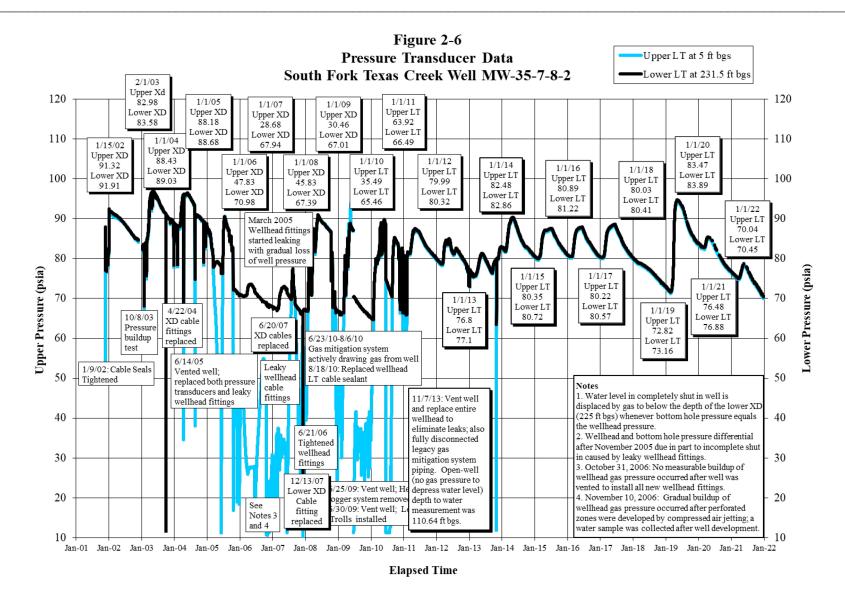
Figure 2-6
Pressure Transducer Data South Fork Texas Creek Well MW-35-7-8-2

Figure 2-6 charts the pressure data for well MW 35-7-8-2, which exhibits an entirely different pressure regime than the deeper monitoring well MW 35-7-8-1. Figure 2-6 shows nearly equal wellhead and downhole pressures for the period of record when the well is completely shut in. For example, wellhead and downhole pressures recorded on January 1, 2022 were 70.04 psia and 70.45 psia respectively under shut-in conditions. Based on the period of record to date, incomplete well shut-in is indicated whenever the well pressure drops below about 70 psia.

Figure 2-6 shows a fairly rapid increase in well pressure after the well was shut in on August 18, 2010. The peak build-up pressure of about 85 psia on September 28, 2010 was followed by an erratic decline in well pressure. The inspection of the well in 2013 documented a minor fitting leak at that time; this was a consistent leak on a pipe fitting that has been attempted to be tightened in the past years but required significant replacement of numerous wellhead fittings. The colder air temperatures occurring with early winter of 2012 and again in 2013 appeared to cause some erratic pressure fluctuations documented with the upper and lower transducers in Figure 2-6. This seemed to indicate that the leak was becoming more significant. On November 7, 2013 a site-specific follow-up trip was conducted to repair the leak that had been most recently documented on September 30, 2013. The well gas pressure was allowed to safely bleed down, with continuous gas detector monitoring. Both upper and lower Level Trolls were removed from the well and the wellhead was completely removed down to the 2-inch line pipe that is the well

A fairly consistent well pressure trend was observed for the previous four years, 2014 – 2017, whereby the well pressure builds in the first two quarters of the year and then falls off during the second two quarters. This trend may be documentation of seasonal effects of groundwater recharge and discharge, natural or otherwise. As 2018 was documented with extreme drought conditions, it appears that the monitored interval did not receive the typical magnitude of recharge. The pressure trend continued to decrease during the usual recharge period of early 2018, with minimal superimposed recharge noted as a slight reversal in the pressure curve character. The excessively wet winter of 2018-2019 appears to have caused a substantial well pressure increase in the late winter and early spring of 2019, with the usual pressure fall-off occurring following for the remainder of the year. The pressure record appears to show that in 2021 the trend was similar to 2019 and 2020.

casing extending up from the cement pad. The threads were reconditioned with a hand-operated 2-inch pipe die. The wellhead was reconstructed using all new carbon steel pipe fittings, with the exception of the Conax compression fittings secured around each Level Troll Rugged Cable, as they had not been documented as leaking. Several manual water level measurements were taken while the wellhead was open. Initially, the water level recovered fairly quickly as the gas pressure was vented. After approximately 2.5 hours open during the new wellhead installation, the water level was relatively stable and measured 110.64 ft bgs. This is the static water level when no gas pressure is allowed to depress the water column in the well. As can be seen in Figure 2-6, the upper and lower Level Troll pressure readings diverge at this time indicating that for the short period following well shut-in the lower Level Troll was actually submerged in water. The lower Level Troll pressure reading was approximately 63.6 psia, which calculates to 111.06 ft bgs. This gives good confidence in the calculated versus measured water level in this well, given error in the assumption of atmospheric pressure which is not currently recorded at this location. To prevent damage to the existing lower Level Troll cable, the Conax compression fitting was not adjusted to offset the new wellhead's increased height above ground surface of 0.25 feet, so the new set depth is 231.25 ft bgs. No leaks have been detected at this wellhead since the replacement.

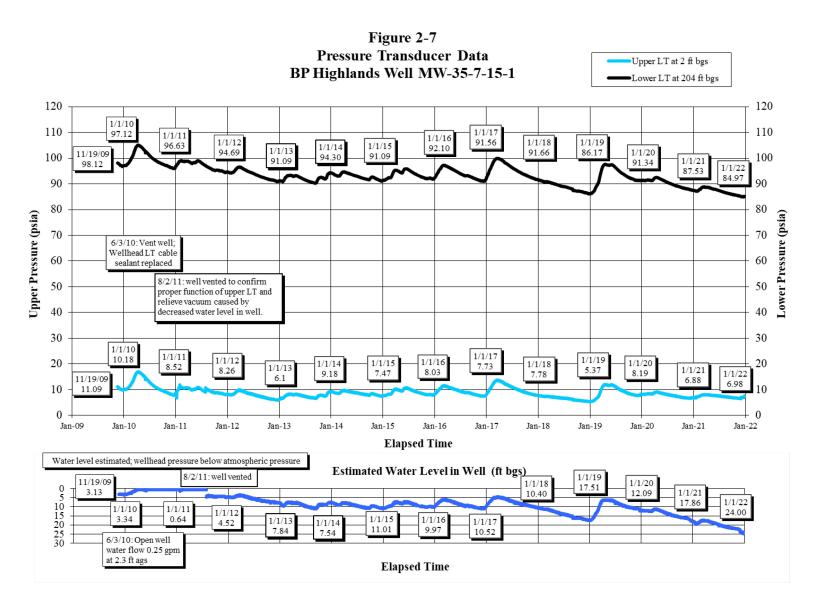
Figure 2-7
Pressure Transducer Data BP Highlands Well MW-35-7-15-1

Monitoring data for MW 35-7-15-1 are plotted in Figure 2-7. As summarized in Table 2-5 for the 12-year period of record, the net change in downhole pressure is a decrease of 13.15 psi. The well follows an overall decreasing pressure trend with seasonal variability dominated by late winter/early spring. The net change in the calculated water level in the well is a decrease of 20.87 feet. The magnitude of this decrease was approximately doubled in 2018 due to extreme drought conditions and complete lack of observable recharge. This all but repeated again in 2020 and 2021, with a very muted recharge trend when compared to 2016 and 2017. As noted on Figure 2-7, water flowed from the well at a rate of 0.25 gallons per minute (gpm) when the well was vented for maintenance on June 3, 2010. For charting purposes, the water level in the shut-in well at that time was estimated to be slightly above ground surface with the upper transducer under water at 2 ft bgs.

The wellhead pressure started dropping below atmospheric pressure around August 12, 2010. This condition suggested either a potential problem with the upper transducer or a well pressure vacuum effect created in a completely shut-in well under declining water level conditions. A well instrumentation inspection and atmospheric pressure check conducted during each subsequent site visit through 2013 has confirmed the proper function of the upper transducer. Venting the well allowed for physical confirmation that the well was under vacuum pressure conditions which have continued through January 1, 2022.

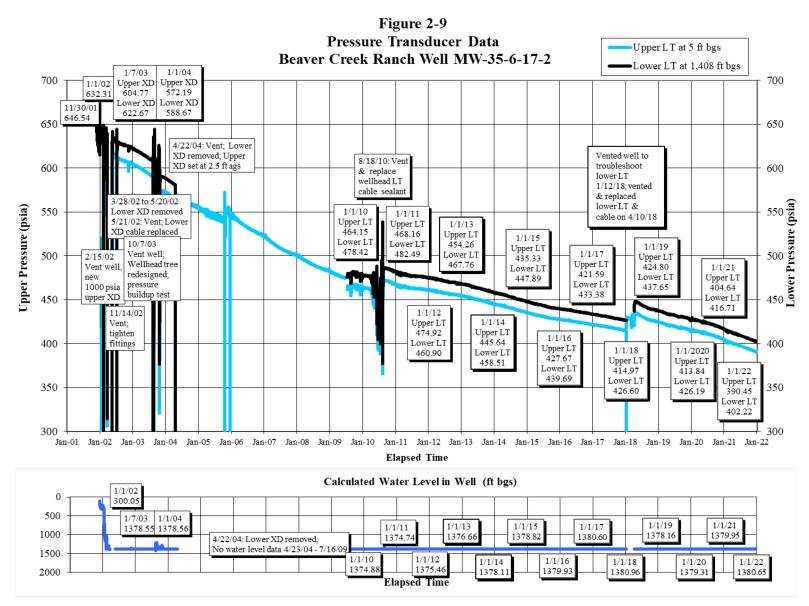
Figure 2-9
Pressure Transducer Data Beaver Creek Ranch Well MW-35-6-17-2

Figure 2-9 shows the well pressure in a declining trend for the entire period record. There is a notable shift in the well pressure curve following the installation of Level Troll instruments on July 17, 2009, followed by erratic well pressure fluctuations associated with incomplete shut-in through August 17, 2010. After the well was vented August 18, 2010 to replace the Level Troll cable fitting sealants, there was a steady build-up of well pressure through early September 2010 followed by a return to a declining trend through the period of record.

As shown on Figure 2-9, no water level data is available for the 6-year period of record when there was only one well pressure transducer. Well pressure data available after installation of wellhead and downhole Level Trolls on July 19, 2009 shows approximately 30 feet decline in the calculated water level and very little, if any seasonal influence on the overall well pressure regime.

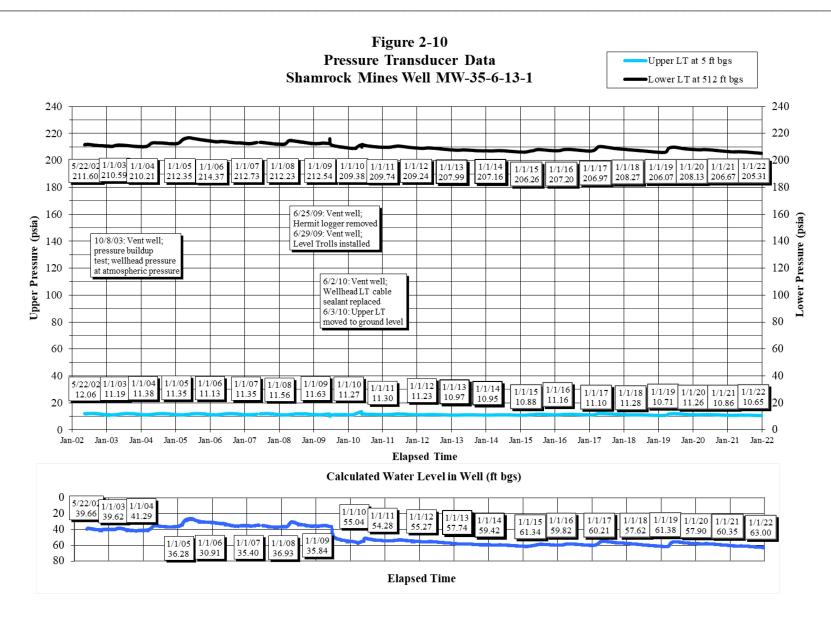
Figure 2-10
Pressure Transducer Data Shamrock Mines Well MW-35-6-13-1

Figures 2-10 shows the wellhead pressure regime continues to be at atmospheric pressure and fluctuates within a range of 2 psi (between 10 psia and 12 psia). During the months of April and May 2010, the wellhead pressure steadily increased to around 13.4 psia. Wellhead pressure returned to the historic atmospheric pressure trend after the Level Troll wellhead cable sealants were replaced on June 2, 2010.

Figure 2-10 also shows the downhole pressure and calculated water level in the well continued to exhibit an overall declining well pressure trend for the period of record since April 2005. With wellhead pressure equal to atmospheric pressure, fluctuation of downhole pressure is associated with the fluctuation of the water level in the well. Downhole pressure and corresponding calculated water levels have documented seasonal groundwater recharge events following the wet winters of 2007-2008, 2009-2010, 2016-2017 and 2018-2019.

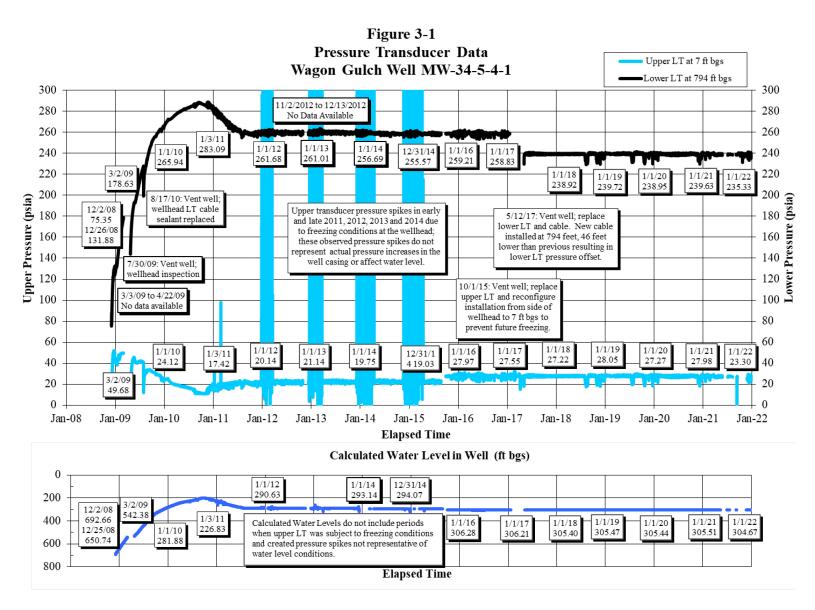
Figure 3-1
Pressure Transducer Data Wagon Gulch Well MW-34-5-4-1

2008. Figure 3-1 shows the trend of rising water level with corresponding increasing downhole pressure continued in 2010 until the trend reversed in mid-September 2010. This may have been related to the transducer cable sealant being changed on August 17, 2010 and possibly eliminating a partial shut-in condition. No leaks were detected during the site inspections in 2012-2014. Between October 1, 2010 and December 31, 2010, Figure 3-1 shows the water level decreased about 21.2 feet while the downhole pressure decreased about 2.7 psia.

During the winters of 2011-2012, 2012-2013, 2013-2014 and 2014-2015 pressure spikes in the upper transducer occurred due to the pressure transducer freezing within its deployment location in the wellhead 2.3 feet above ground surface. These are not actual increases in gas pressure within the well casing, but rather caused when the air volume next to the transducer inlet is trapped and then compressed by expanding frozen water condensate. When the 2011 well inspection was conducted at MW 34-5-4-1 the well was vented to ensure that the transducer would return to atmospheric pressure; this test successfully showed that the transducer continued to function properly and was not damaged. The transducer recovered after surface temperatures warmed each spring. The transducer was inspected for damage in each subsequent site visit since this problem began in 2011 until the 2015 site inspection when the Level Troll was replaced and lowered into the well to 7 ft bgs. As evidenced by the winter 2015 data shown in Figure 3-1, the condensate freezing problem in this location has been corrected by lowering the Level Troll below the ground surface.

Several pressure decreases on the order of 10 psi were observed by both the upper and lower transducers in the second half of 2018, 2019, and 2020, and then fairly consistently during 2021. The duration of each event was on the order of days to weeks and full recovery to static pressure conditions occurred after each event. These are likely observed interference effects from nearby groundwater production.

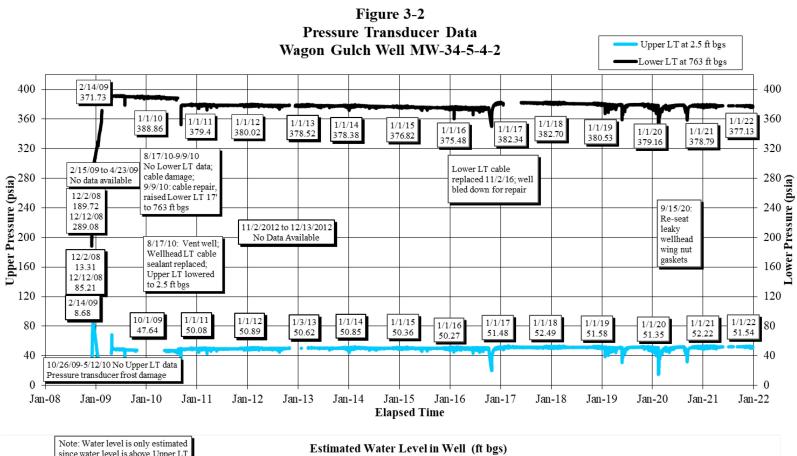
Figure 3-2 Pressure Transducer Data Wagon Gulch Well MW-34-5-4-2

Figure 3-2 shows a relatively constant wellhead pressure of about 47 to 48 psia between April 24, 2009 and October 25, 2009. An erratic pressure spiking pattern between October 26, 2009 and May 12, 2010 suggested wellhead Level Troll pressure sensor freeze damage, so the data were omitted from Figure 3-2. Between May 13, 2010 and August 16, 2010, the wellhead pressure remained fairly constant at around 47 psia.

Freeze damage to the upper Level Troll pressure transducer sensor was confirmed after the well was vented on August 17, 2010. As noted on Figure 3-2, the water level inside the open wellhead was at a height of about 2.5 feet above ground level. The new upper Level Troll was changed from an external mount to an internal depth setting of 2.5 ft bgs on August 17, 2010 to protect the transducer sensor from freezing conditions. After well shut-in on August 17, 2010, Figure 3-2 shows a relatively rapid return of wellhead pressure to an average constant pressure of about 50 psia.

The lower Level Troll cable was damaged during replacement of Level Troll wellhead cable sealants on August 17, 2010. Cable repair performed on September 9, 2010 included raising the Level Troll 17 feet from 780 ft bgs to 763 ft bgs. As a result of this change, Figure 3-2 shows a shift in the downhole pressure curve to a corrected constant downhole pressure regime of 378 to 379 psia.

As noted above, the water level was inside the open wellhead at a height of about 2.5 feet above ground level on August 17, 2010. The wellhead pressure build-up after shut-in may reflect water and/or gas pressure build-up. For charting purposes, the water level in the shut-in well is estimated to be at or near ground surface above the upper Level Troll (set at 2.5 ft bgs). However, there is a possibility that the observed build-up in wellhead pressure is from gas pressure, which could result in a downward displacement of the water in the well to some level below the upper Level Troll.

The pressure regime observed in 2021, as well as for the full period of record since post-completion stabilization in 2009, has been quite stable with an overall minor decreasing trend. The exception is apparent multiple drawdown cycles observed in 2019 and 2020, which are likely observed interference effects from nearby groundwater production.

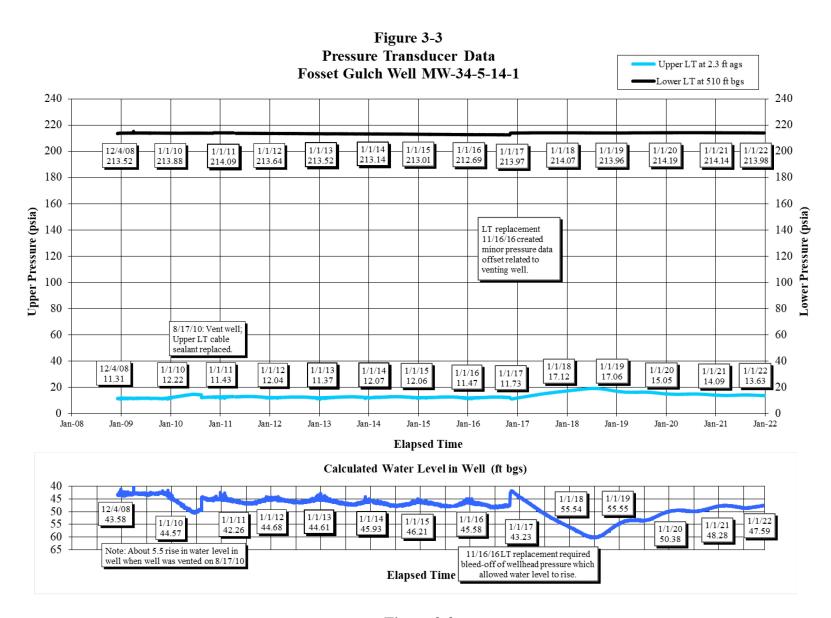
Figure 3-3 Pressure Transducer Data Fosset Gulch Well MW-34-5-14-1

Figure 3-3 charts the upper and lower pressure transducer data and the calculated water level in the well. Table 3-2 and Figure 3-3 show the wellhead pressure at atmospheric pressure prior to 2010 followed by a gradual increase in pressure through August 16, 2010 to 14.19 psia. Following the August 17, 2010 well maintenance event including venting, the wellhead pressure has remained relatively constant within a normal atmospheric pressure range through November 16, 2016. At that time, upper transducer replacement required venting the wellhead. Following the maintenance, the wellhead pressure increased slowly until July 2018 when it began to trend down. This is likely a response to gas production stimulation that occurred when the well was vented. Figure 3-3 shows a stable downhole pressure trend (213.52-214.19 psia) for the entire period of record. Figure 3-3 also shows a stable water level averaging 43.0 ft bgs until November 2009, followed by a gradually declining water level trend through July 1, 2010 (50.13 ft bgs). The water level increased to 49.28 ft bgs until the well was vented on August 17, 2010. The water level immediately rose to 44.36 ft bgs when the well was vented on August 17, 2010 but has since followed apparent gentle seasonal fluctuation until November 16, 2016. At that time, the well was vented to replace the upper pressure transducer. Upon replacement, the pressure measured at the wellhead has steadily increased from approximately 12.20 psi to 17 psi on January 1, 2019 and then changed to a decreasing pressure trend. As such, the calculated water level was in steady decline during this time period as gas pressure has apparently depressed it. Likewise, with the 2018 reversal of the wellhead gas pressure

2021 4M Project Monitor Wells Summary Report - Final	COGCC
increase trend to a decreasing trend, the calculated water level is now shown superimposed over seasonal fluctuations.	to be increasing through 2021
3-7

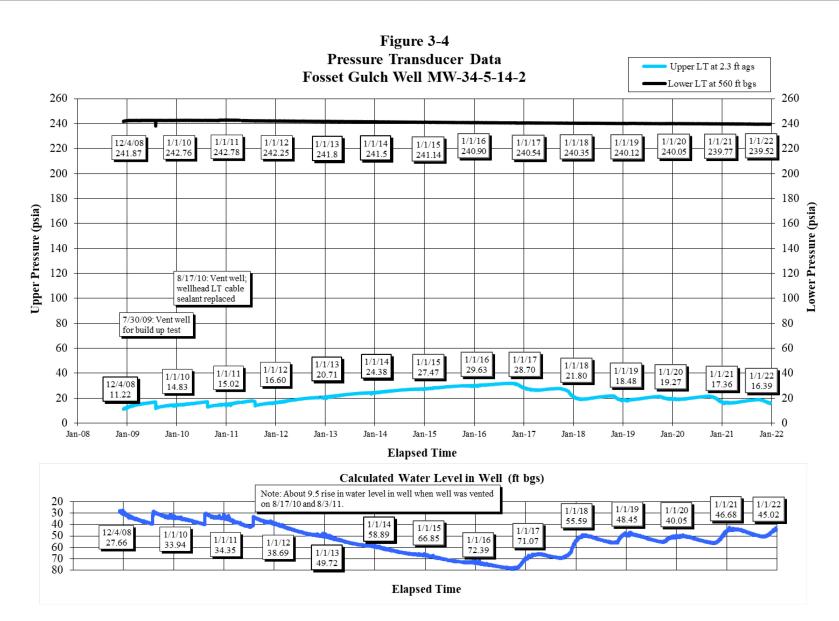
Figure 3-4
Pressure Transducer Data Fosset Gulch Well MW-34-5-14-2

Figure 3-4 plots the upper and lower pressure transducer data and the calculated water level in the well. Although the well was shut in for monitoring on December 4, 2008, wellhead pressure did not stabilize at about 17 psia until July 2009. Table 3-2 and Figure 3-4 show a net increase of 5.04 psi in wellhead pressure for the period of record between December 4, 2008 (11.35 psia) and January 1, 2022 (16.39 psia). Figure 3-4 shows a stable but slightly declining downhole well pressure trend for the entire period of record, with fluctuations ranging between a minimum pressure of about 239.52 psia to a maximum pressure of 242.78 psia. The downhole pressure was 239.52 psia on January 1, 2022, a new low as the pressure trend has been very slightly decreasing over 13 years of monitoring.

Table 3-2 indicates a net water level drop of 5.73 feet in the well as of January 1, 2022. However, Figure 3-4 shows that the wellhead pressure and water level in the last five years has apparently shown an effect of venting MW 34-5-14-1 for maintenance on 11/16/16. This would suggest some amount of hydraulic connection between the two wells. Although there is an immediate drop in wellhead pressure and corresponding rise in the water level each time the well is vented to the atmosphere in the past, Figure 3-4 also shows the build-up in wellhead pressure takes approximately 12 months to return to the pressure exhibited prior to each venting event so unless required for servicing the instrumentation, the well will not be vented in attempt to determine the static wellhead pressure.

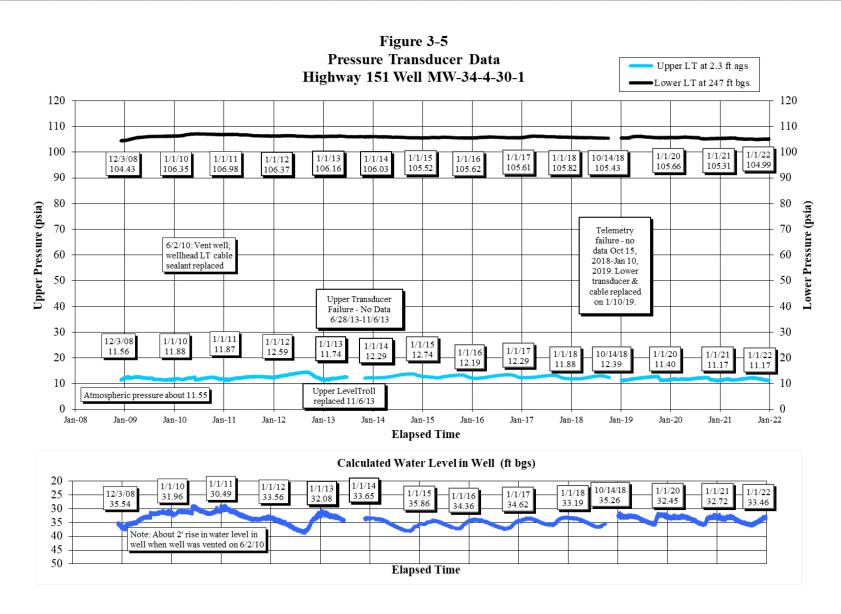
Figure 3-5
Pressure Transducer Data Highway 151 Well MW-34-4-30-1

Figure 3-5 charts the upper and lower pressure transducer data and the calculated water level in the well. Table 3-3 and Figure 3-5 show a relatively stable well pressure regime with a stable wellhead pressure trend at atmospheric pressure, a stable downhole pressure trend of about 104-107 psia, and a fluctuating water level trend of 30-39 ft bgs since August 2009. Sharp fluctuations in both wellhead pressure and the calculated water level shown on Figure 3-5 correspond to the immediate loss of pressure when the well is vented (e.g., June 2, 2010), followed by a gradual return to the well pressure regime exhibited prior to venting the well.

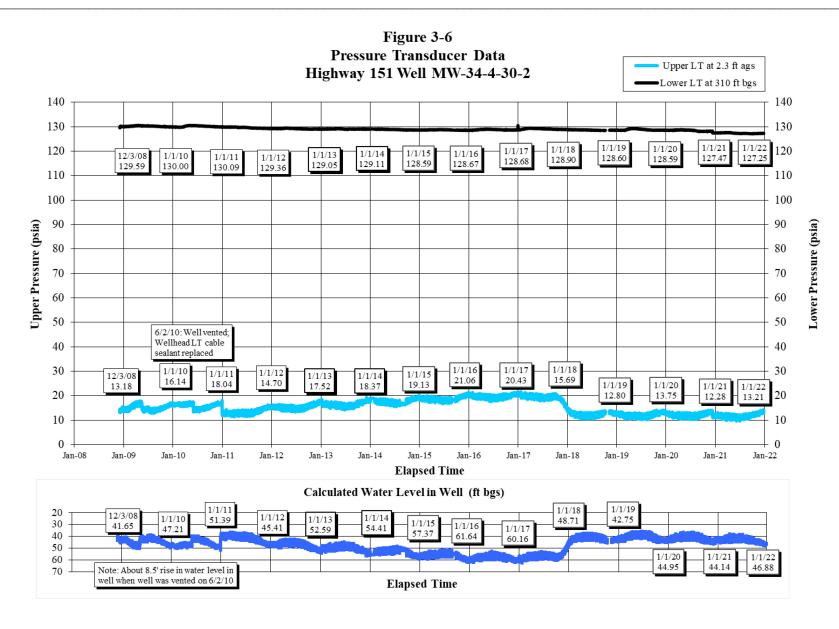
Figure 3-6 Pressure Transducer Data Highway 151 Well MW-34-4-30-2

Figure 3-6 charts the upper and lower pressure transducer data and the calculated water level in the well. Table 3-3 and Figure 3-6 shows a stable downhole pressure trend with 2.34 psi change from 129.59 psia on December 3, 2008 to 127.25 psia on January 1, 2022. In addition, there was a net wellhead pressure decrease of 0.03 psi with a corresponding net water level decline of 5.23 feet for the entire period of record from December 3, 2008 to January 1, 2022. However, the wellhead pressure decreased slowly in the fourth quarter of 2017 with a loss measured at approximately 4.3 psi in 3 months. The pressure then stabilized at atmospheric pressure and has remained in that range through 2020. The well was inspected in 2019 during routine maintenance and no wellhead pressure leaks were found. A seasonal water level fluctuation trend has continued over the last four years superimposed over a long-term trend of approximately 0.5 feet of water level decline per year.

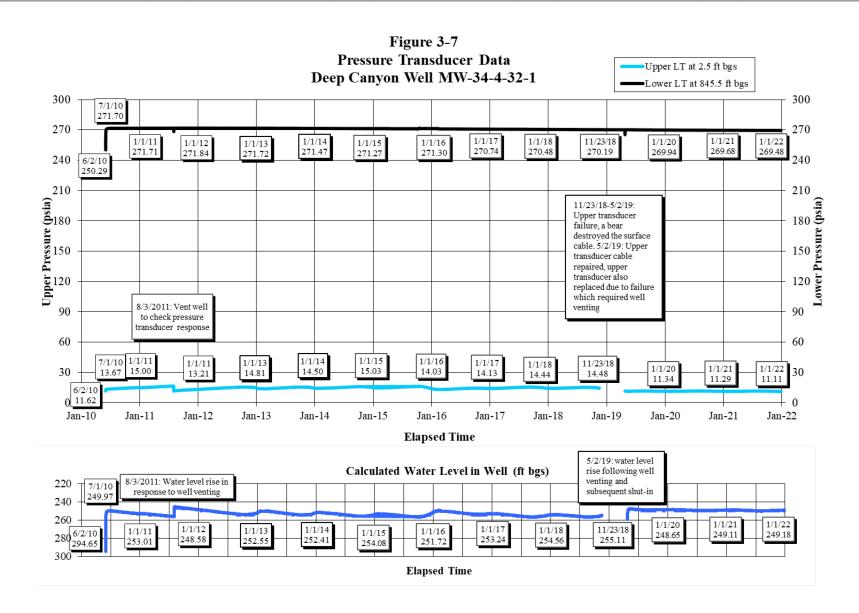
Figure 3-7
Pressure Transducer Data Deep Canyon Well MW-34-4-32-1

Figure 3-7 charts the upper and lower pressure transducer data and the calculated water level in the well. Table 3-4 and Figure 3-7 show the well pressure initially stabilized on June 8, 2010, six days after the well was shut in for monitoring on June 2, 2010. Table 3-4 and Figure 3-7 also show a relatively stable well pressure regime for the 11.5-year period of record through November 23, 2018 with only a slight increase in well pressure and a corresponding net water level decrease of 7.39 feet in the well. Data for this well is limited from November 23, 2018 to May 2, 2019 due to an upper Level Troll transducer failure. When investigated in early 2019 after the location was accessible following winter it was found that the surface cable for this Level Troll was damaged by what appeared to be a bear mauling of the telemetry station based on the type of cable damage and muddy paw prints on the telemetry instrumentation enclosure. At that time the cable was repaired, the Level Troll was replaced and full function has resumed. Since May 2, 2019, the upper and lower pressure transducer data has been stable, with corresponding stable calculated water levels which do not seem to demonstrate significant seasonal fluctuation.
