Colorado Oil and Gas Conservation Commission

**Monitor Wells Summary Report
2022**

**4M Project Monitoring Program
Archuleta and La Plata Counties
Colorado**

March 31, 2023

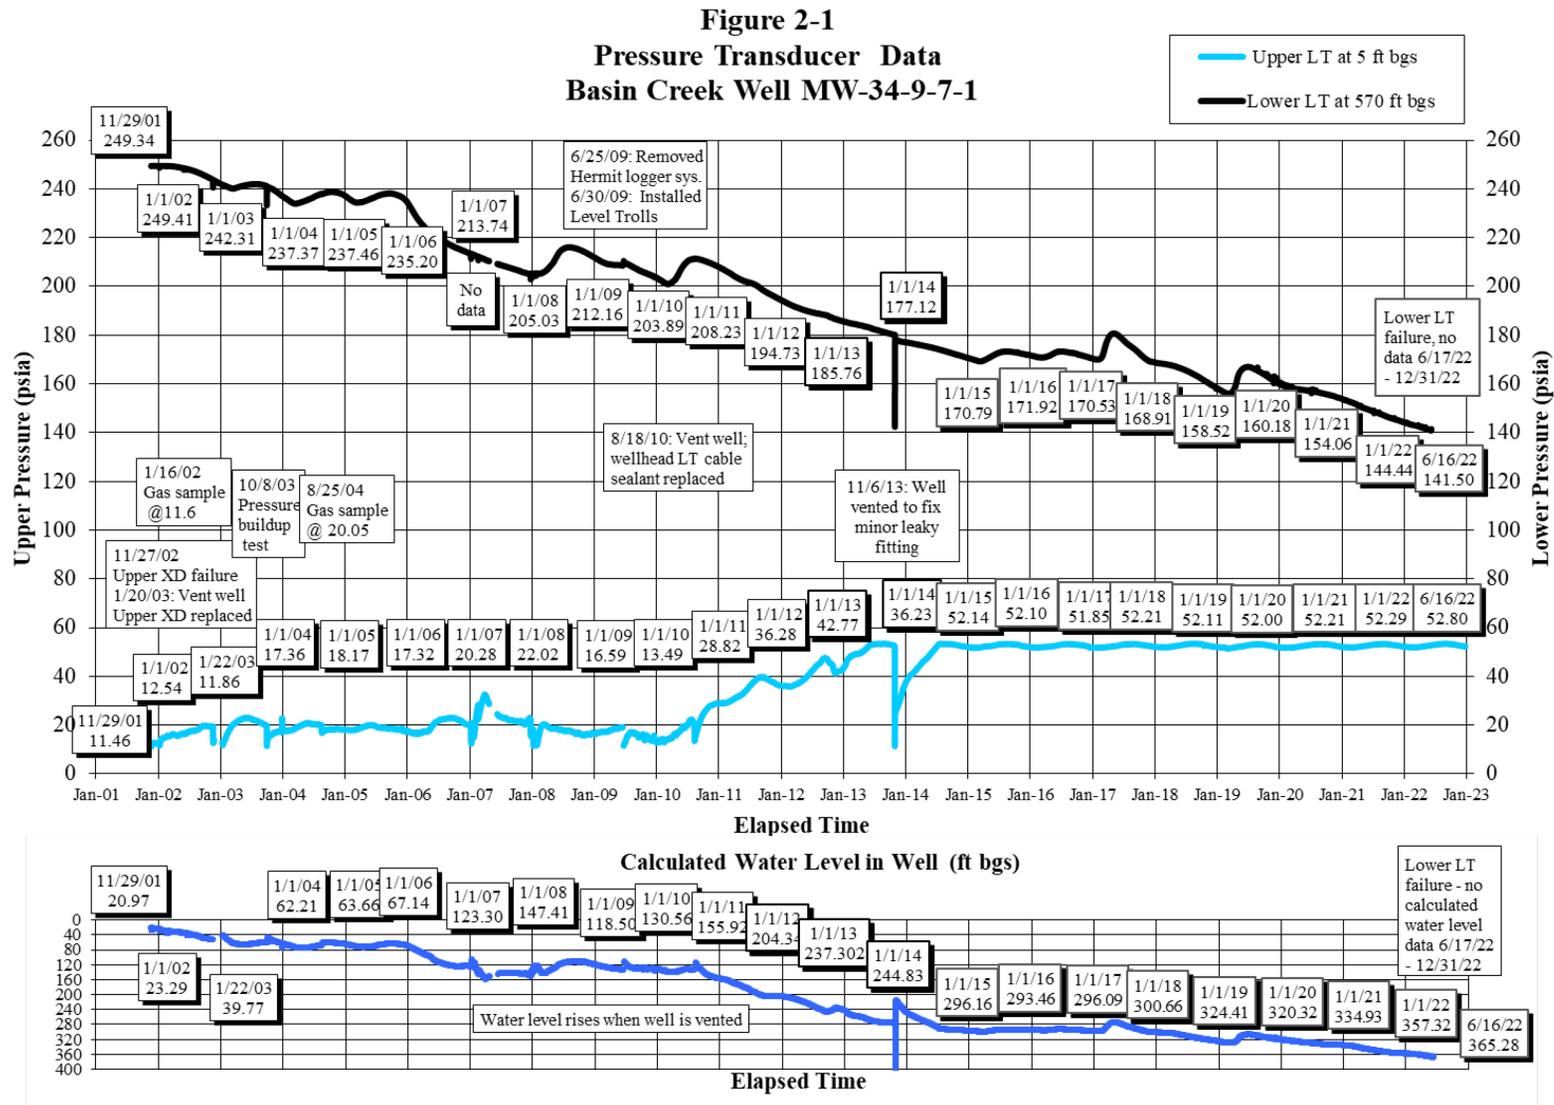
**Figure 2-1
Pressure Transducer Data Basin Creek Well MW-34-9-7-1**

Figure 2-1 charts the upper and lower pressure transducer data and the calculated water level in the well. Table 2-1 and Figure 2-1 show a net increase of 41.34 psi in wellhead pressure for the entire 21.5-year period of record from November 29, 2001 (11.46 psia) to June 16, 2022 (52.80 psia). The lower transducer stopped functioning on June 17, 2022, resulting in only a partial 2022 data set. Figure 2-1 generally shows a pattern of minor seasonal fluctuations within an overall stable trend in wellhead pressure prior to wellhead cable gland seal replacement on August 18, 2010, followed by a rise in wellhead pressure to a recorded high of 53.42 psia on September 11, 2013. A very minor leak persisted so on November 6, 2013 the well was vented to allow a safe condition to repair leaking threads at the wellhead. Recovery of the previous wellhead pressure occurred for about nine months following this wellhead venting. Since

recovery in the second half of 2014, wellhead pressure has remained relatively stable. 2019 data demonstrated a groundwater recharge response to the very wet winter of 2018-2019; this effect was greater in magnitude than a similar pressure and water level response to the wet winters of 2007-2008, 2009-2010, 2016-2017.

In contrast to the wellhead pressure patterns, Table 2-1 and Figure 2-1 show a substantial net decline of 344.31 feet in the calculated well water level and a corresponding net decline in downhole pressure of 107.84 psi for the period of record. Figure 2-1 also shows a pattern of slight seasonal fluctuations within the overall declining trend in the water level and corresponding downhole pressure for the period of record.

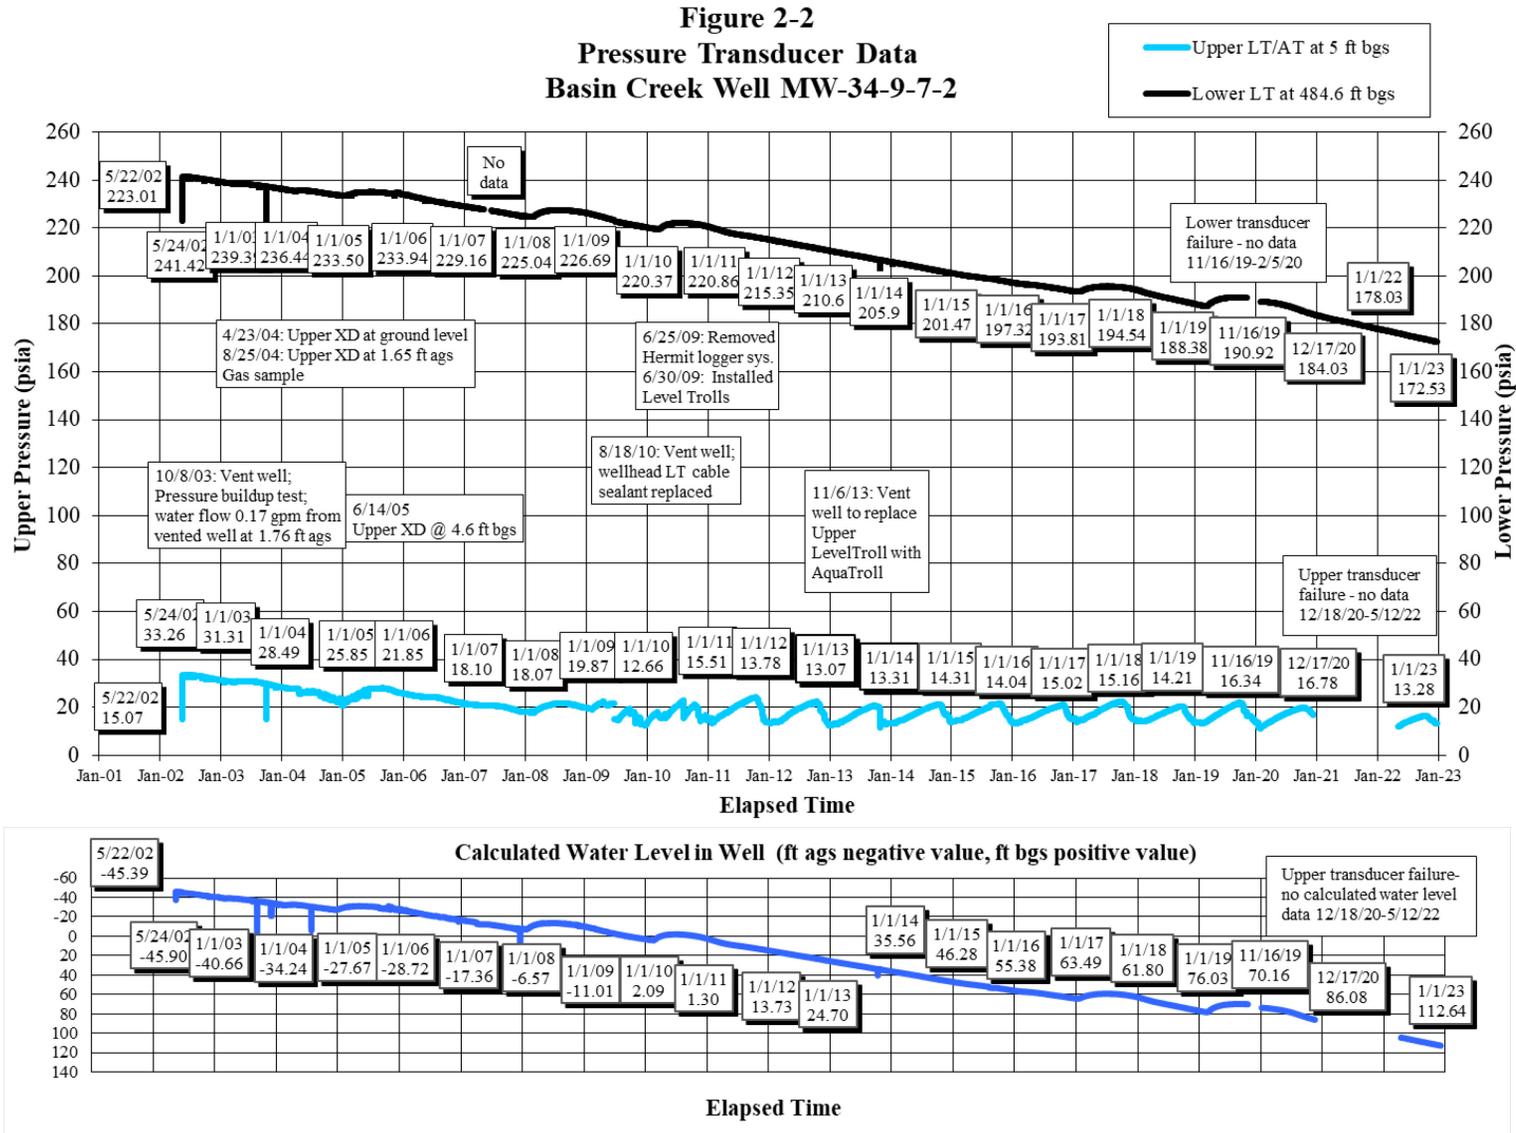
**Figure 2-2
Pressure Transducer Data Basin Creek Well MW-34-9-7-2**

A small amount of gas was released and artesian flow (~0.2 gpm) from the well consistently occurred each time the well was vented for maintenance during the period of record between 2002 and 2010. The pressure regime documented was relatively high pressure but low volume based on the head pressure versus artesian flow. Artesian flow from the well did not occur when the wellhead was vented on August 18, 2010 to replace the Level Troll wellhead cable Conax gland sealants. The final recorded upper transducer pressure in 2011 of 13.7 psi was very near atmospheric pressure indicating the well was essentially in hydrostatic balance. The pressure fluctuations since early 2009 suggest that ambient surface temperatures may be affecting the gas pressure as measured by the upper transducer. In order to attempt to distinguish water pressure versus gas pressure being recorded by the upper transducer, the Level Troll was replaced by an Aqua Troll, which records specific conductance (SC) in addition to pressure and temperature. The concept was that if water was present at the Aqua Troll, it would record an SC value greater than zero. If a value of zero was recorded for SC, then a pressure greater than atmospheric pressure would be gas pressure only. The Aqua Troll was installed on November 6, 2013, but it appears by this time the static water level in this well had dropped from the near-surface balance of 2009-2011. 2017 brought a change in trend of the downhole pressure; it increased slightly throughout the first half of 2017, plateaued and then continued to decrease in the linear trend followed since mid-2011. This was a similar trend as observed in 2010. 2019 data demonstrated a groundwater recharge response to the very wet winter of 2018-2019, similar to that observed after the wet winters of 2007-2008, 2009-2010, 2016-2017.

Substantial water level decline has been documented in this well, going from artesian flowing with a calculated shut-in head of approximately 53 feet above ground surface just after construction to 162.91 feet below ground surface on January 1, 2023. This calculated water level data set has been verified by a manual open-well water level measurement on November 6, 2013 of 40.20 ft bgs used as a calibration point for water level calculation using the lower Level Troll data within fifteen minutes on the same date of 40.46 feet below ground surface.

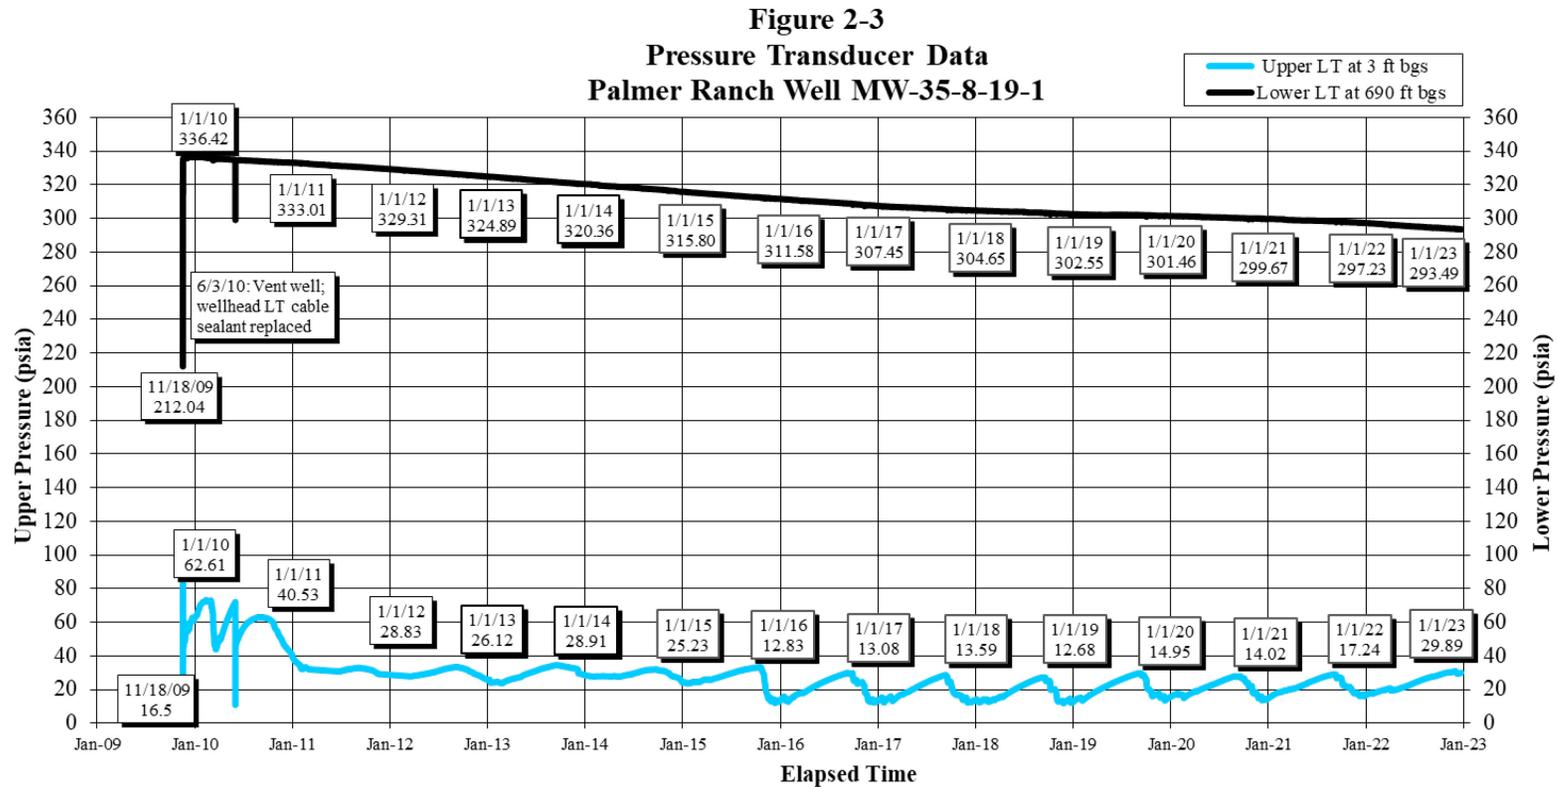
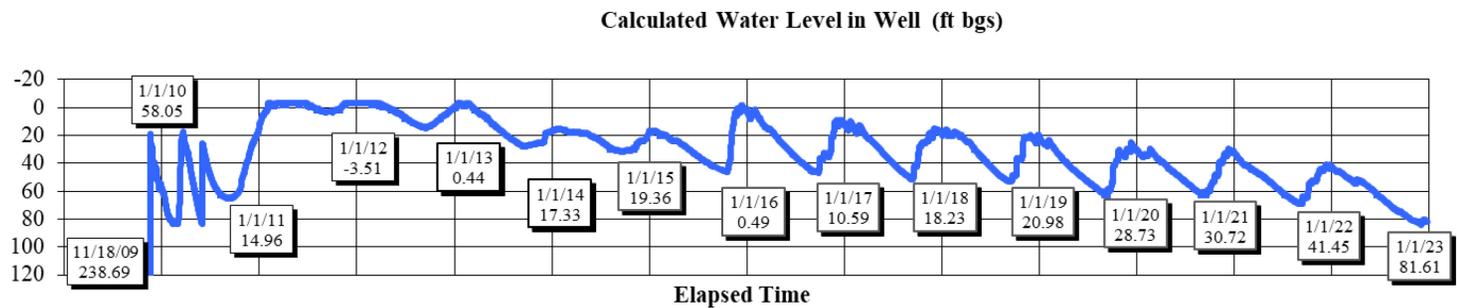
**Figure 2-3
Pressure Transducer Data Palmer Ranch Well MW-35-8-19-1**

In late October 2015, wellhead pressure apparently began dropping slowly from approximately 33 psi to approximately 12 psi in mid-December 2015. Wellhead pressure then was fairly stable through the winter and then slowly built up from late winter through late summer. The pressure trend appears to be similar but stronger seasonal trend that has been occurring since 2011. The trend repeated through 2022 and suggests the well has been demonstrating an apparent increased response to seasonal groundwater level

changes, increased local groundwater production effects or coal seam reservoir pressure fluctuations. The Florida River runs immediately adjacent to the well and flows are significantly impacted by agricultural irrigation schedules, which may have both direct and indirect effects on observed Fruitland coal seam reservoir pressure and water levels.

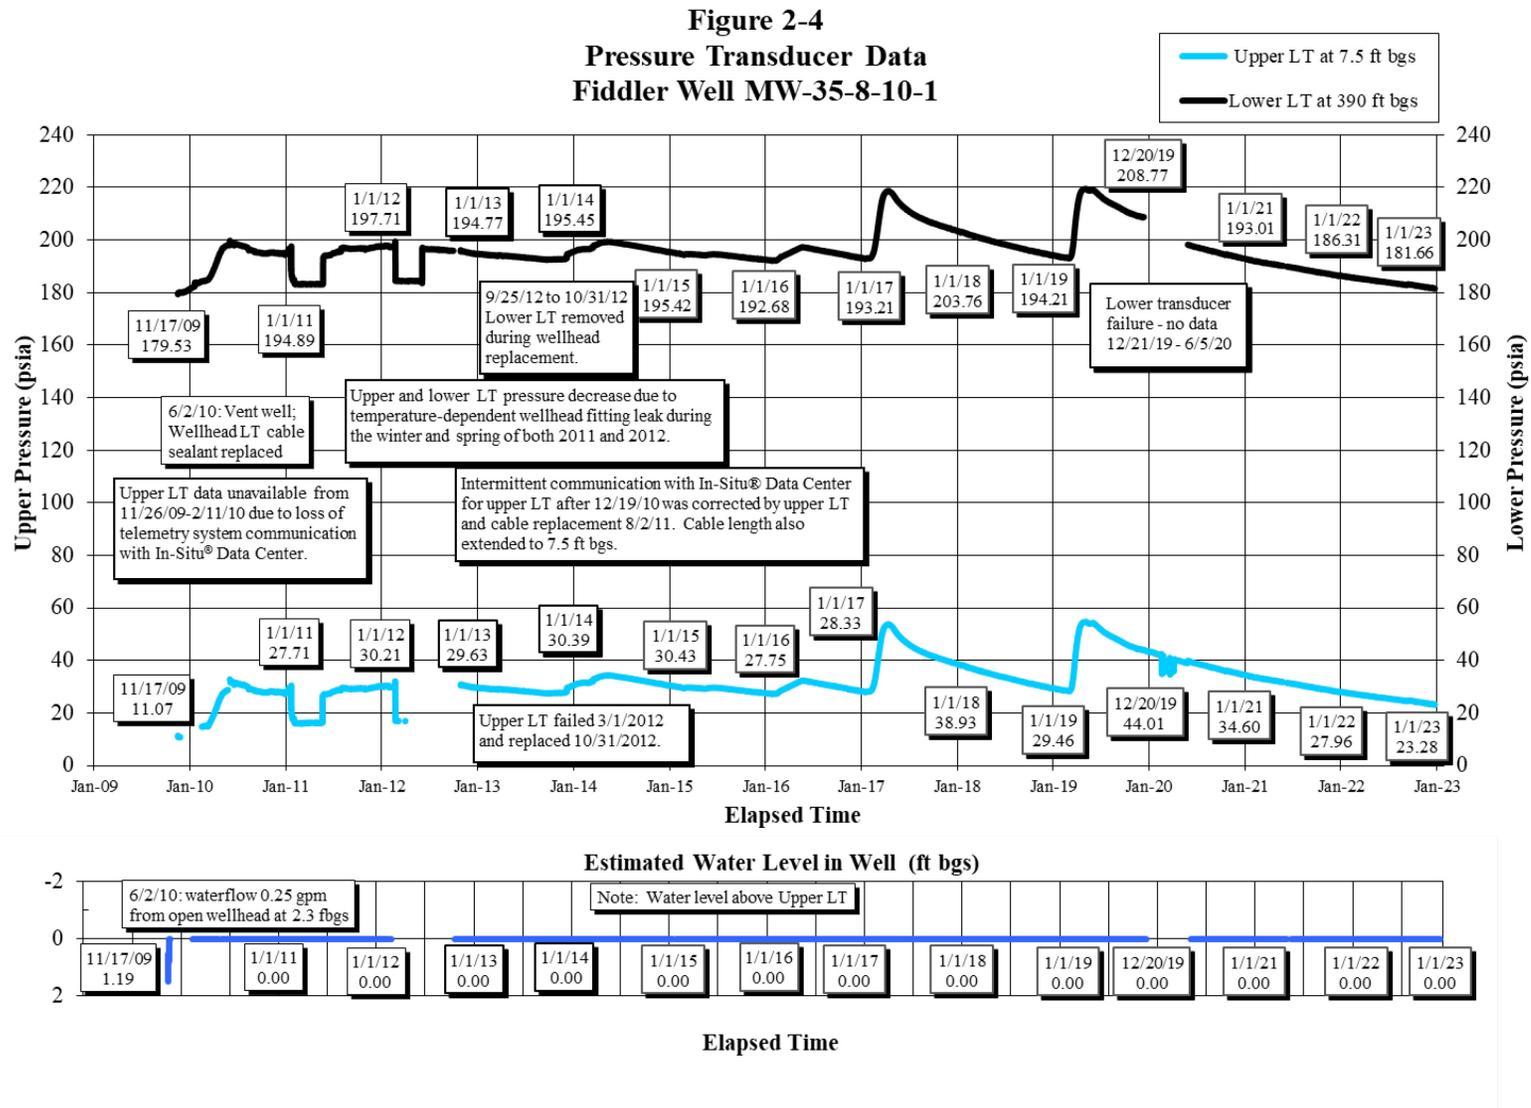
**Figure 2-4
Pressure Transducer Data Fiddler MW-35-8-10-1**

Monitoring data for MW 35-8-10-1 are plotted in Figure 2-4. The net change in wellhead pressure is 8.44 psi and the net change in downhole pressure is -2.64 psi for the 13-year period of record. As Figure 2-4 shows, both the wellhead pressure and downhole pressure steadily increased from installation on November 17, 2009 to early June, 2010. This well has seen moderate fluctuation in the pressure regime, however instrumentation problems and wellhead leakage occurred until 2013. These issues are discussed below.

As noted on Figure 2-4 the lower Level Troll was removed during wellhead maintenance on September 25, 2012 and reinstalled on October 31, 2012. A net water level change was not calculated because the upper transducer is below the water level in the well. Figure 2-4 documents a natural flow rate from the well at a rate of 0.25 gallons per minute (gpm) when the well was vented for maintenance on June 2, 2010. At the time of the well inspection on October 31, 2012, the flow rate was measured at 0.14 gpm. For charting purposes, the water level in the shut-in well is estimated to be at or near ground surface above the upper pressure transducer (set at 7.5 ft bgs).

Also noted on Figure 2-4, telemetry system communication with the In-Situ[®] Data Center for the upper transducer was lost from November 26, 2009 through February 11, 2010 due to cable connection problem and was intermittent from December 19, 2010 to January 1, 2011. The upper transducer and cable were replaced during the 2011 well inspection and the cable length was extended from 3 ft bgs to 7.5 ft bgs. Additionally, a wellhead fitting leak during the winter and spring of 2011 through the summer of 2012 caused a pressure decrease observed on both the upper and lower transducers. Related to the freeze-thaw cycles, the upper transducer failed again March 1, 2012. Inspection of the wellhead on June 6, 2012

revealed the minor water leak at an estimated flow rate of 0.1 to 0.2 gpm. Evidence of the wellhead freezing and then popping the wellhead seal is observed by the minor pressure spiking on both transducers in January 2011 and February 2012. The tubing head threading was cleaned in an attempt to achieve a pressure tight seal at the mandrel head, but both the rubber seals and threading had deteriorated significantly. Documentation was conducted for a later wellhead replacement. Souder Miller Associates supervised installation of the new wellhead on September 25, 2012, which required removal of all instrumentation from the well. Rather than reset the instrumentation at that time, it was planned to remain out of service until the well inspection conducted by COGCC, Norwest and In-Situ, Inc. on October 31, 2012. During that well inspection the upper transducer was replaced with a new 100 psia Level Troll. Also, as planned, the lower transducer and cable was reset, however the new set depth was approximately 15 feet deeper than the previous set depth, so the proper offset has been incorporated into the lower transducer data in Figure 2-4.

Since mid-2014, the Fiddler monitoring well showed a fairly steady decline in bottom-hole and wellhead pressure of approximately 6 psi through January 1, 2016. However, bottom hole and wellhead pressure measurements show a steady increase of approximately 5 psi from late February 2016 through May 2016. This could have been a response related to temporary shut-in of one or more nearby coal bed methane production wells. A similar pressure decline trend as the 2014-2015 resumed in June 2016.

2017 demonstrated a substantial pressure build-up measured on both the upper and lower transducers. It appears to represent significant groundwater recharge to at least one, if not all of the five Fruitland coal seams monitored in the Fiddler well following the wet winter of 2016-2017. This effect is observed again with similar magnitude following the very wet winter of 2018-2019.

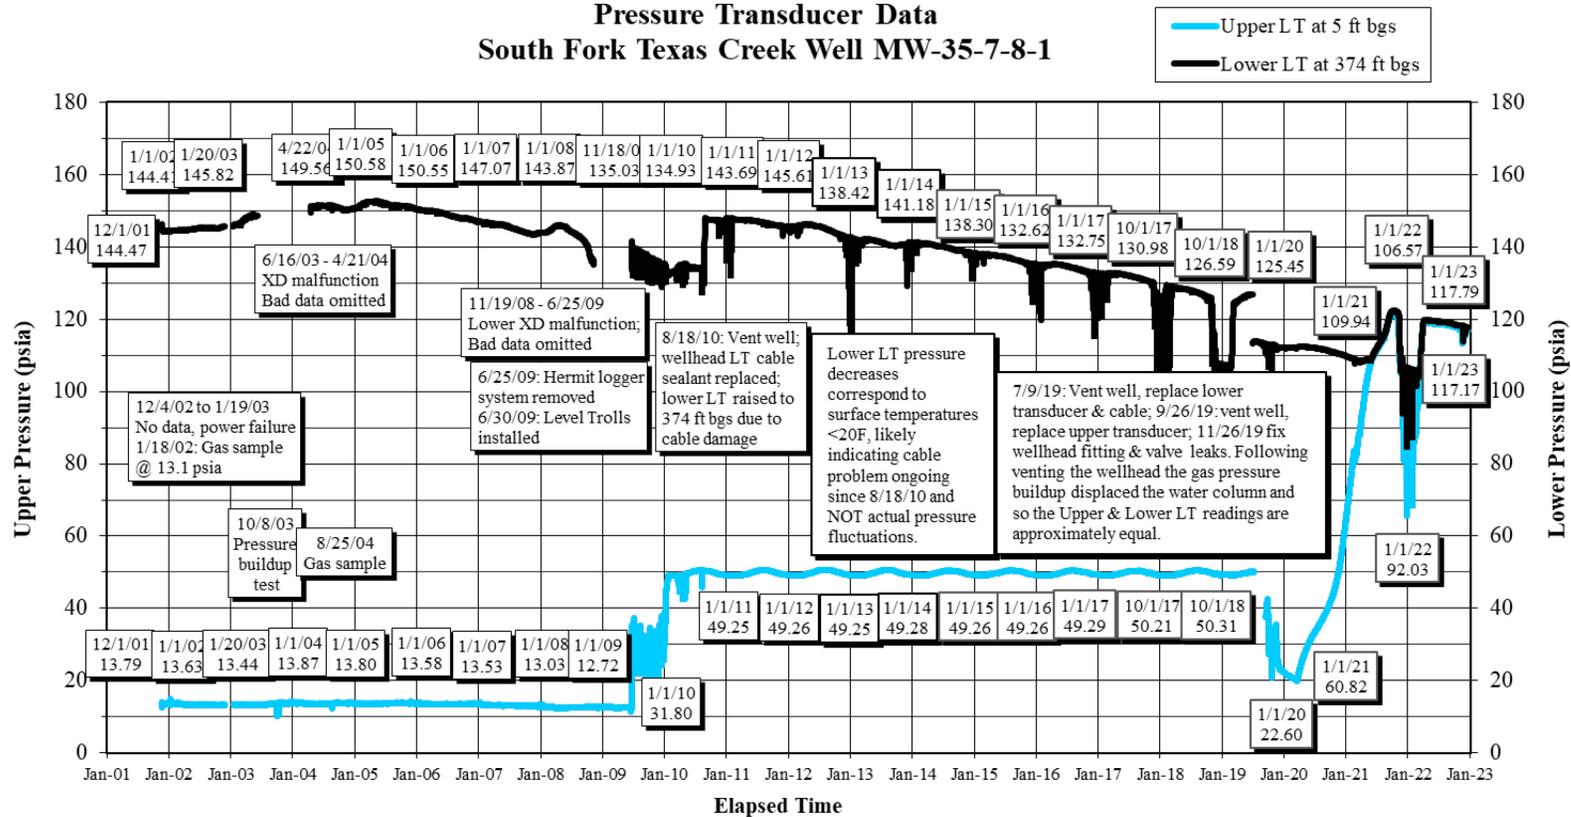
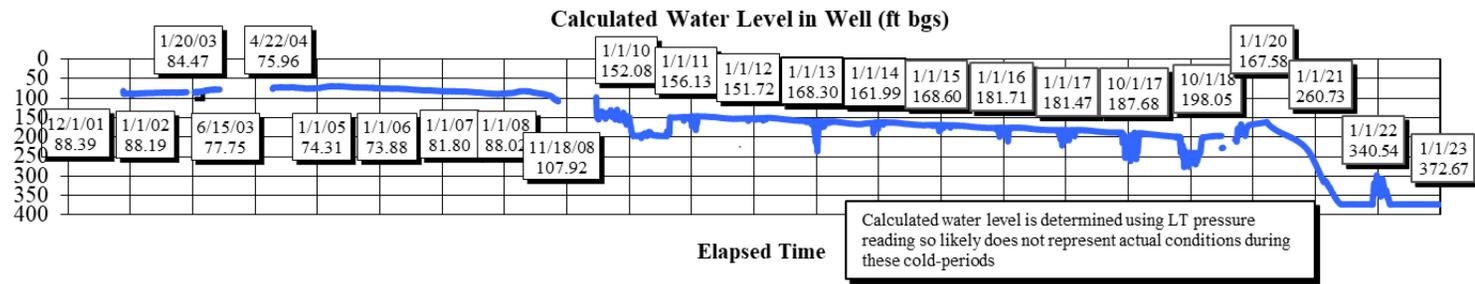
**Figure 2-5
Pressure Transducer Data South Fork Texas Creek Well MW-35-7-8-1**

of record during winter (cold) periods. In the summer of 2019, the lower transducer and cable were replaced as planned to address the cold weather pressure spikes. The upper transducer was replaced due to failure. Following those repairs and during the subsequent shut-in, the wellhead pressure declined for a period of several months until April 1st of 2020. At that time there was a significant, fairly steady wellhead pressure increase of over 100 psi through September of 2021, which may relate to decrease of groundwater production and thus an increase of reservoir gas pressure in the vicinity, or an intrawell pressure regime transition created by the first venting of this well since 2010. The difference in pressure readings between the upper and lower Level Trolls since June 2021 is only about 0.6 psi (1.4 feet) and demonstrates that the lower Level Troll is now only submerged by 1.4 feet of water, or more likely, the lower Level Troll is no longer submerged and the difference in readings is simply due to accuracy differences between the two Level Trolls. The corresponding calculated water level has decreased approximately 210 feet since the 2019 wellhead venting and instrumentation repairs, but as discussed previously, the water level may be lower given a total well depth of 463 feet below ground surface and a lower Level Troll set depth of 374 feet below ground surface.

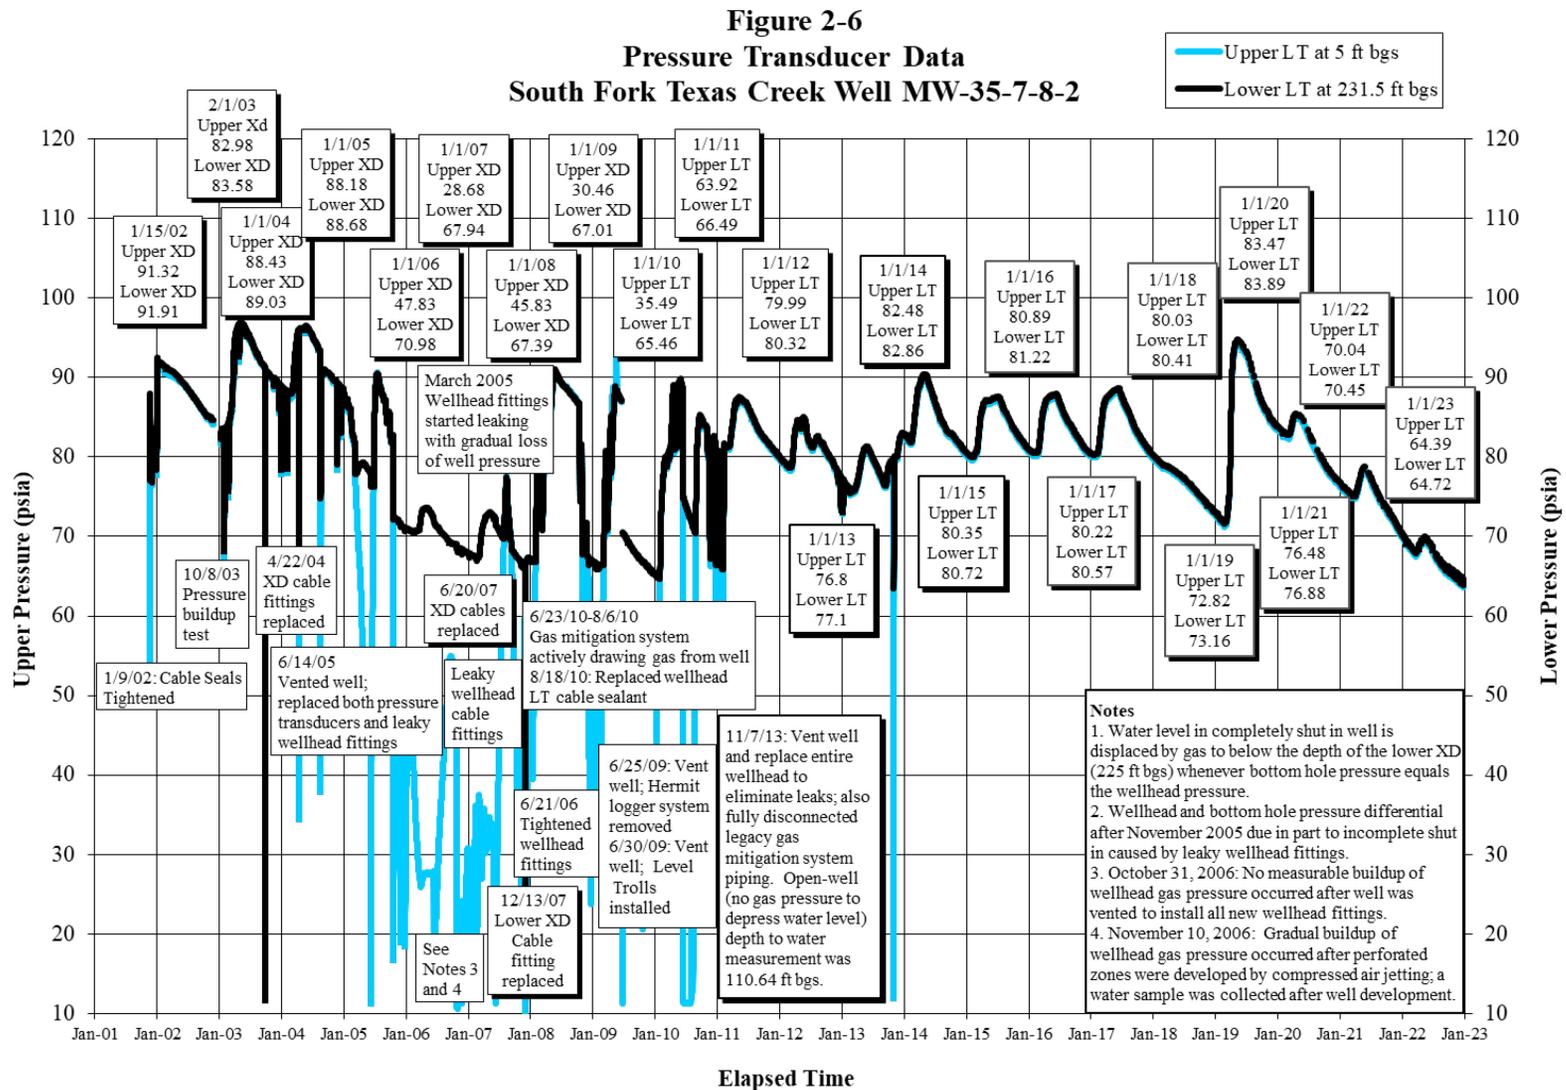
**Figure 2-6
Pressure Transducer Data South Fork Texas Creek Well MW-35-7-8-2**

Figure 2-6 charts the pressure data for well MW 35-7-8-2. Figure 2-6 shows nearly equal wellhead and downhole pressures for the period of record when the well is completely shut in. For example, wellhead and downhole pressures recorded on January 1, 2023 were 64.39 psia and 64.72 psia respectively under shut-in conditions. Based on the period of record to date, incomplete well shut-in is indicated whenever the well pressure drops below about 70 psia.

Figure 2-6 shows a fairly rapid increase in well pressure after the well was shut in on August 18, 2010. The peak build-up pressure of about 85 psia on September 28, 2010 was followed by an erratic decline in well pressure. The inspection of the well in 2013 documented a minor fitting leak at that time; this was a consistent leak on a pipe fitting that has been attempted to be tightened in the past years but required significant replacement of numerous wellhead fittings. The colder air temperatures occurring with early winter of 2012 and again in 2013 appeared to cause some erratic pressure fluctuations documented with the upper and lower transducers in Figure 2-6. This seemed to indicate that the leak was becoming more significant. On November 7, 2013 a site-specific follow-up trip was conducted to repair the leak that had been most recently documented on September 30, 2013. The well gas pressure was allowed to safely bleed down, with continuous gas detector monitoring. Both upper and lower Level Trolls were removed from the well and the wellhead was completely removed down to the 2-inch line pipe that is the well casing extending up from the cement pad. The threads were reconditioned with a hand-operated 2-inch

A fairly consistent well pressure trend was observed for the previous four years, 2014 – 2017, whereby the well pressure builds in the first two quarters of the year and then falls off during the second two quarters. This trend may be documentation of seasonal effects of groundwater recharge and discharge, natural or otherwise. As 2018 was documented with extreme drought conditions, it appears that the monitored interval did not receive the typical magnitude of recharge. The pressure trend continued to decrease during the usual recharge period of early 2018, with minimal superimposed recharge noted as a slight reversal in the pressure curve character. The excessively wet winter of 2018-2019 appears to have caused a substantial well pressure increase in the late winter and early spring of 2019, with the usual pressure fall-off occurring following for the remainder of the year. The pressure record appears to show that in 2022 the trend was similar to 2019-2021, which is an overall declining trend with an apparent minor seasonal recharge pattern.

pipe die. The wellhead was reconstructed using all new carbon steel pipe fittings, with the exception of the Conax compression fittings secured around each Level Troll Rugged Cable, as they had not been documented as leaking. Several manual water level measurements were taken while the wellhead was open. Initially, the water level recovered fairly quickly as the gas pressure was vented. After approximately 2.5 hours open during the new wellhead installation, the water level was relatively stable and measured 110.64 ft bgs. This is the static water level when no gas pressure is allowed to depress the water column in the well. As can be seen in Figure 2-6, the upper and lower Level Troll pressure readings diverge at this time indicating that for the short period following well shut-in the lower Level Troll was actually submerged in water. The lower Level Troll pressure reading was approximately 63.6 psia, which calculates to 111.06 ft bgs. This gives good confidence in the calculated versus measured water level in this well, given error in the assumption of atmospheric pressure which is not currently recorded at this location. To prevent damage to the existing lower Level Troll cable, the Conax compression fitting was not adjusted to offset the new wellhead's increased height above ground surface of 0.25 feet, so the new set depth is 231.25 ft bgs. No leaks have been detected at this wellhead since the replacement.

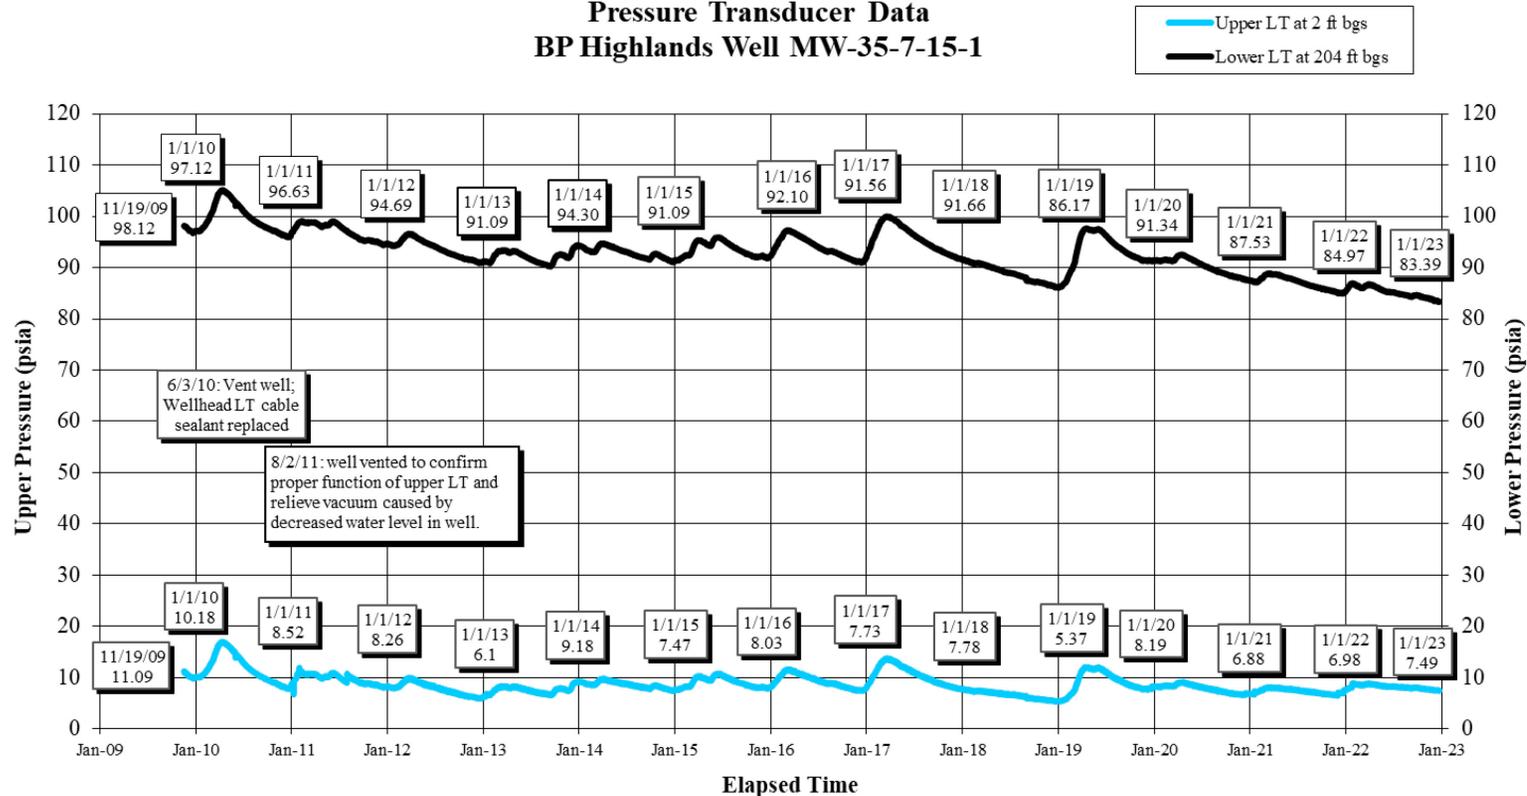
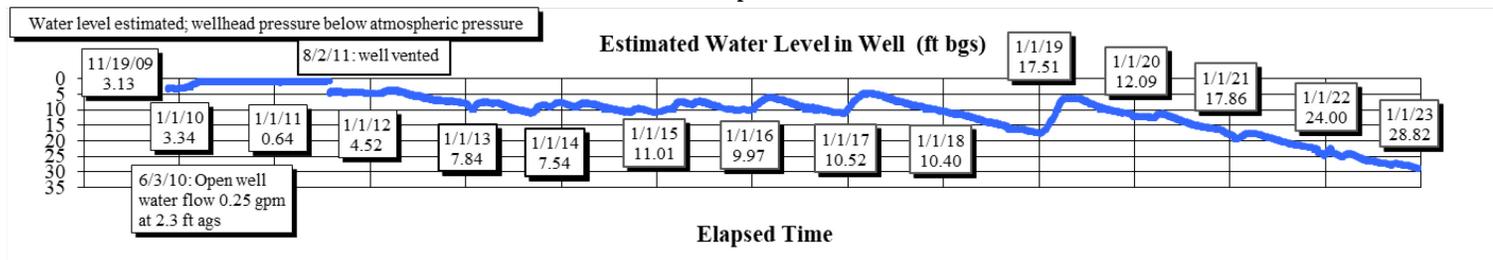
**Figure 2-7
Pressure Transducer Data BP Highlands Well MW-35-7-15-1**

Monitoring data for MW 35-7-15-1 are plotted in Figure 2-7. As summarized in Table 2-5 for the 13-year period of record, the net change in downhole pressure is a decrease of 14.73 psi. The well follows an overall decreasing pressure trend with seasonal variability dominated by late winter/early spring recharge. The net change in the calculated water level in the well is a decrease of 25.69 feet. The magnitude of this decrease was approximately doubled in 2018 due to extreme drought conditions and complete lack of observable recharge. This all but repeated again in 2020-2022, with a very muted recharge trend when compared to 2016 and 2017. As noted on Figure 2-7, water flowed from the well at a rate of 0.25 gallons per minute (gpm) when the well was vented for maintenance on June 3, 2010. For charting purposes, the water level in the shut-in well at that time was estimated to be slightly above ground surface with the upper transducer under water at 2 ft bgs.

The wellhead pressure started dropping below atmospheric pressure around August 12, 2010. This condition suggested either a potential problem with the upper transducer or a well pressure vacuum effect created in a completely shut-in well under declining water level conditions. A well instrumentation inspection and atmospheric pressure check conducted during each subsequent site visit through 2013 has confirmed the proper function of the upper transducer. Venting the well allowed for physical confirmation that the well was under vacuum pressure conditions which have continued through January 1, 2023.

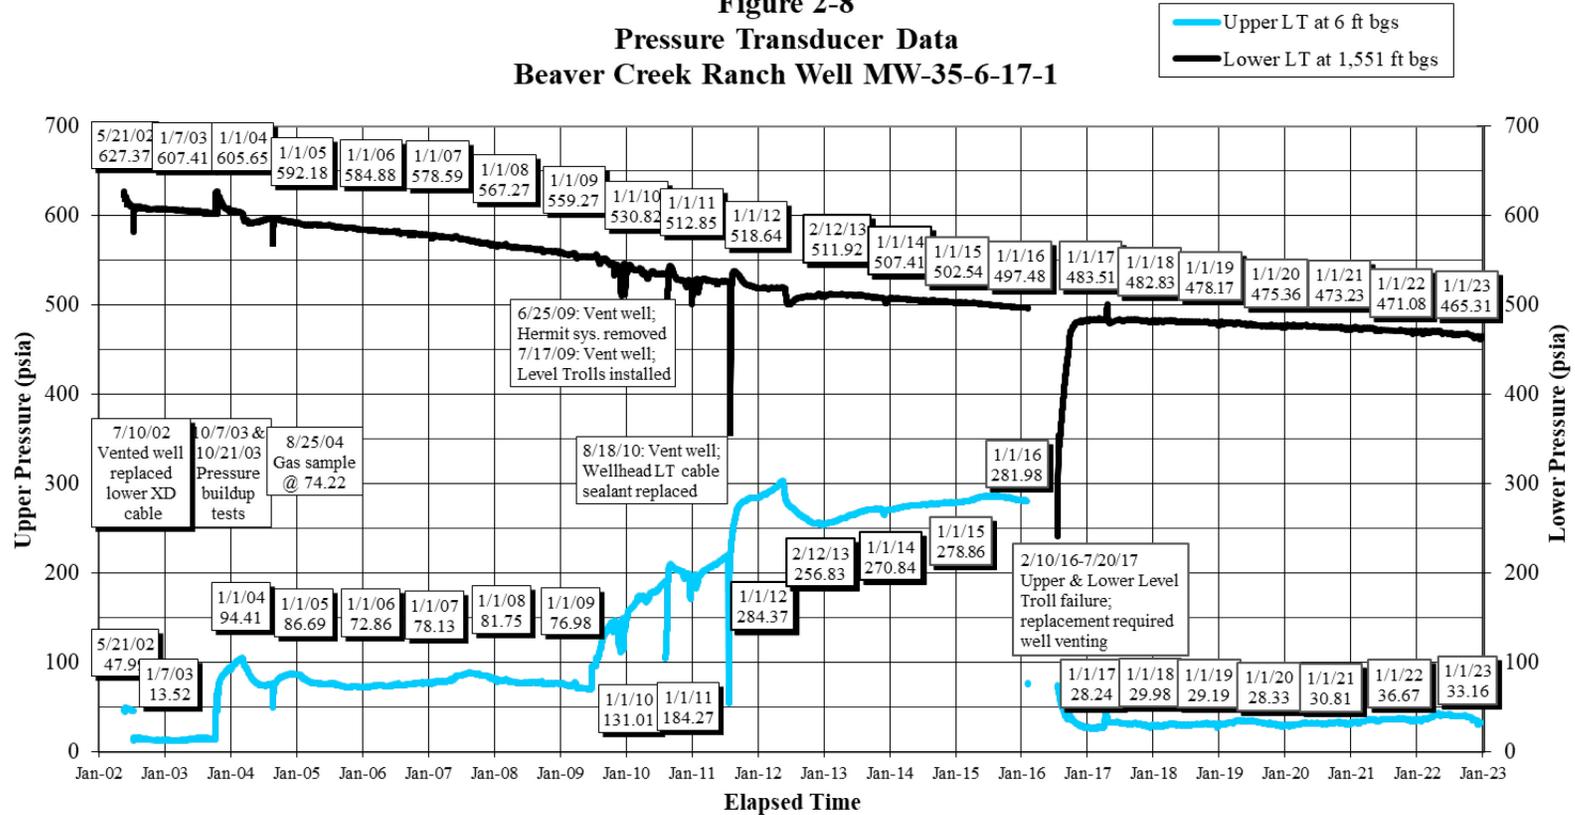
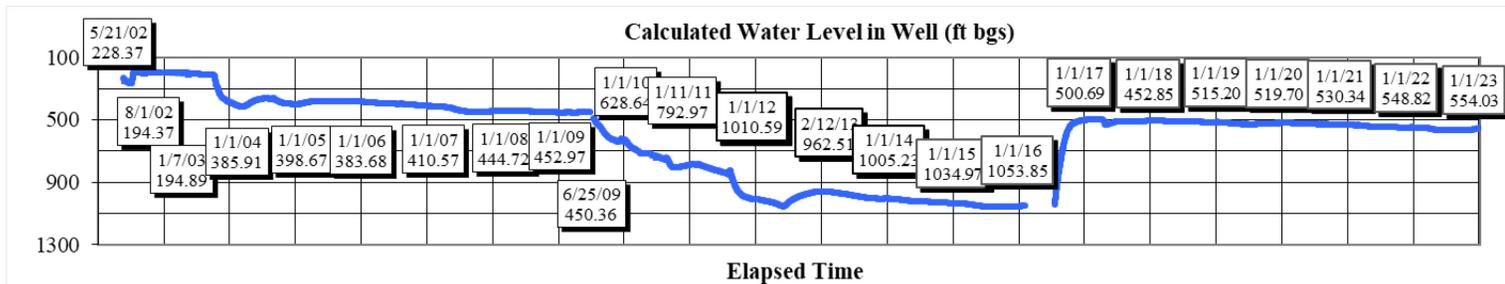
**Figure 2-8
Pressure Transducer Data Beaver Creek Ranch Well MW-35-6-17-1**

pressure regime. 2018-2022 pressure data demonstrates that following this bleed-off the wellhead pressure has remained depressed at approximately 30 psi and relatively stable but slightly increasing pressure trend. This is likely because the water head pressure of approximately 1000 feet (430 psi) is effectively preventing significant gas build-up at the wellhead.

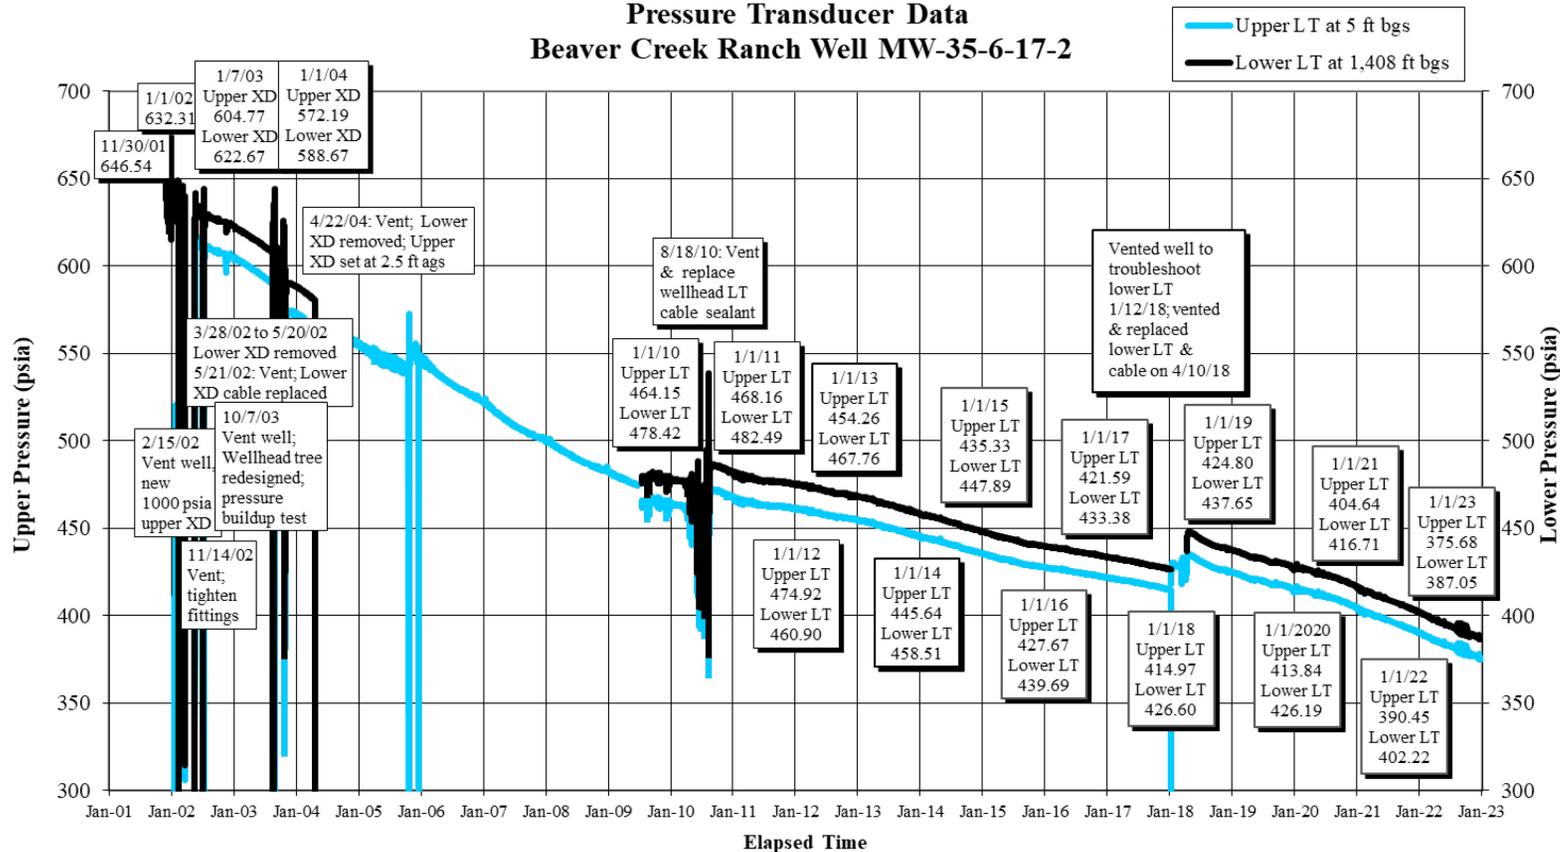
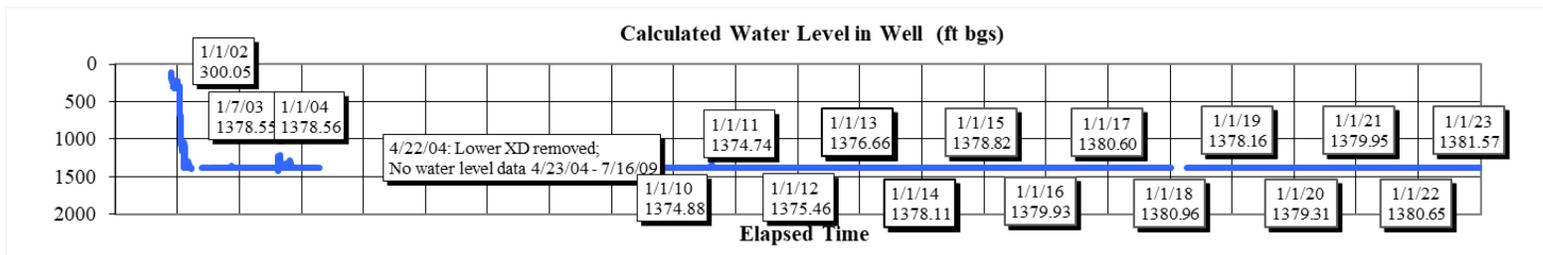
**Figure 2-9
Pressure Transducer Data Beaver Creek Ranch Well MW-35-6-17-2**

Figure 2-9 shows the well pressure in a declining trend for the entire period record. There is a notable shift in the well pressure curve following the installation of Level Troll instruments on July 17, 2009, followed by erratic well pressure fluctuations associated with incomplete shut-in through August 17, 2010. After the well was vented August 18, 2010 to replace the Level Troll cable fitting sealants, there was a steady build-up of well pressure through early September 2010 followed by a return to a declining trend through the period of record.

As shown on Figure 2-9, no water level data is available for the 6-year period of record when there was only one well pressure transducer. Well pressure data available after installation of wellhead and downhole Level Trolls on July 19, 2009 shows approximately 30 feet decline in the calculated water level and very little, if any seasonal influence on the overall well pressure regime.

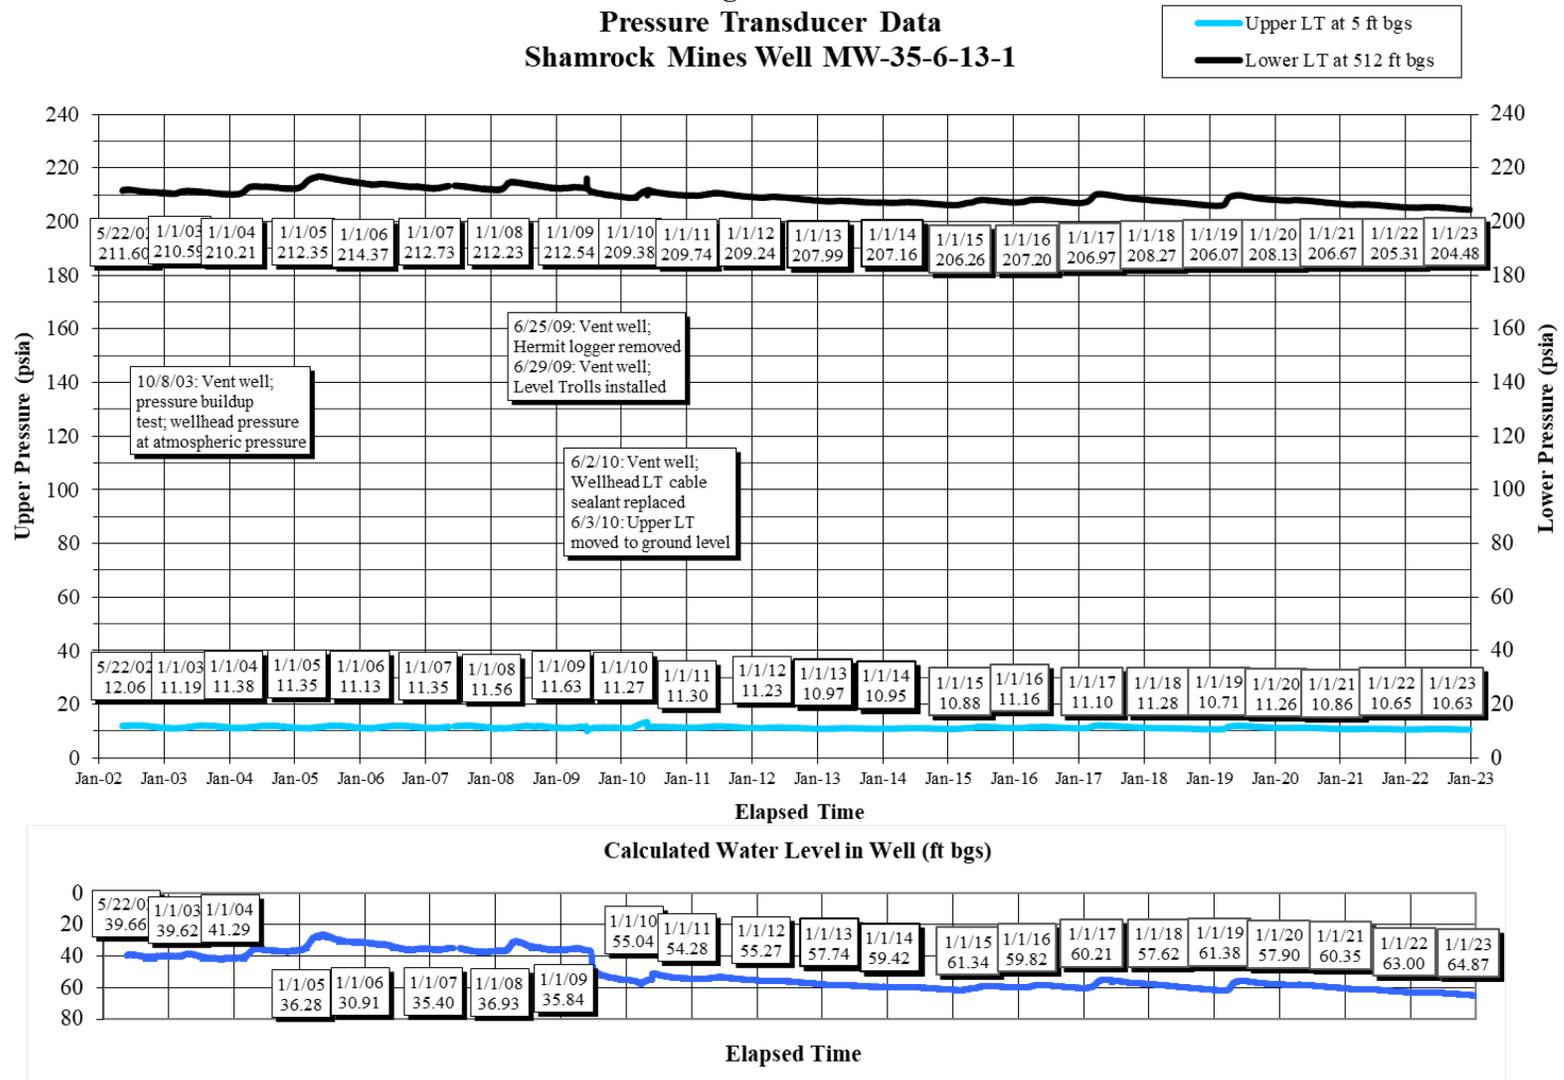
Figure 2-10
Pressure Transducer Data Shamrock Mines Well MW-35-6-13-1

Figures 2-10 shows the wellhead pressure regime continues to be at atmospheric pressure and fluctuates within a range of 2 psi (between 10 psia and 12 psia). During the months of April and May 2010, the wellhead pressure steadily increased to around 13.4 psia. Wellhead pressure returned to the historic atmospheric pressure trend after the Level Troll wellhead cable sealants were replaced on June 2, 2010.

Figure 2-10 also shows the downhole pressure and calculated water level in the well continued to exhibit an overall declining well pressure trend for the period of record since April 2005. With wellhead pressure equal to atmospheric pressure, fluctuation of downhole pressure is associated with the fluctuation of the water level in the well. Downhole pressure and corresponding calculated water levels have documented seasonal groundwater recharge events following the wet winters of 2007-2008, 2009-2010, 2016-2017 and 2018-2019.
