Colorado Oil and Gas Conservation Commission

**Monitor Wells Summary Report
2022**

**4M Project Monitoring Program
Archuleta and La Plata Counties
Colorado**

March 31, 2023

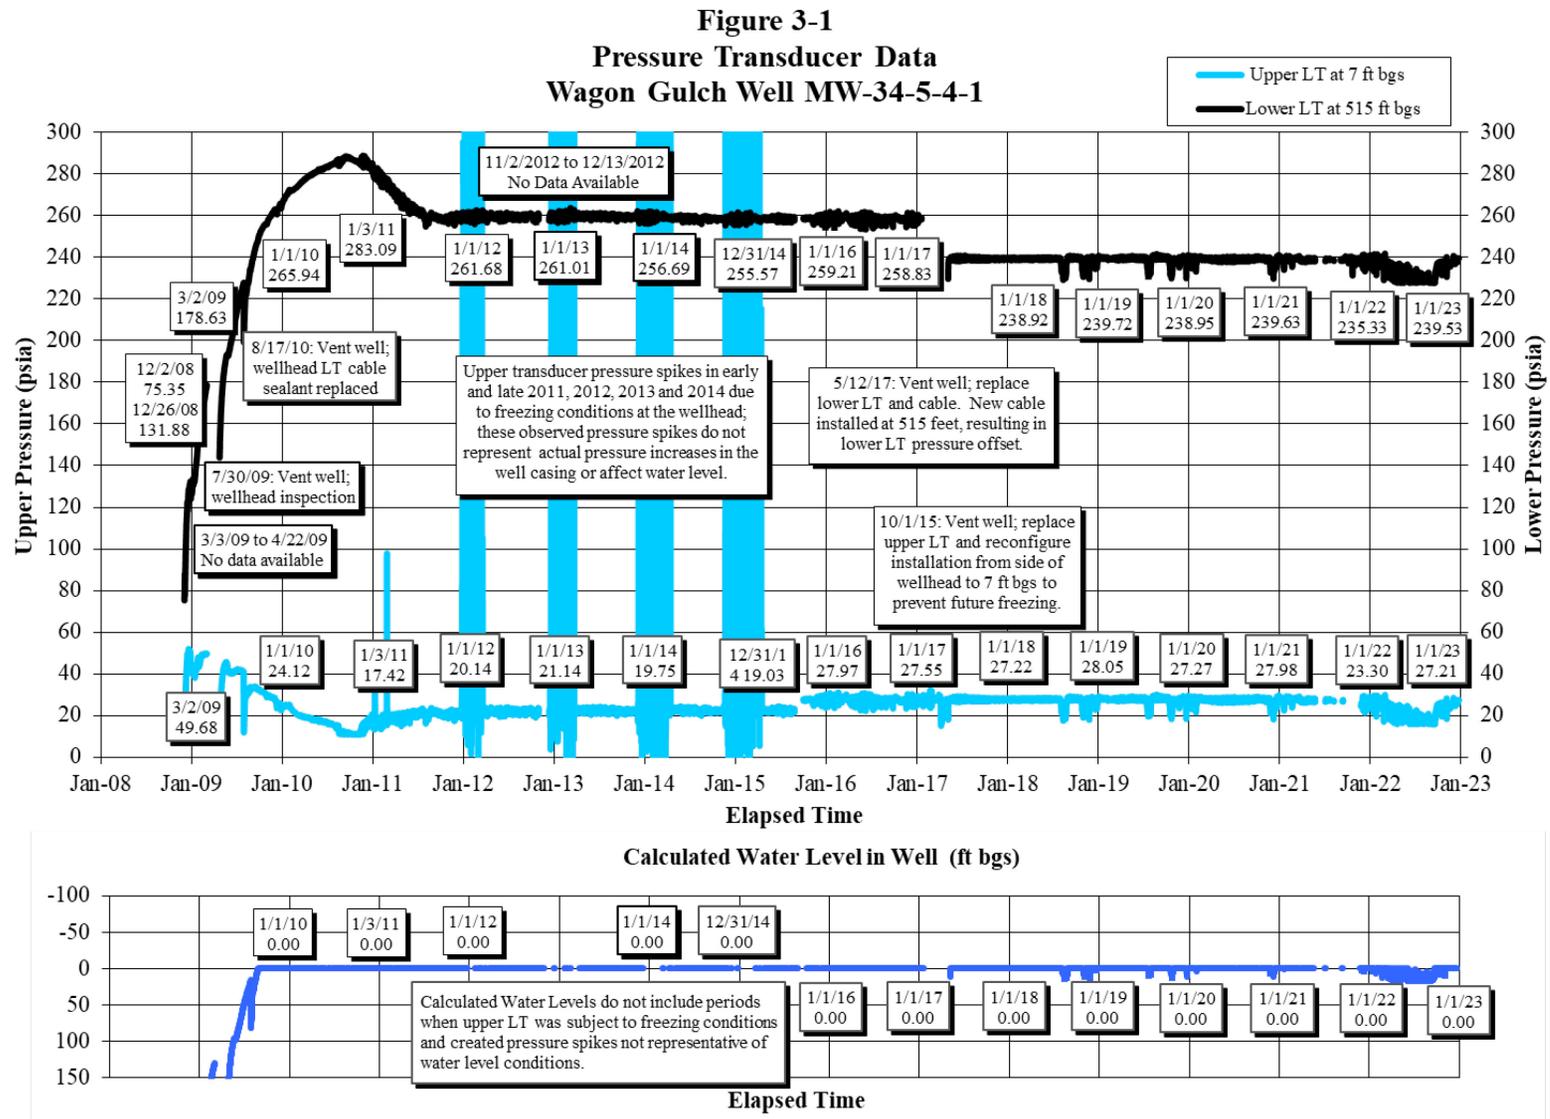
**Figure 3-1
Pressure Transducer Data Wagon Gulch Well MW-34-5-4-1**

2008. Figure 3-1 shows the trend of rising water level with corresponding increasing downhole pressure continued in 2010 until the trend reversed in mid-September 2010. This may have been related to the transducer cable sealant being changed on August 17, 2010 and possibly eliminating a partial shut-in condition. No leaks were detected during the site inspections in 2012-2014. Between October 1, 2010 and December 31, 2010, Figure 3-1 shows the water level decreased about 21.2 feet while the downhole pressure decreased about 2.7 psia.

During the winters of 2011-2012, 2012-2013, 2013-2014 and 2014-2015 pressure spikes in the upper transducer occurred due to the pressure transducer freezing within its deployment location in the wellhead 2.3 feet above ground surface. These are not actual increases in gas pressure within the well casing, but rather caused when the air volume next to the transducer inlet is trapped and then compressed by expanding frozen water condensate. When the 2011 well inspection was conducted at MW 34-5-4-1 the well was vented to ensure that the transducer would return to atmospheric pressure; this test successfully showed that the transducer continued to function properly and was not damaged. The transducer recovered after surface temperatures warmed each spring. The transducer was inspected for damage in each subsequent site visit since this problem began in 2011 until the 2015 site inspection when the Level Troll was replaced and lowered into the well to 7 ft bgs. As evidenced by the winter 2015 data shown in Figure 3-1, the condensate freezing problem in this location has been corrected by lowering the Level Troll below the ground surface.

Several pressure decreases on the order of 10 psi were observed by both the upper and lower transducers in the second half of 2018, 2019, and 2020, and then fairly consistently during 2021 and 2022. The duration of each event was on the order of days to weeks and full recovery to static pressure conditions occurred after each event.

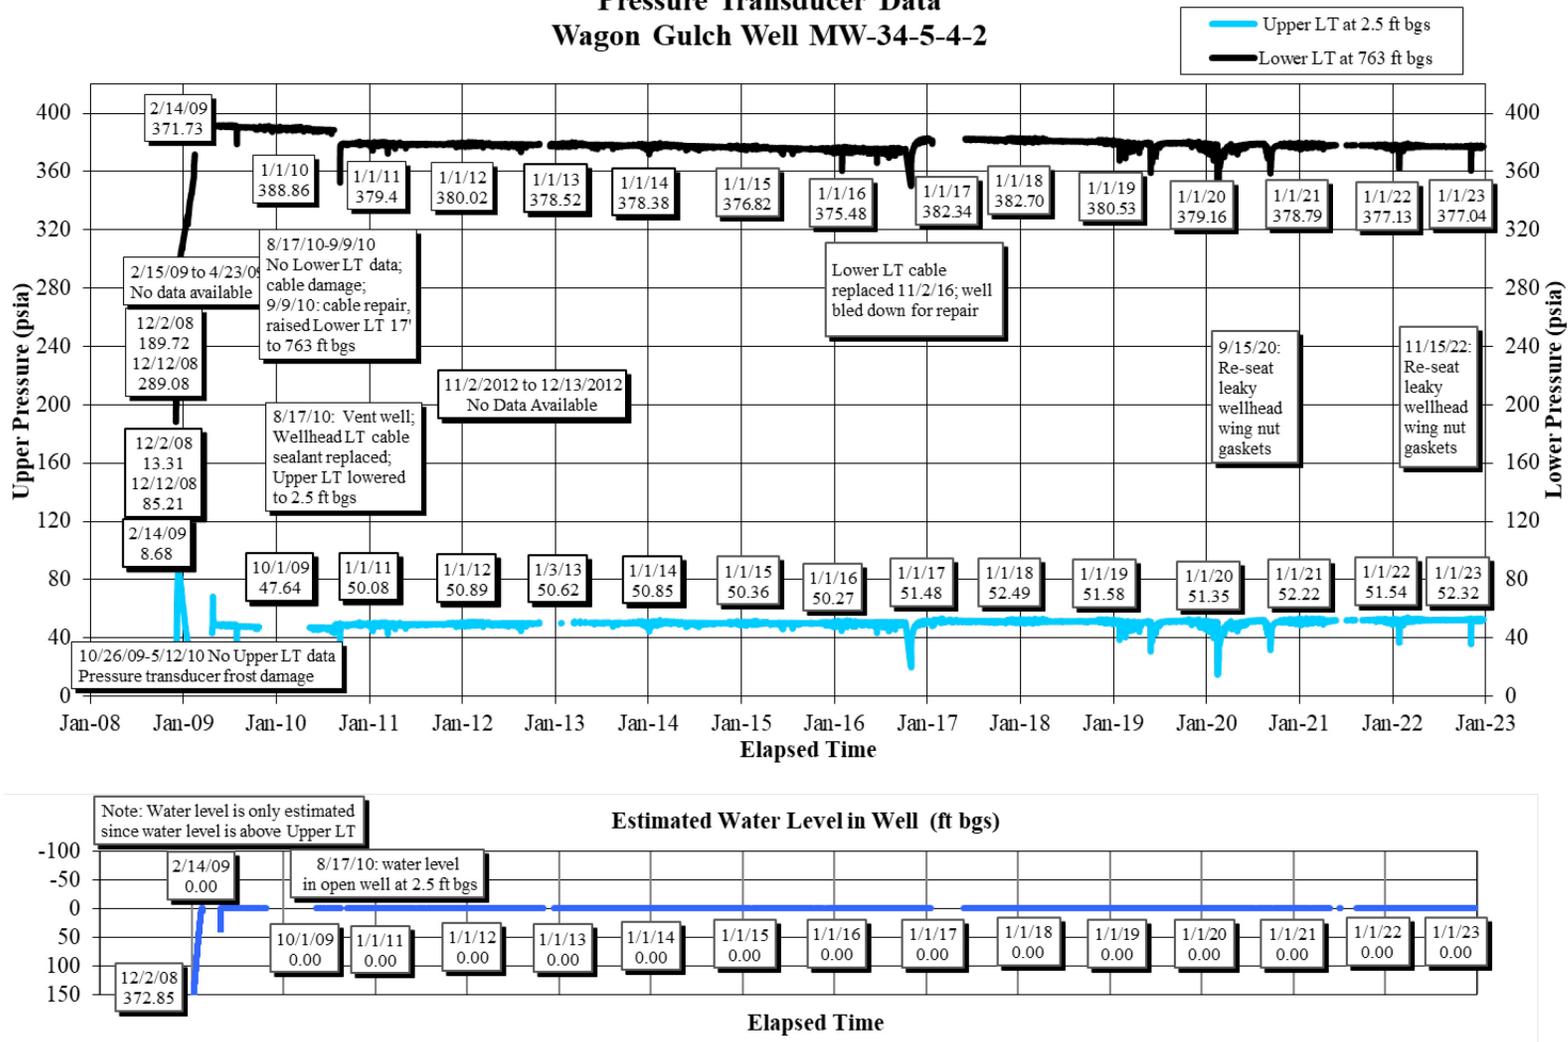
**Figure 3-2
Pressure Transducer Data Wagon Gulch Well MW-34-5-4-2**

Figure 3-2 shows a relatively constant wellhead pressure of about 47 to 48 psia between April 24, 2009 and October 25, 2009. An erratic pressure spiking pattern between October 26, 2009 and May 12, 2010 suggested wellhead Level Troll pressure sensor freeze damage, so the data were omitted from Figure 3-2. Between May 13, 2010 and August 16, 2010, the wellhead pressure remained fairly constant at around 47 psia.

Freeze damage to the upper Level Troll pressure transducer sensor was confirmed after the well was vented on August 17, 2010. As noted on Figure 3-2, the water level inside the open wellhead was at a height of about 2.5 feet above ground level. The new upper Level Troll was changed from an external mount to an internal depth setting of 2.5 ft bgs on August 17, 2010 to protect the transducer sensor from freezing conditions. After well shut-in on August 17, 2010, Figure 3-2 shows a relatively rapid return of wellhead pressure to an average constant pressure of about 50 psia.

The lower Level Troll cable was damaged during replacement of Level Troll wellhead cable sealants on August 17, 2010. Cable repair performed on September 9, 2010 included raising the Level Troll 17 feet from 780 ft bgs to 763 ft bgs. As a result of this change, Figure 3-2 shows a shift in the downhole pressure curve to a corrected constant downhole pressure regime of 378 to 379 psia.

As noted above, the water level was inside the open wellhead at a height of about 2.5 feet above ground level on August 17, 2010. The wellhead pressure build-up after shut-in may reflect water and/or gas pressure build-up. For charting purposes, the water level in the shut-in well is estimated to be at or near ground surface above the upper Level Troll (set at 2.5 ft bgs). However, there is a possibility that the observed build-up in wellhead pressure is from gas pressure, which could result in a downward displacement of the water in the well to some level below the upper Level Troll.

The pressure regime observed in 2022, as well as for the full period of record since post-completion stabilization in 2009, has been quite stable with an overall minor decreasing trend. The exception is apparent multiple drawdown cycles observed in 2019 and 2020, which are likely observed interference effects from nearby groundwater production.

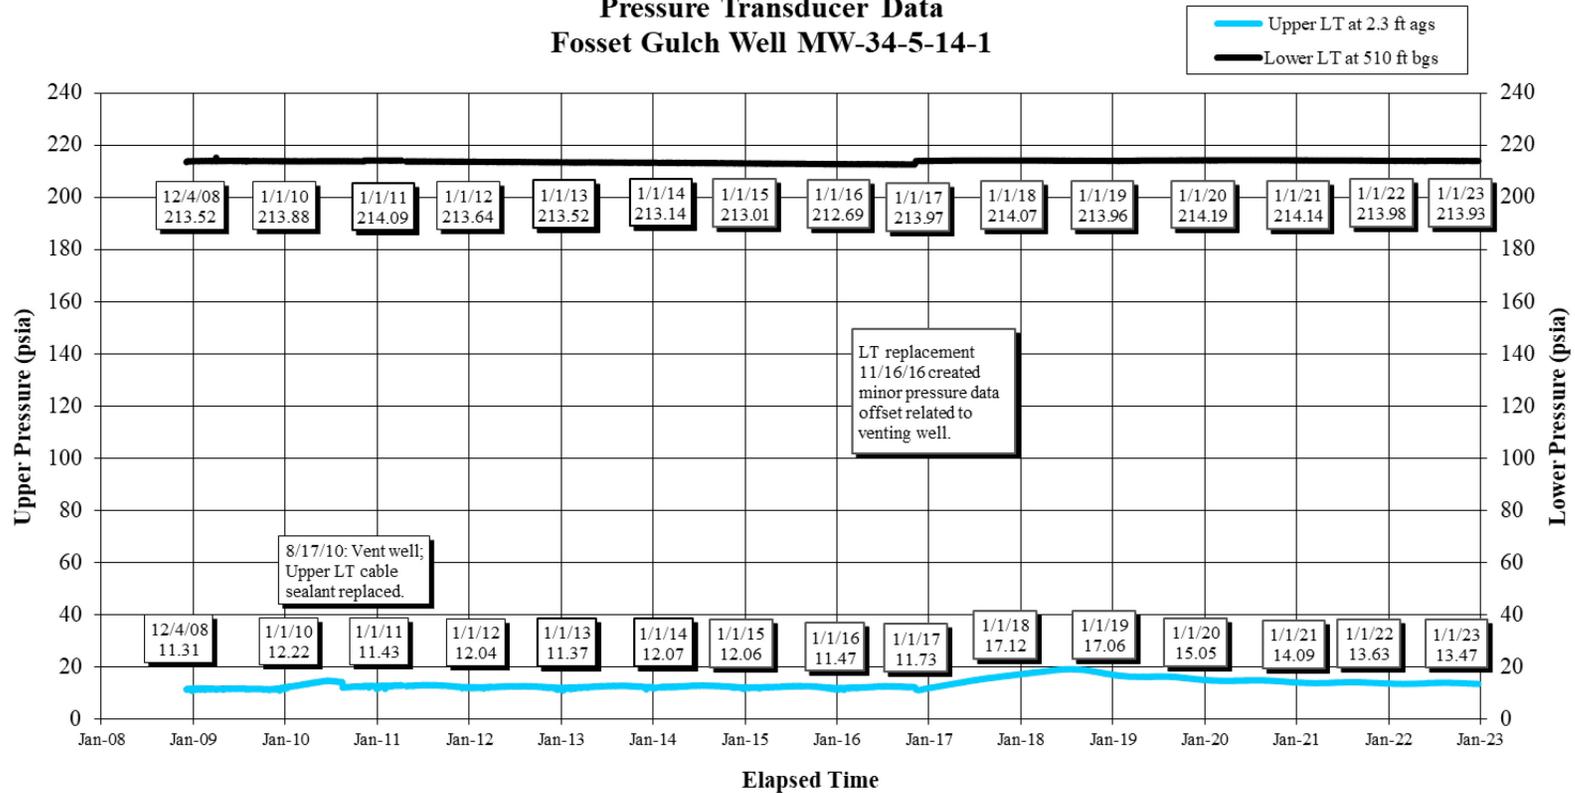
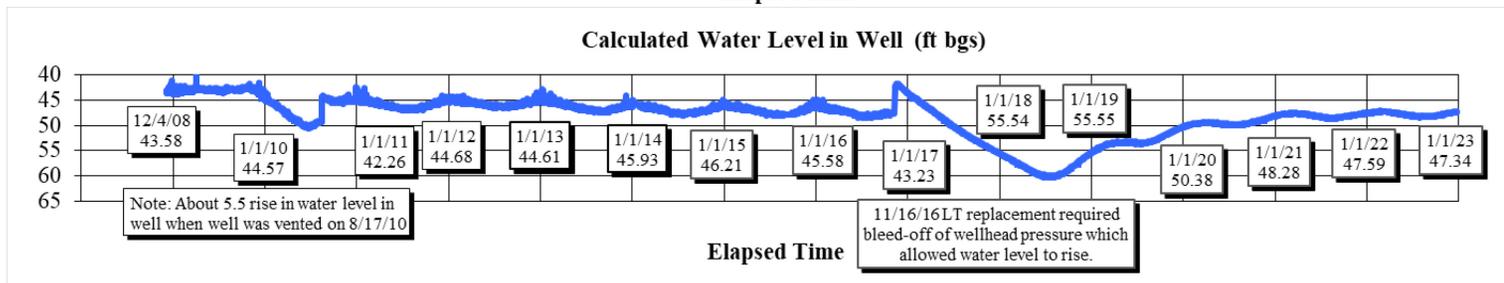
**Figure 3-3
Pressure Transducer Data Fosset Gulch Well MW-34-5-14-1**

Figure 3-3 charts the upper and lower pressure transducer data and the calculated water level in the well. Table 3-2 and Figure 3-3 show the wellhead pressure at atmospheric pressure prior to 2010 followed by a gradual increase in pressure through August 16, 2010 to 14.19 psia. Following the August 17, 2010 well maintenance event including venting, the wellhead pressure has remained relatively constant within a normal atmospheric pressure range through November 16, 2016. At that time, upper transducer replacement required venting the wellhead. Following the maintenance, the wellhead pressure increased slowly until July 2018 when it began to trend down. This is likely a response to gas production stimulation that occurred when the well was vented. Figure 3-3 shows a stable downhole pressure trend (213.52-214.19 psia) for the entire period of record. Figure 3-3 also shows a stable water level averaging 43.0 ft bgs until November 2009, followed by a gradually declining water level trend through July 1, 2010 (50.13 ft bgs). The water level increased to 49.28 ft bgs until the well was vented on August 17, 2010. The water level immediately rose to 44.36 ft bgs when the well was vented on August 17, 2010 but has since followed apparent gentle seasonal fluctuation until November 16, 2016. At that time, the well was vented to replace the upper pressure transducer. Upon replacement, the pressure measured at the wellhead has steadily increased from approximately 12.20 psi to 17 psi on January 1, 2019 and then changed to a decreasing pressure trend. As such, the calculated water level was in steady decline during this time period as gas pressure has apparently depressed it. Likewise, with the 2018 reversal of the wellhead gas pressure

increase trend to a decreasing trend, the calculated water level is now shown to be increasing through 2022 superimposed over seasonal fluctuations.

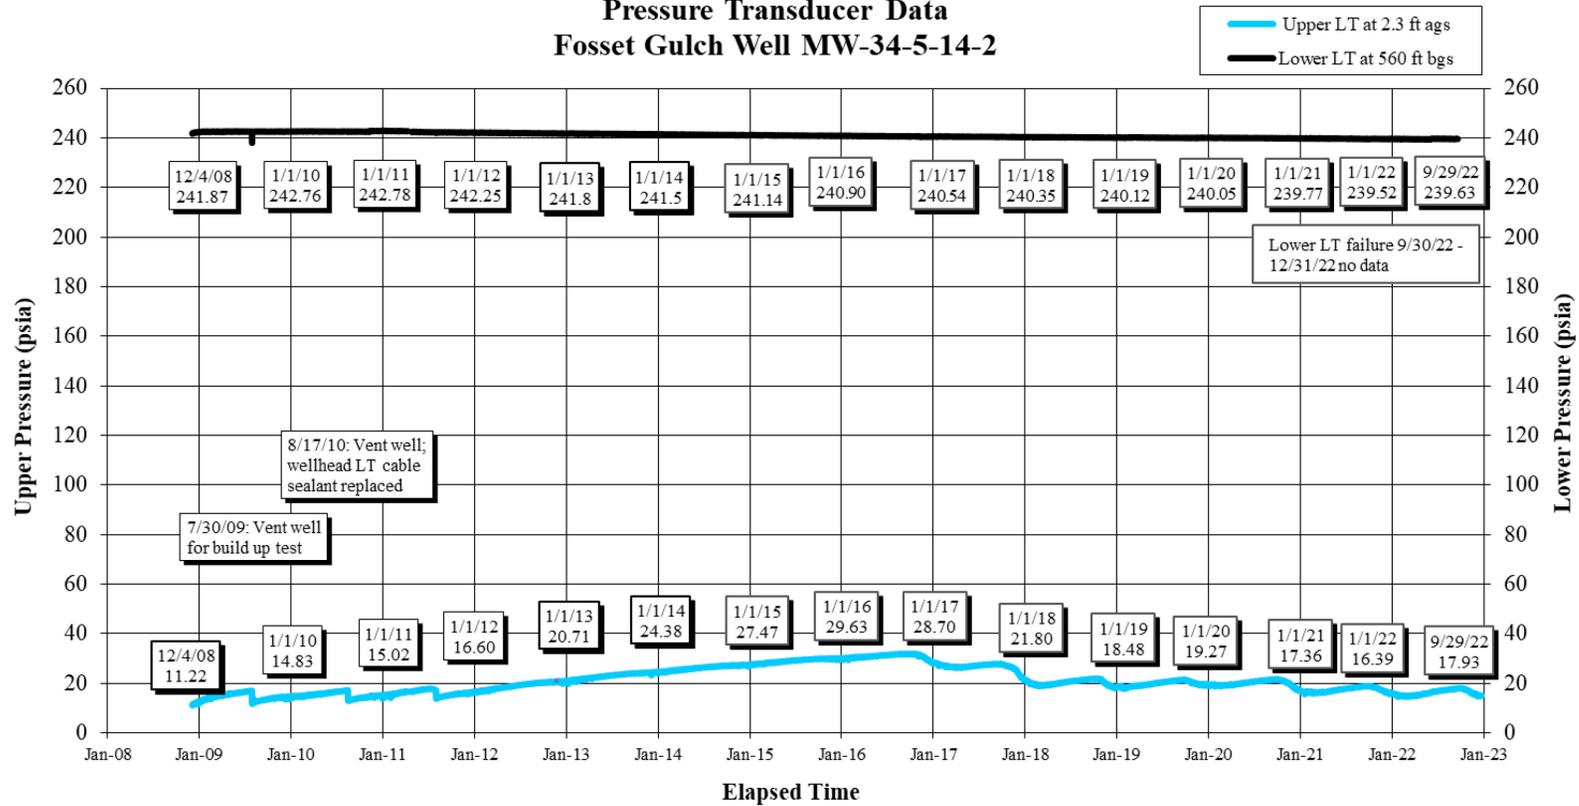
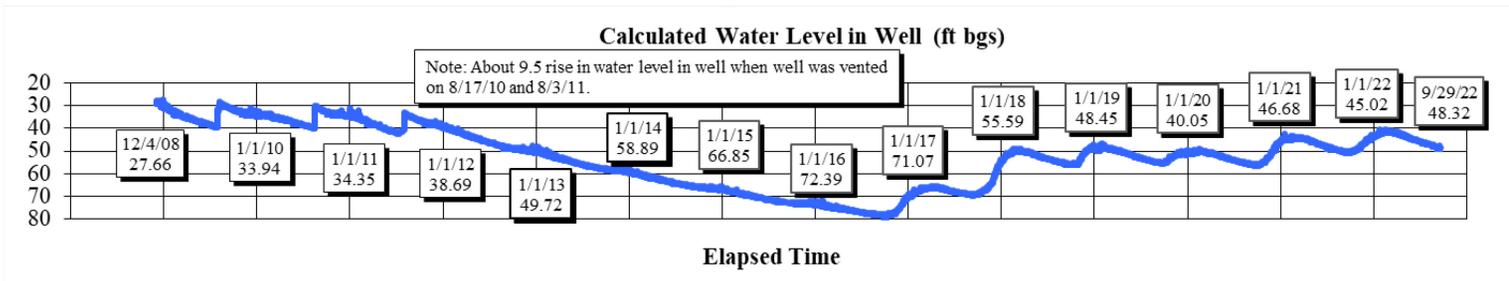
**Figure 3-4
Pressure Transducer Data Fosset Gulch Well MW-34-5-14-2**

Figure 3-4 plots the upper and lower pressure transducer data and the calculated water level in the well. Although the well was shut in for monitoring on December 4, 2008, wellhead pressure did not stabilize at about 17 psia until July 2009. Table 3-2 and Figure 3-4 show a net increase of 6.58 psi in wellhead pressure for the period of record between December 4, 2008 (11.35 psia) and September 29, 2022 (17.93 psia). After that date, the lower Level Troll failed and so no data is available for the remainder of 2022. Figure 3-4 shows a stable but slightly declining downhole well pressure trend for the entire period of record, with fluctuations ranging between a minimum pressure of about 239.52 psia to a maximum pressure of 242.78 psia. The downhole pressure was 239.63 psia on September 29, 2022, a new low as the pressure trend has been very slightly decreasing over 14 years of monitoring.

Table 3-2 indicates a net water level drop of 3.02 feet in the well as of September 29, 2022. However, Figure 3-4 shows that the wellhead pressure and water level in the last five years has apparently shown an effect of venting MW 34-5-14-1 for maintenance on 11/16/16. This would suggest some amount of hydraulic connection between the two wells. Although there is an immediate drop in wellhead pressure and corresponding rise in the water level each time the well is vented to the atmosphere in the past, Figure 3-4 also shows the build-up in wellhead pressure takes approximately 12 months to return to the pressure exhibited prior to each venting event so unless required for servicing the instrumentation, the well will not be vented in attempt to determine the static wellhead pressure.

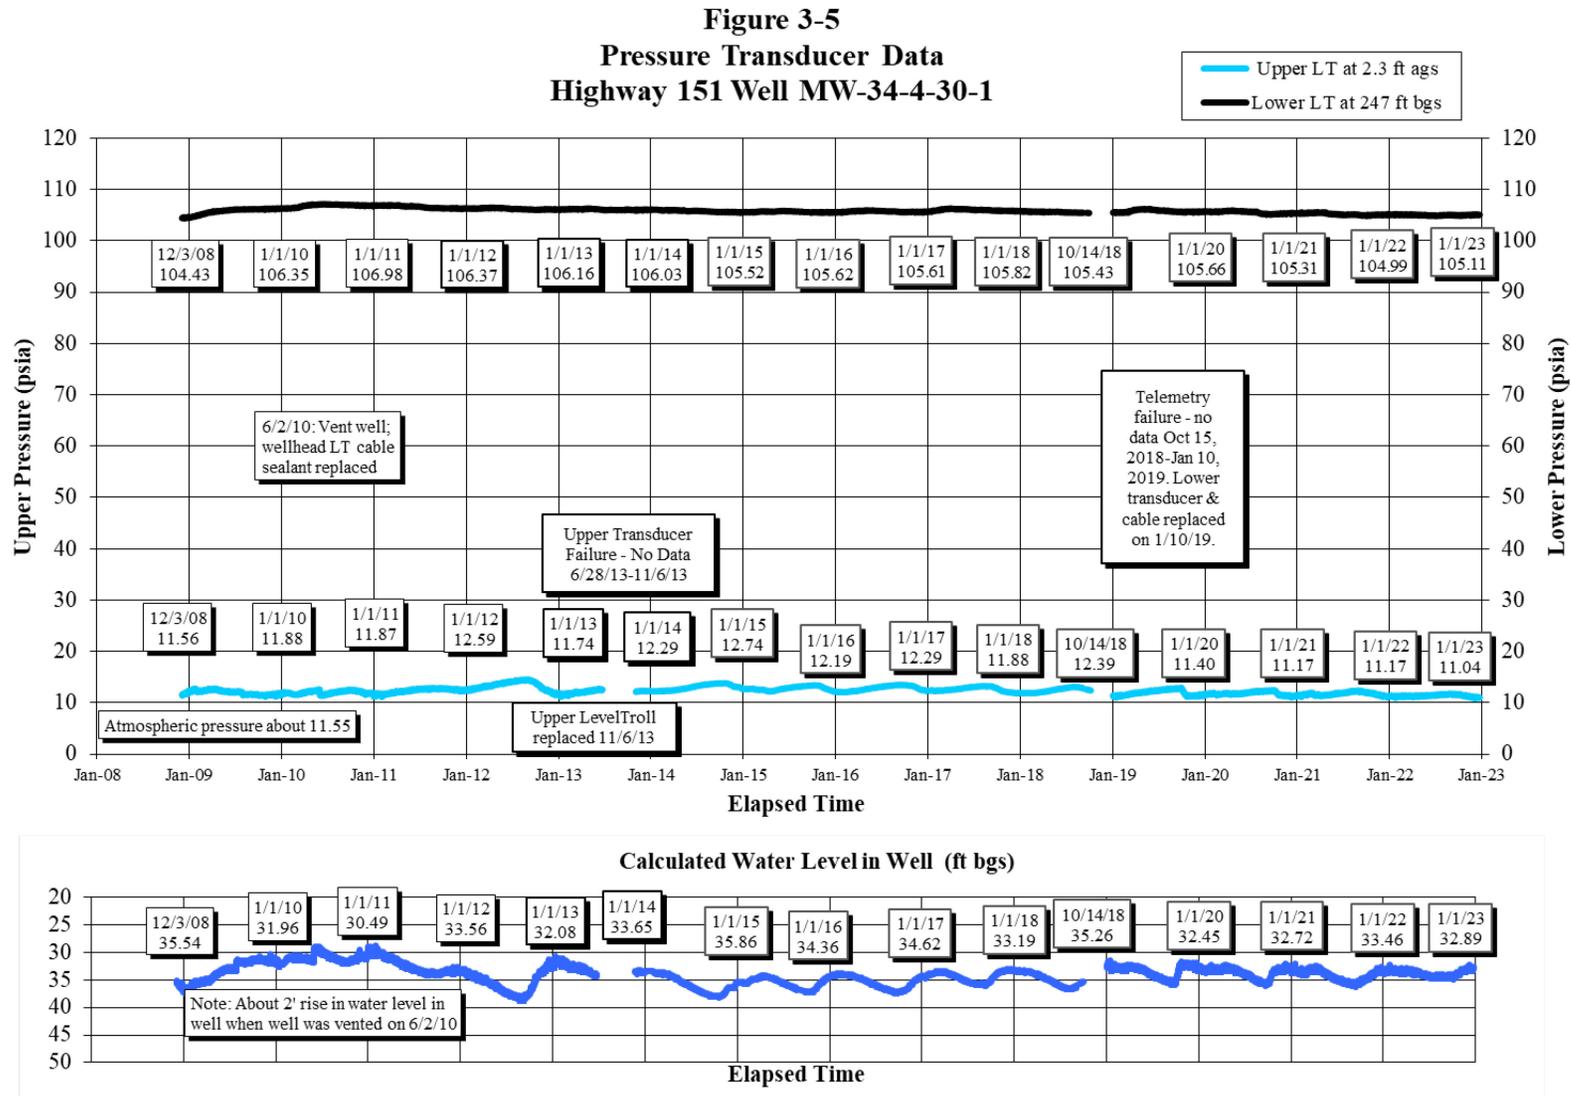
**Figure 3-5
Pressure Transducer Data Highway 151 Well MW-34-4-30-1**

Figure 3-5 charts the upper and lower pressure transducer data and the calculated water level in the well. Table 3-3 and Figure 3-5 show a relatively stable well pressure regime with a stable wellhead pressure trend at atmospheric pressure, a stable downhole pressure trend of about 104-107 psia, and a fluctuating water level trend of 30-39 ft bgs since August 2009. Sharp fluctuations in both wellhead pressure and the calculated water level shown on Figure 3-5 correspond to the immediate loss of pressure when the well is vented (e.g., June 2, 2010), followed by a gradual return to the well pressure regime exhibited prior to venting the well.

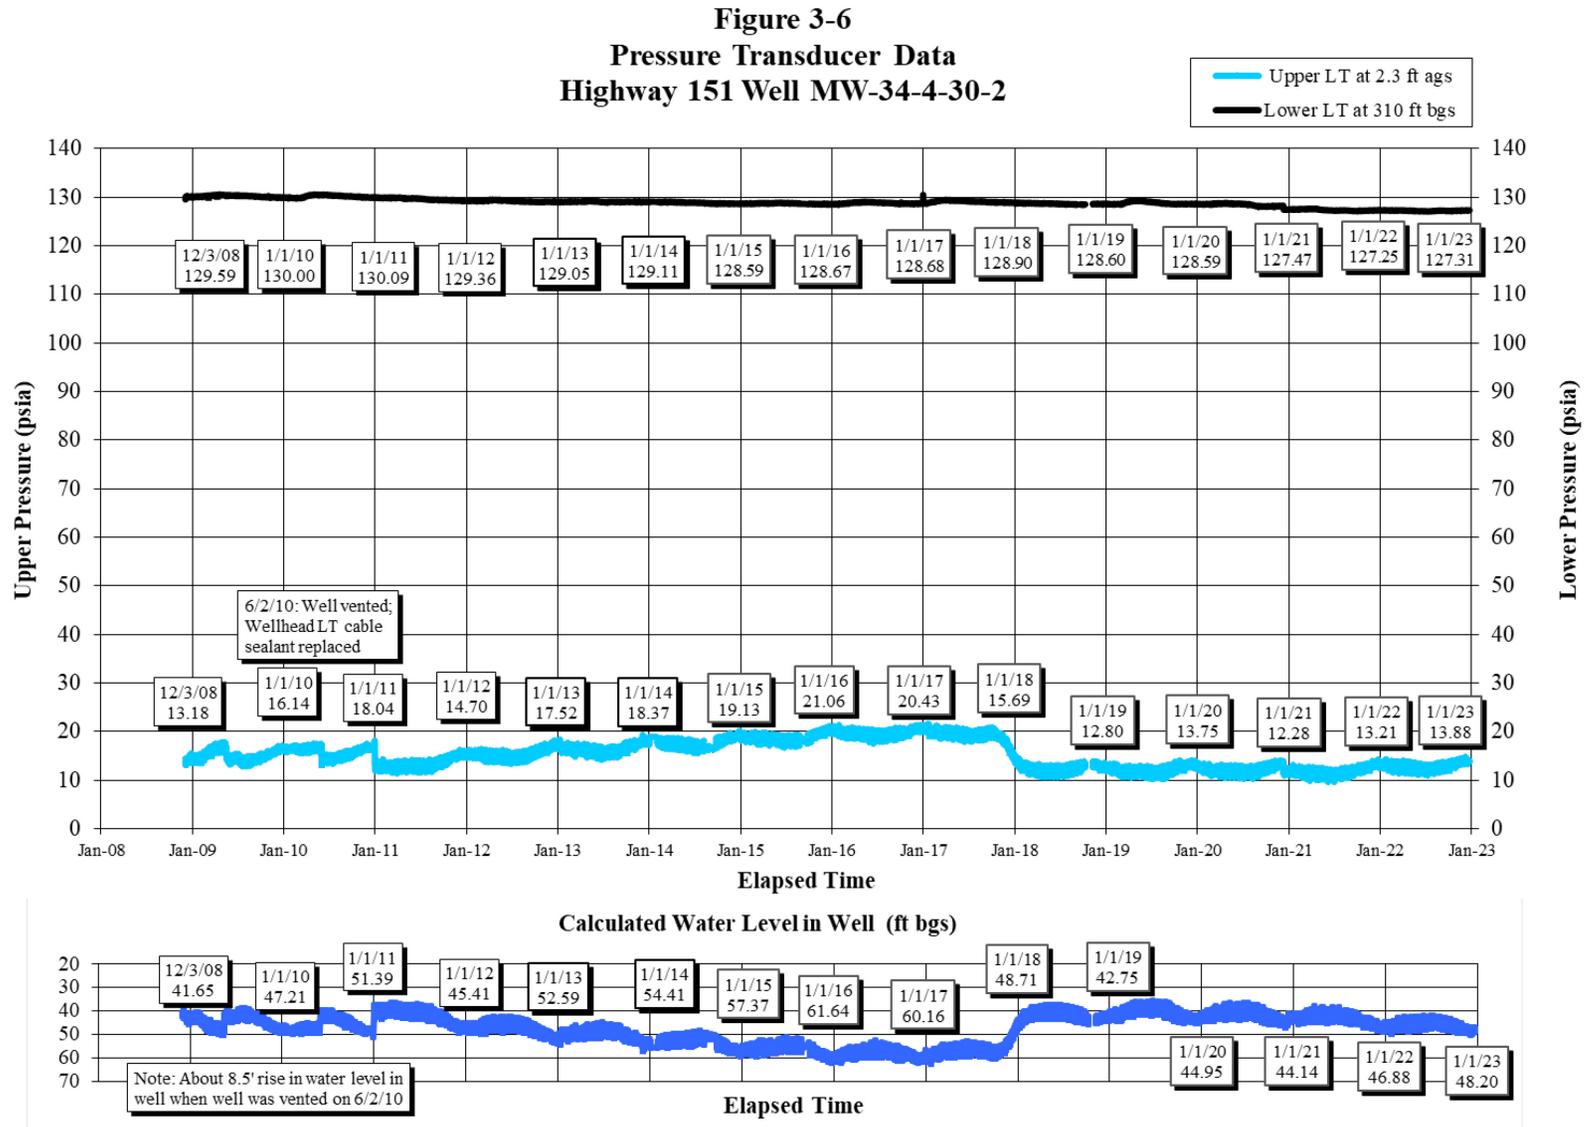
**Figure 3-6
Pressure Transducer Data Highway 151 Well MW-34-4-30-2**

Figure 3-6 charts the upper and lower pressure transducer data and the calculated water level in the well. Table 3-3 and Figure 3-6 shows a stable downhole pressure trend with 2.28 psi change from 129.59 psia on December 3, 2008 to 127.31 psia on January 1, 2023. In addition, there was a net wellhead pressure decrease of 0.70 psi with a corresponding net water level decline of 6.55 feet for the entire period of record from December 3, 2008 to January 1, 2023. However, the wellhead pressure decreased slowly in the fourth quarter of 2017 with a loss measured at approximately 4.3 psi in 3 months. The pressure then stabilized at atmospheric pressure and has remained in that range through 2022. The well was inspected in 2019 during routine maintenance and no wellhead pressure leaks were found. A seasonal water level fluctuation trend has continued superimposed over a long-term trend of approximately 0.5 feet of water level decline per year.

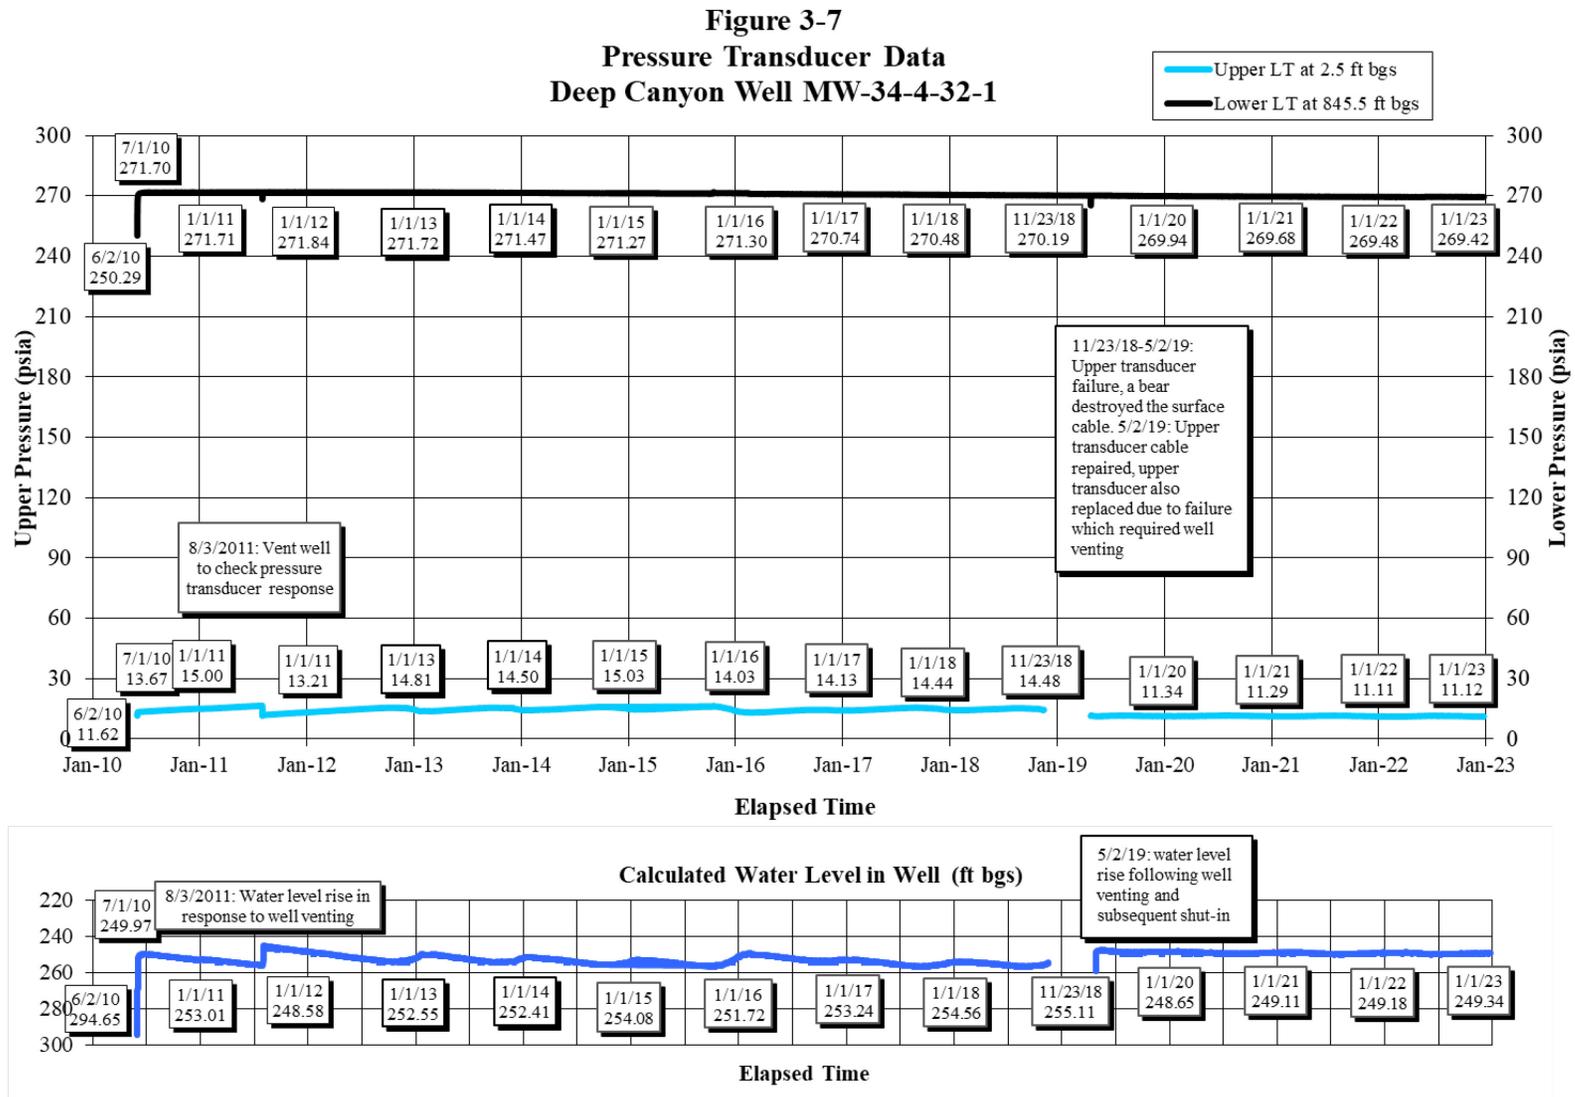
**Figure 3-7
Pressure Transducer Data Deep Canyon Well MW-34-4-32-1**

Figure 3-7 charts the upper and lower pressure transducer data and the calculated water level in the well. Table 3-4 and Figure 3-7 show the well pressure initially stabilized on June 8, 2010, six days after the well was shut in for monitoring on June 2, 2010. Table 3-4 and Figure 3-7 also show a relatively stable well pressure regime for the 12.5-year period of record through November 23, 2018 with only a slight increase in well pressure and a corresponding net water level decrease of 7.39 feet in the well. Data for this well is limited from November 23, 2018 to May 2, 2019 due to an upper Level Troll transducer failure. When investigated in early 2019 after the location was accessible following winter it was found that the surface cable for this Level Troll was damaged by what appeared to be a bear mauling of the telemetry station based on the type of cable damage and muddy paw prints on the telemetry instrumentation enclosure. At that time the cable was repaired, the Level Troll was replaced and full function has resumed. Since May 2, 2019, the upper and lower pressure transducer data has been stable, with corresponding stable calculated water levels which do not seem to demonstrate significant seasonal fluctuation.
