Colorado Energy & Carbon Management Commission

**Monitor Wells Summary Report
2023**

**4M Project Monitoring Program
Archuleta and La Plata Counties
Colorado**

June 10, 2024

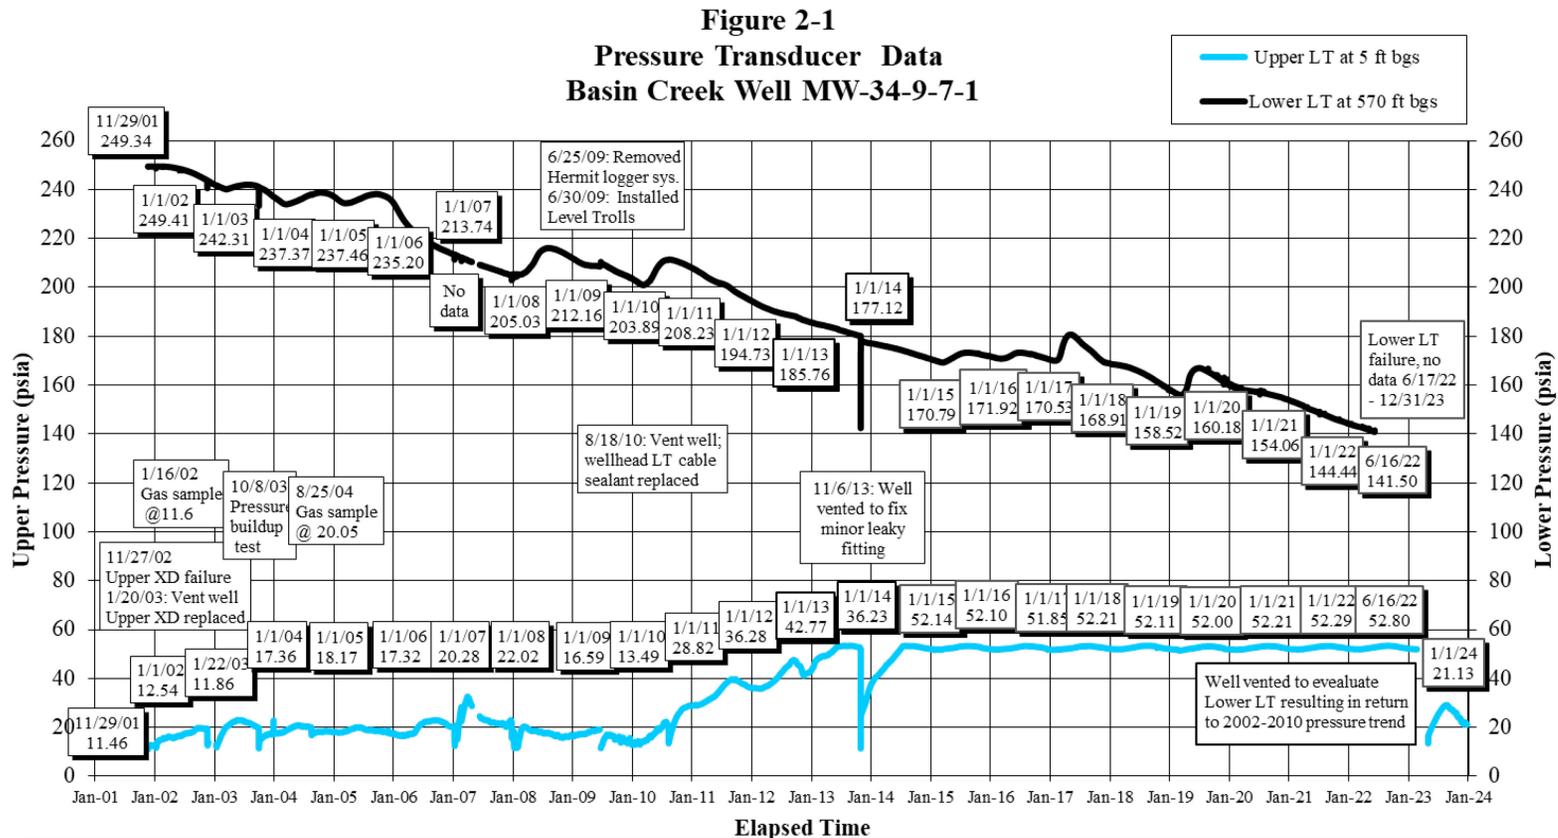
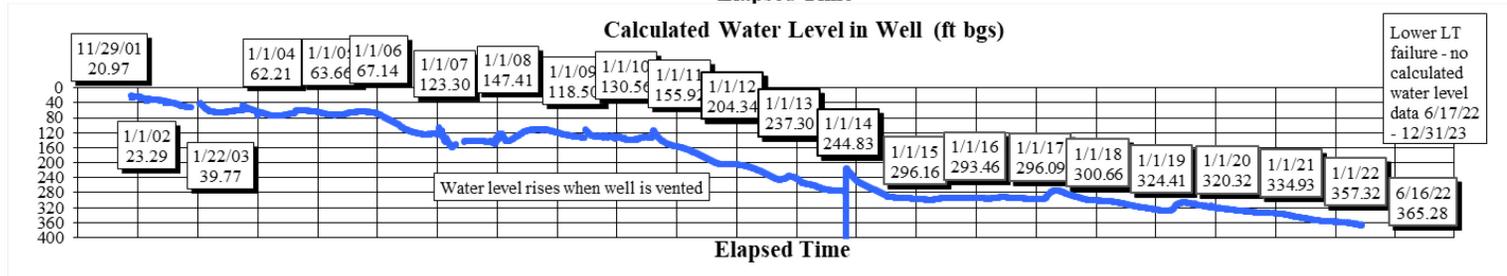
**Figure 2-1
Pressure Transducer Data Basin Creek Well MW-34-9-7-1**

Figure 2-1 charts the upper and lower pressure transducer data and the calculated water level in the well. Table 2-1 and Figure 2-1 show a net increase of 9.67 psi in wellhead pressure for the entire 22.5-year period of record from November 29, 2001 (11.46 psia) to January 1, 2024 (21.13 psia). The lower transducer stopped functioning on June 17, 2022, resulting in only a partial 2022 data set and no data in 2023. This lower transducer has subsequently been successfully replaced in 2024. Figure 2-1 generally shows a pattern of minor seasonal fluctuations within an overall stable trend in wellhead pressure prior to wellhead cable gland seal replacement on August 18, 2010, followed by a rise in wellhead pressure to a recorded high of 53.42 psia on September 11, 2013. A very minor leak persisted so on November 6, 2013 the well was vented to allow a safe condition to repair leaking threads at the wellhead. Recovery of the

previous wellhead pressure occurred for about nine months following this wellhead venting. Since recovery in the second half of 2014, wellhead pressure has remained relatively stable. 2019 data demonstrated a groundwater recharge response to the very wet winter of 2018-2019; this effect was greater in magnitude than a similar pressure and water level response to the wet winters of 2007-2008, 2009-2010, 2016-2017. The venting of the well in January 2023 to evaluate the failed lower transducer has apparently reset the pressure regime to that of 2001 through 2009 time period.

In contrast to the wellhead pressure patterns, Table 2-1 and Figure 2-1 show a substantial net decline of 365.28 feet in the calculated well water level and a corresponding net decline in downhole pressure of 107.84 psi for the period of record through June 16, 2022. Given the lower transducer is required to calculate well water levels, there is no water level update for 2023, but as noted above, the lower transducer has now been replaced in 2024. Figure 2-1 also shows a pattern of slight seasonal fluctuations within the overall declining trend in the water level and corresponding downhole pressure for the period of record.

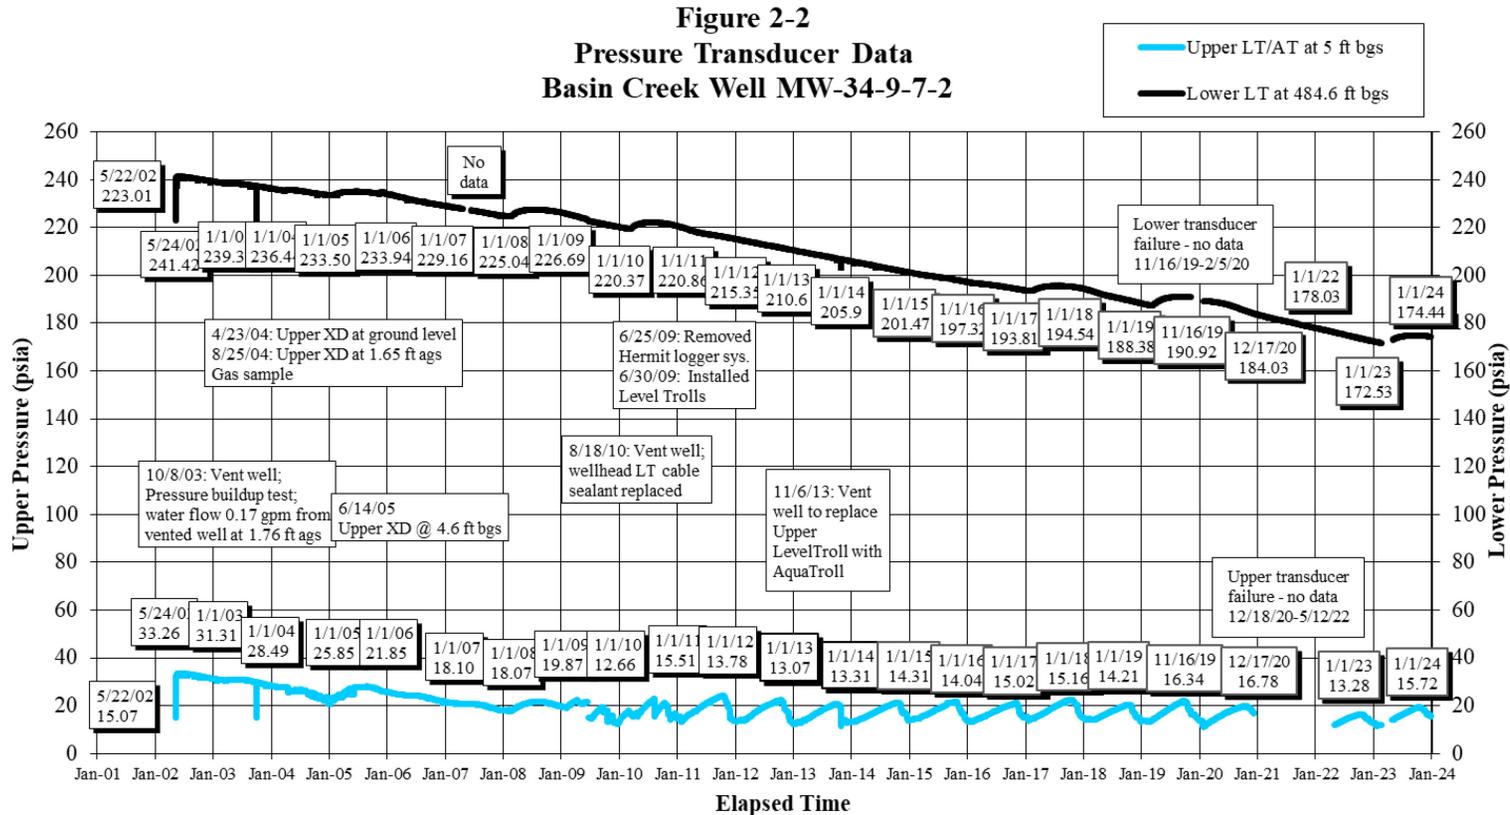
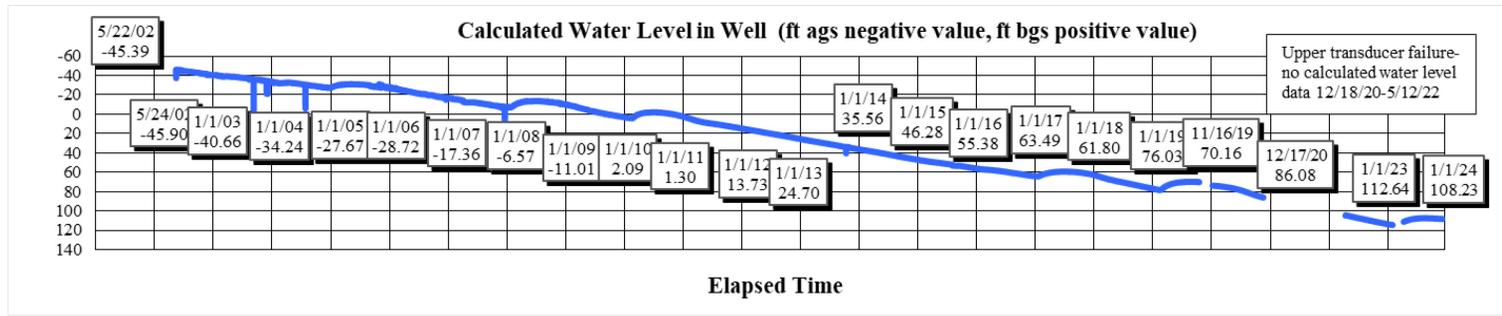
**Figure 2-2
Pressure Transducer Data Basin Creek Well MW-34-9-7-2**

A small amount of gas was released and artesian flow (~0.2 gpm) from the well consistently occurred each time the well was vented for maintenance during the period of record between 2002 and 2010. The pressure regime documented was relatively high pressure but low volume based on the head pressure versus artesian flow. Artesian flow from the well did not occur when the wellhead was vented on August 18, 2010 to replace the Level Troll wellhead cable Conax gland sealants. The final recorded upper transducer pressure in 2011 of 13.7 psi was very near atmospheric pressure indicating the well was essentially in hydrostatic balance. The pressure fluctuations since early 2009 suggest that ambient surface temperatures may be affecting the gas pressure as measured by the upper transducer. In order to attempt to distinguish water pressure versus gas pressure being recorded by the upper transducer, the Level Troll was replaced by an Aqua Troll, which records specific conductance (SC) in addition to pressure and temperature. The concept was that if water was present at the Aqua Troll, it would record an SC value greater than zero. If a value of zero was recorded for SC, then a pressure greater than atmospheric pressure would be gas pressure only. The Aqua Troll was installed on November 6, 2013, but it appears by this time the static water level in this well had dropped from the near-surface balance of 2009-2011. 2017 brought a change in trend of the downhole pressure; it increased slightly throughout the first half of 2017, plateaued and then continued to decrease in the linear trend followed since mid-2011. This was a similar trend as observed in 2010. 2023 data demonstrated a groundwater recharge response to the very wet winter of 2022-2023, similar to that observed after the wet winters of 2007-2008, 2009-2010, 2016-2017, 2018-2019.

Substantial water level decline has been documented in this well, going from artesian flowing with a calculated shut-in head of approximately 45 feet above ground surface just after construction to 108.23 feet below ground surface on January 1, 2024. This calculated water level data set has been verified by a manual open-well water level measurement on November 6, 2013 of 40.20 ft bgs used as a calibration point for water level calculation using the lower Level Troll data within fifteen minutes on the same date of 40.46 feet below ground surface.

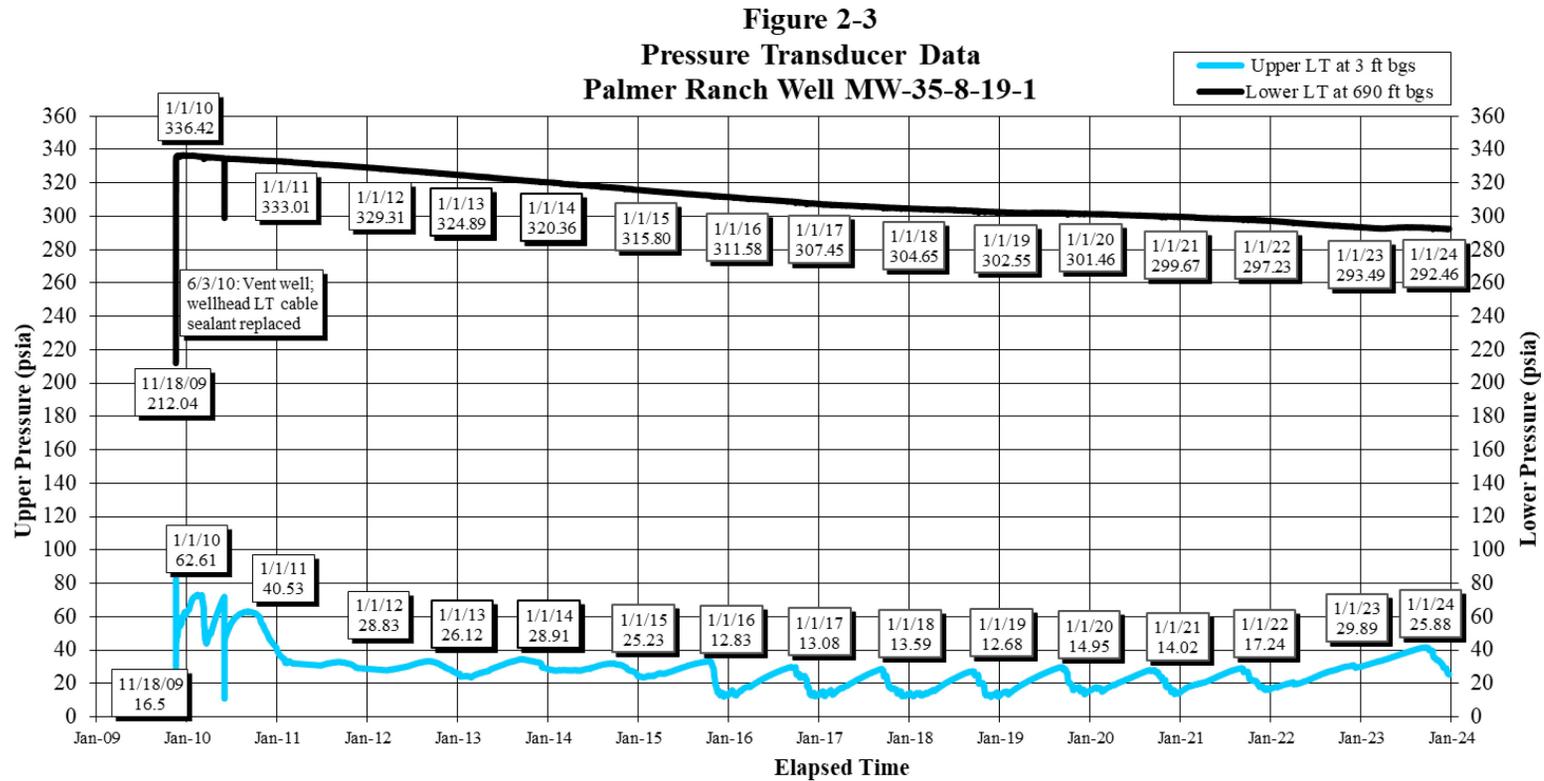
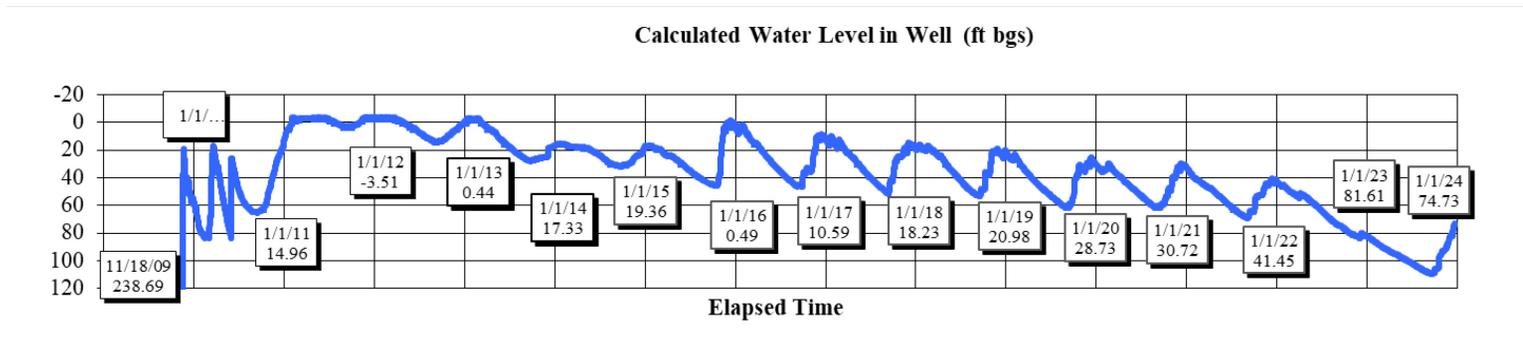
**Figure 2-3
Pressure Transducer Data Palmer Ranch Well MW-35-8-19-1**

In late October 2015, wellhead pressure apparently began dropping slowly from approximately 33 psi to approximately 12 psi in mid-December 2015. Wellhead pressure then was fairly stable through the winter and then slowly built up from late winter through late summer. The pressure trend appears to be similar but stronger seasonal trend that has been occurring since 2011. The trend repeated through 2022 and suggests the well has been demonstrating an apparent increased response to seasonal groundwater level

changes, increased local groundwater production effects or coal seam reservoir pressure fluctuations. The Florida River runs immediately adjacent to the well and flows are significantly impacted by agricultural irrigation schedules, which may have both direct and indirect effects on observed Fruitland coal seam reservoir pressure and water levels. In the winter of 2022-2023, the typical groundwater recharge event started several months later than typical, and was very short in duration to the point that groundwater level generally continued on the same near-linear decline trend in 2023 as 2022 until the irrigation season ended and seasonal groundwater recharge occurred through the end of 2023.

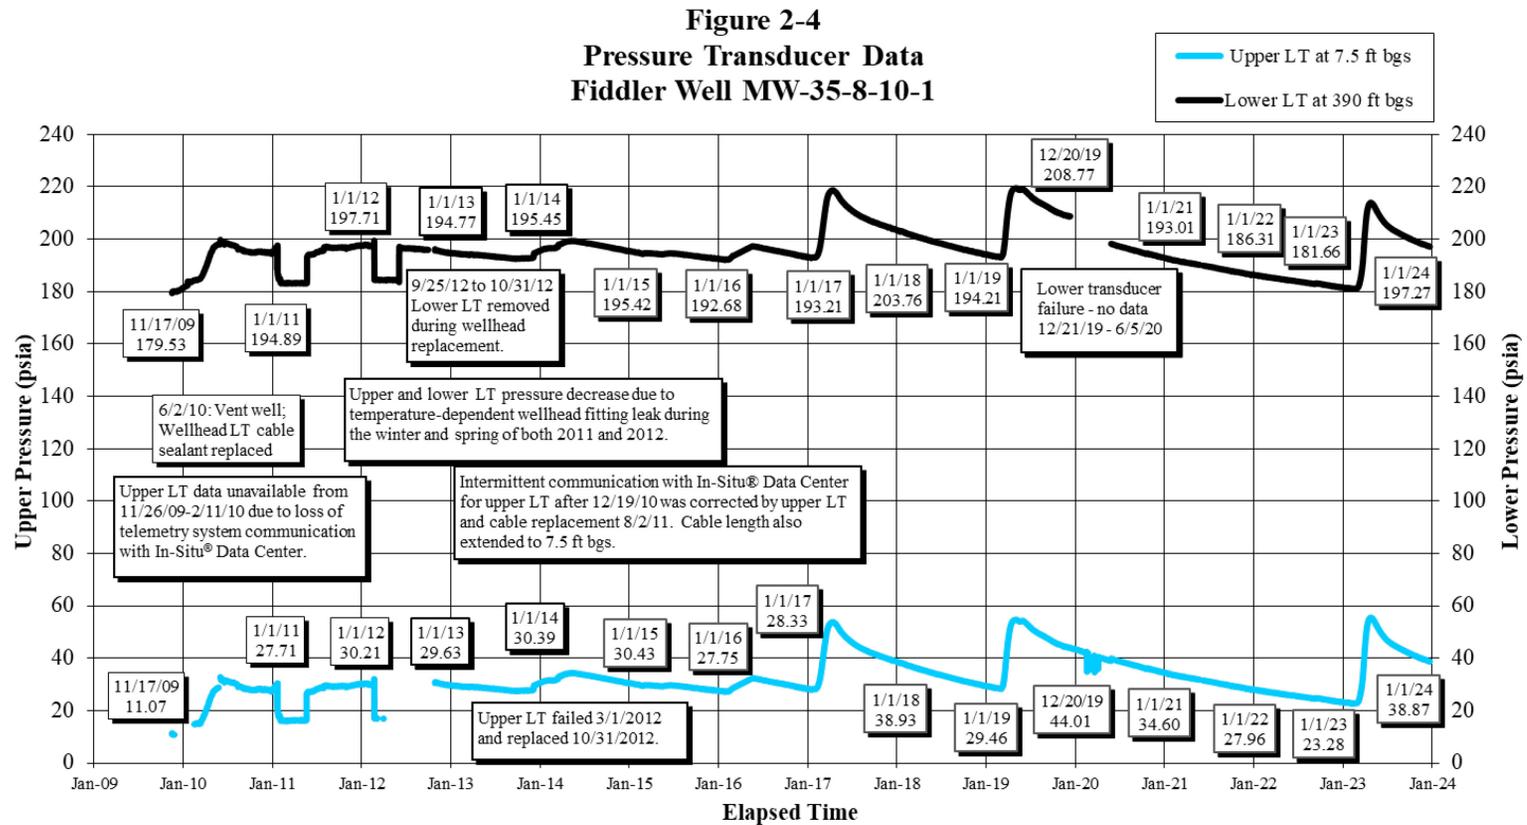
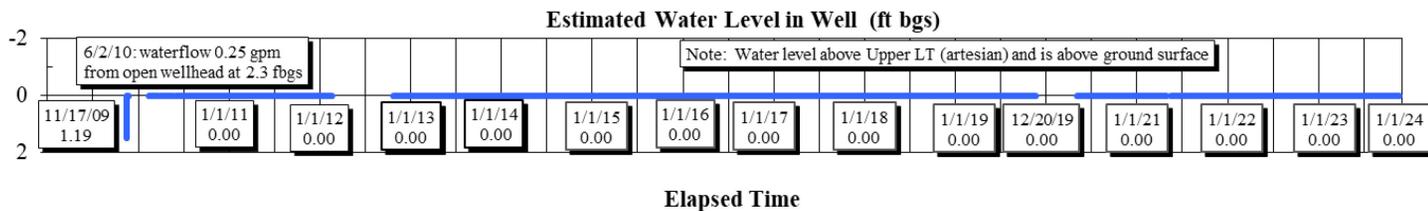
**Figure 2-4
Pressure Transducer Data Fiddler MW-35-8-10-1**

Monitoring data for MW 35-8-10-1 are plotted in Figure 2-4. The net change in wellhead pressure is 24.03 psi and the net change in downhole pressure is 12.97 psi for the 14-year period of record. As Figure 2-4 shows, both the wellhead pressure and downhole pressure steadily increased from installation on November 17, 2009 to early June, 2010. This well has seen moderate fluctuation in the pressure regime, however instrumentation problems and wellhead leakage occurred until 2013. These issues are discussed below.

As noted on Figure 2-4 the lower Level Troll was removed during wellhead maintenance on September 25, 2012 and reinstalled on October 31, 2012. A net water level change was not calculated because the upper transducer is below the water level in the well. Figure 2-4 documents a natural flow rate from the well at a rate of 0.25 gallons per minute (gpm) when the well was vented for maintenance on June 2, 2010. At the time of the well inspection on October 31, 2012, the flow rate was measured at 0.14 gpm. For charting purposes, the water level in the shut-in well is estimated to be at or near ground surface above the upper pressure transducer (set at 7.5 ft bgs).

Also noted on Figure 2-4, telemetry system communication with the In-Situ[®] Data Center for the upper transducer was lost from November 26, 2009 through February 11, 2010 due to cable connection problem and was intermittent from December 19, 2010 to January 1, 2011. The upper transducer and cable were replaced during the 2011 well inspection and the cable length was extended from 3 ft bgs to 7.5 ft bgs. Additionally, a wellhead fitting leak during the winter and spring of 2011 through the summer of 2012 caused a pressure decrease observed on both the upper and lower transducers. Related to the freeze-thaw cycles, the upper transducer failed again March 1, 2012. Inspection of the wellhead on June 6, 2012

revealed the minor water leak at an estimated flow rate of 0.1 to 0.2 gpm. Evidence of the wellhead freezing and then popping the wellhead seal is observed by the minor pressure spiking on both transducers in January 2011 and February 2012. The tubing head threading was cleaned in an attempt to achieve a pressure tight seal at the mandrel head, but both the rubber seals and threading had deteriorated significantly. Documentation was conducted for a later wellhead replacement. Souder Miller Associates supervised installation of the new wellhead on September 25, 2012, which required removal of all instrumentation from the well. Rather than reset the instrumentation at that time, it was planned to remain out of service until the well inspection conducted by ECMC, Norwest and In-Situ, Inc. on October 31, 2012. During that well inspection the upper transducer was replaced with a new 100 psia Level Troll. Also, as planned, the lower transducer and cable was reset, however the new set depth was approximately 15 feet deeper than the previous set depth, so the proper offset has been incorporated into the lower transducer data in Figure 2-4.

Since mid-2014, the Fiddler monitoring well showed a fairly steady decline in bottom-hole and wellhead pressure of approximately 6 psi through January 1, 2016. However, bottom hole and wellhead pressure measurements show a steady increase of approximately 5 psi from late February 2016 through May 2016. This could have been a response related to temporary shut-in of one or more nearby coal bed methane production wells. A similar pressure decline trend as the 2014-2015 resumed in June 2016.

2017 demonstrated a substantial pressure build-up measured on both the upper and lower transducers. It appears to represent significant groundwater recharge to at least one, if not all of the five Fruitland coal seams monitored in the Fiddler well following the wet winter of 2016-2017. This effect is observed again with similar magnitude following the very wet winter of 2018-2019. In 2023 the pressure regime returned to the fall-off trend as seen in 2019 following that previous wet winter.

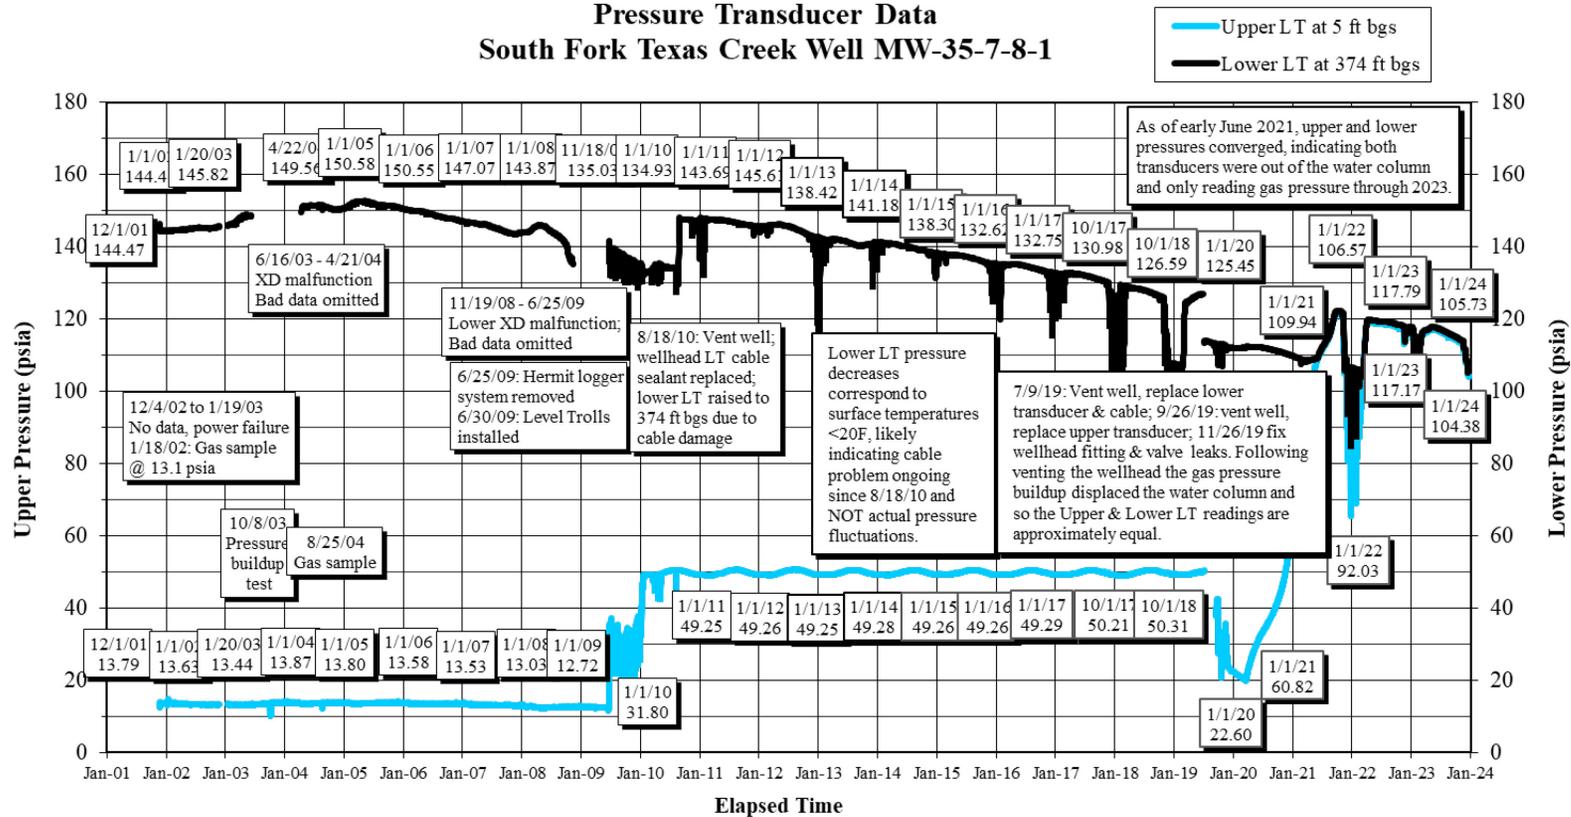
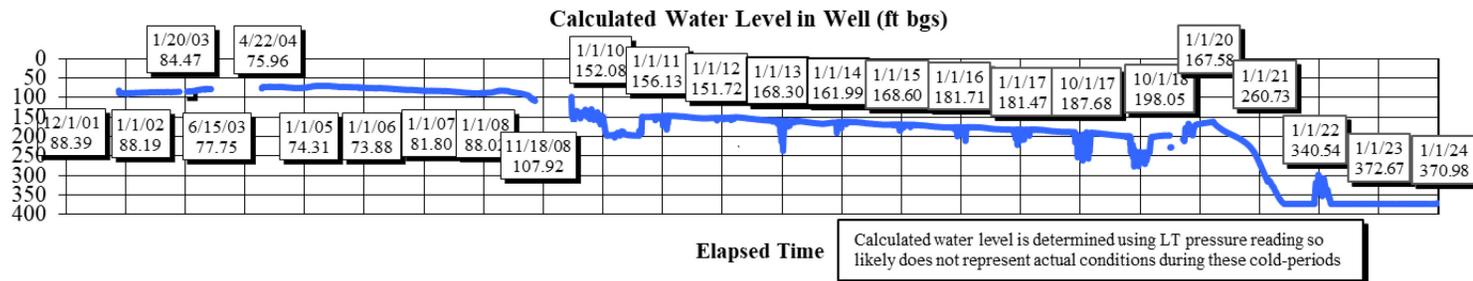
**Figure 2-5
Pressure Transducer Data South Fork Texas Creek Well MW-35-7-8-1**

of record during winter (cold) periods. In the summer of 2019, the lower transducer and cable were replaced as planned to address the cold weather pressure spikes. The upper transducer was replaced due to failure. Following those repairs and during the subsequent shut-in, the wellhead pressure declined for a period of several months until April 1st of 2020. At that time there was a significant, fairly steady wellhead pressure increase of over 100 psi through September of 2021, which may relate to decrease of groundwater production and thus an increase of reservoir gas pressure in the vicinity, or an intrawell pressure regime transition created by the first venting of this well since 2010. The difference in pressure readings between the upper and lower Level Trolls since June 2021 is only about 0.6 psi (1.4 feet) and demonstrates that the lower Level Troll is now only submerged by 1.4 feet of water, or more likely, the lower Level Troll is no longer submerged and the difference in readings is simply due to accuracy differences between the two Level Trolls. The corresponding calculated water level has decreased approximately 208 feet since the 2019 wellhead venting and instrumentation repairs, but as discussed previously, the water level may be lower given a total well depth of 463 feet below ground surface and a lower Level Troll set depth of 374 feet below ground surface.

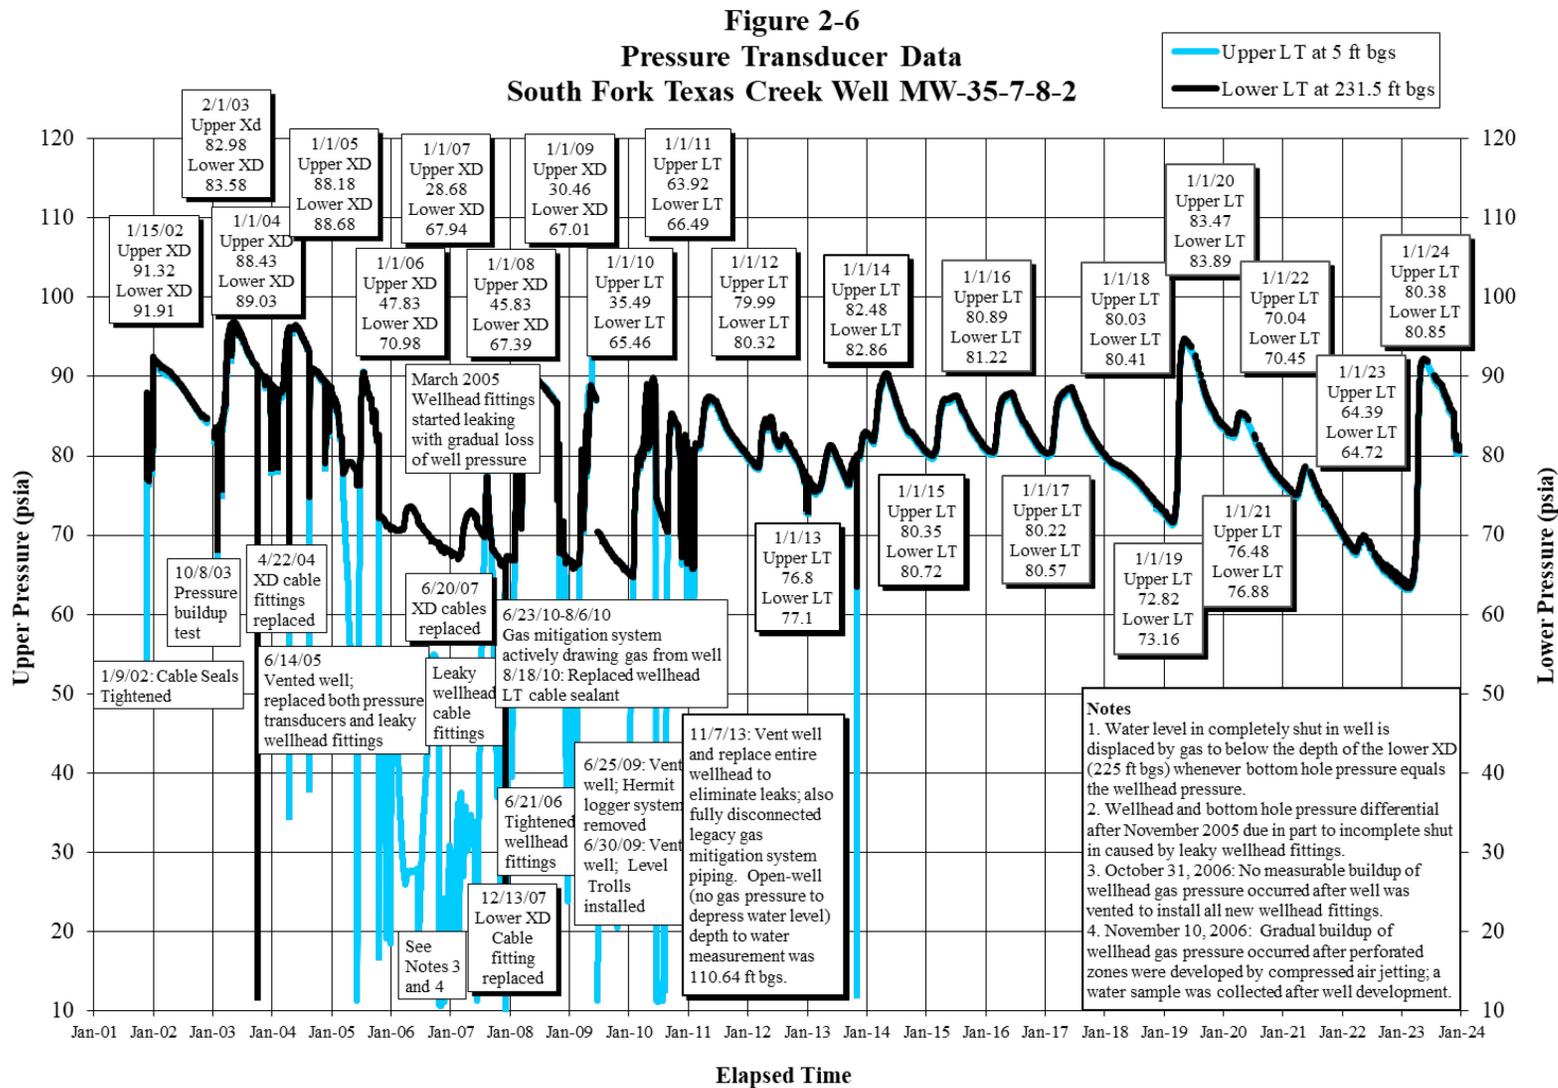
**Figure 2-6
Pressure Transducer Data South Fork Texas Creek Well MW-35-7-8-2**

Figure 2-6 charts the pressure data for well MW 35-7-8-2. Figure 2-6 shows nearly equal wellhead and downhole pressures for the period of record when the well is completely shut in with no leaks. For example, wellhead and downhole pressures recorded on January 1, 2024 were 80.38 psia and 80.85 psia respectively under shut-in conditions.

Figure 2-6 shows a fairly rapid increase in well pressure after the well was shut in on August 18, 2010. The peak build-up pressure of about 85 psia on September 28, 2010 was followed by an erratic decline in well pressure. The inspection of the well in 2013 documented a minor fitting leak at that time; this was a consistent leak on a pipe fitting that has been attempted to be tightened in the past years but required significant replacement of numerous wellhead fittings. The colder air temperatures occurring with early winter of 2012 and again in 2013 appeared to cause some erratic pressure fluctuations documented with the upper and lower transducers in Figure 2-6. This seemed to indicate that the leak was becoming more significant. On November 7, 2013 a site-specific follow-up trip was conducted to repair the leak that had been most recently documented on September 30, 2013. The well gas pressure was allowed to safely bleed down, with continuous gas detector monitoring. Both upper and lower Level Trolls were removed from the well and the wellhead was completely removed down to the 2-inch line pipe that is the well casing extending up from the cement pad. The threads were reconditioned with a hand-operated 2-inch pipe die. The wellhead was reconstructed using all new carbon steel pipe fittings, with the exception of

the Conax compression fittings secured around each Level Troll Rugged Cable, as they had not been documented as leaking. Several manual water level measurements were taken while the wellhead was open. Initially, the water level recovered fairly quickly as the gas pressure was vented. After approximately 2.5 hours open during the new wellhead installation, the water level was relatively stable and measured 110.64 ft bgs. This is the static water level when no gas pressure is allowed to depress the water column in the well. As can be seen in Figure 2-6, the upper and lower Level Troll pressure readings diverge at this time indicating that for the short period following well shut-in the lower Level Troll was actually submerged in water. The lower Level Troll pressure reading was approximately 63.6 psia, which calculates to 111.06 ft bgs. This gives good confidence in the calculated versus measured water level in this well, given error in the assumption of atmospheric pressure which is not currently recorded at this location. To prevent damage to the existing lower Level Troll cable, the Conax compression fitting was not adjusted to offset the new wellhead's increased height above ground surface of 0.25 feet, so the new set depth is 231.25 ft bgs. No leaks have been detected at this wellhead since the replacement.

A fairly consistent well pressure trend was observed for the previous years, 2014 – 2017, whereby the well pressure builds in the first two quarters of the year and then falls off during the second two quarters. This trend may be documentation of seasonal effects of groundwater recharge and discharge, natural or otherwise. As 2018 was documented with extreme drought conditions, it appears that the monitored interval did not receive the typical magnitude of recharge. The pressure trend continued to decrease during the usual recharge period of early 2018, with minimal superimposed recharge noted as a slight reversal in the pressure curve character. The excessively wet winter of 2018-2019 appears to have caused a substantial well pressure increase in the late winter and early spring of 2019, with the usual pressure fall-off occurring following for the remainder of the year. The pressure record appears to show that in 2022 the trend was similar to 2019-2021, which is an overall declining trend with an apparent minor seasonal recharge pattern. In 2023 another substantial well pressure increase and fall-off occurred following the very wet winter of 2022-2023.

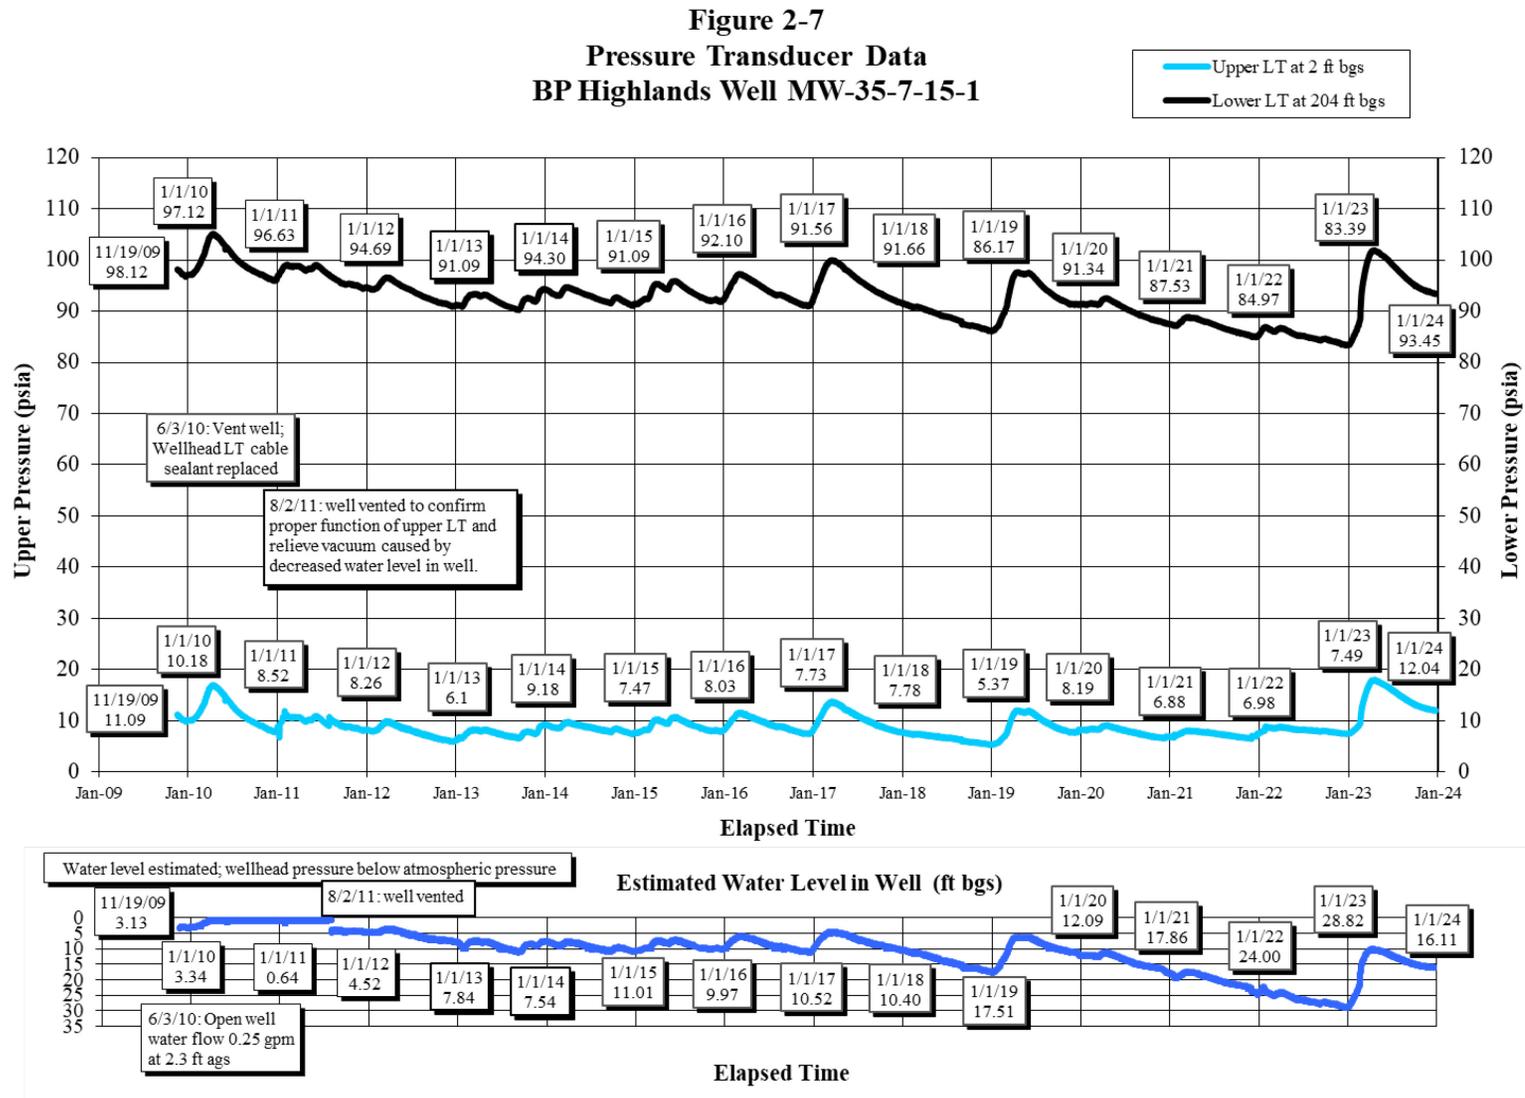
**Figure 2-7
Pressure Transducer Data BP Highlands Well MW-35-7-15-1**

Monitoring data for MW 35-7-15-1 are plotted in Figure 2-7. As summarized in Table 2-5 for the 14-year period of record, the net change in downhole pressure is a decrease of 4.67 psi. The well follows an overall decreasing pressure trend with seasonal variability dominated by late winter/early spring recharge. The net change in the calculated water level in the well is a decrease of 12.98 feet. The magnitude of this decrease was approximately doubled in 2018 due to extreme drought conditions and complete lack of observable recharge. This all but repeated again in 2020-2022, with a very muted recharge trend when compared to 2016 and 2017. 2023 showed a substantial pressure increase due to water level rise associated with groundwater recharge from the very wet winter of 2022-2023, which regained the level decline that started following the very wet winter of 2018-2019. As noted on Figure 2-7, water flowed from the well at a rate of 0.25 gallons per minute (gpm) when the well was vented for maintenance on June 3, 2010. For charting purposes, the water level in the shut-in well at that time was estimated to be slightly above ground surface with the upper transducer under water at 2 ft bgs.

The wellhead pressure started dropping below atmospheric pressure around August 12, 2010. This condition suggested either a potential problem with the upper transducer or a well pressure vacuum effect created in a completely shut-in well under declining water level conditions. A well instrumentation inspection and atmospheric pressure check conducted during each subsequent site visit through 2013 has confirmed the proper function of the upper transducer. Venting the well allowed for physical confirmation that the well was under vacuum pressure conditions which have continued through January 1, 2024.

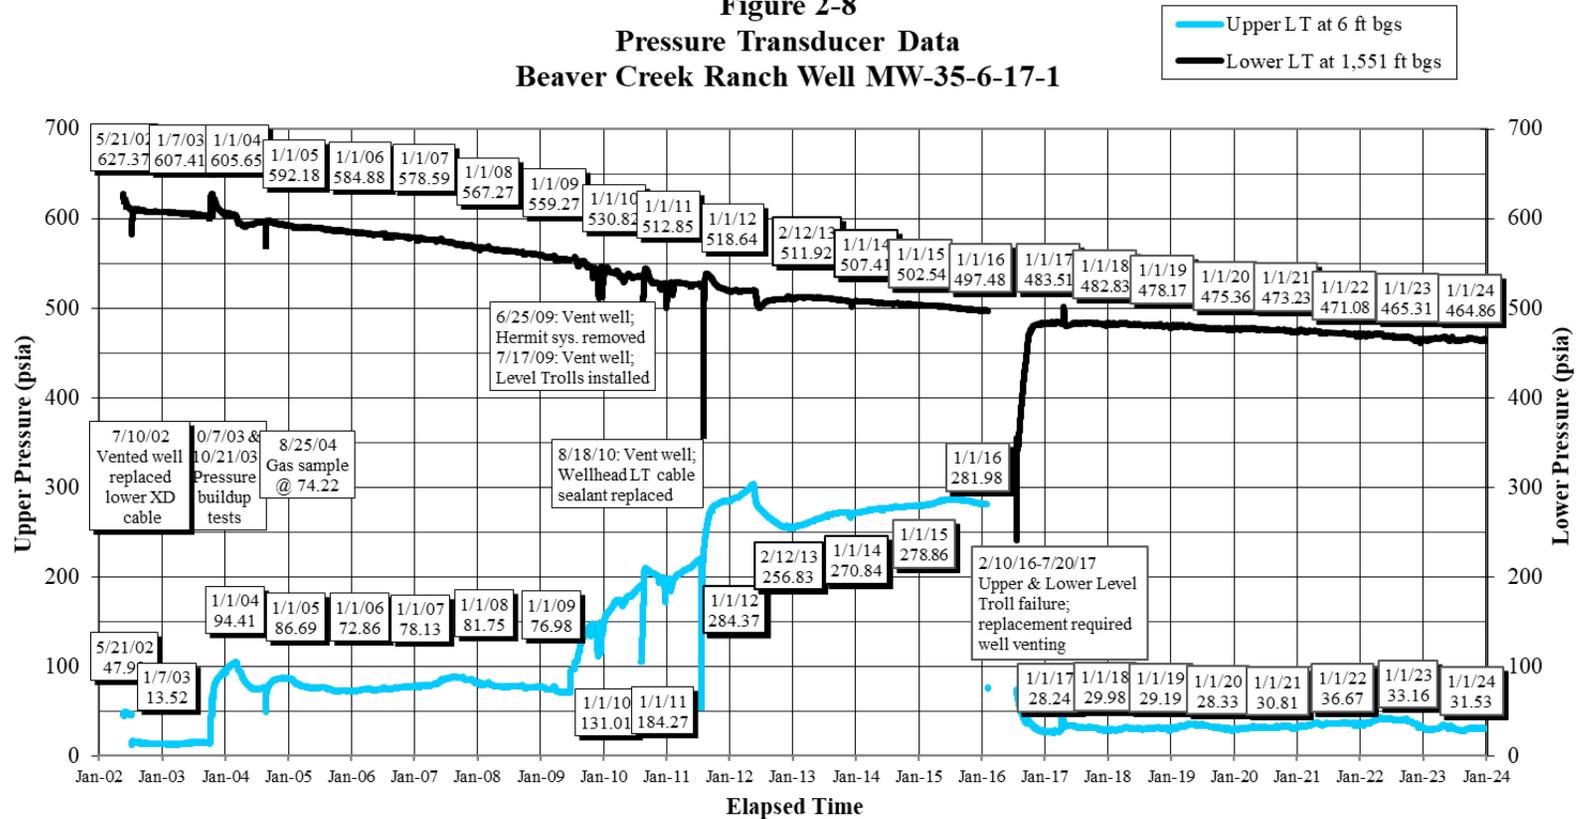
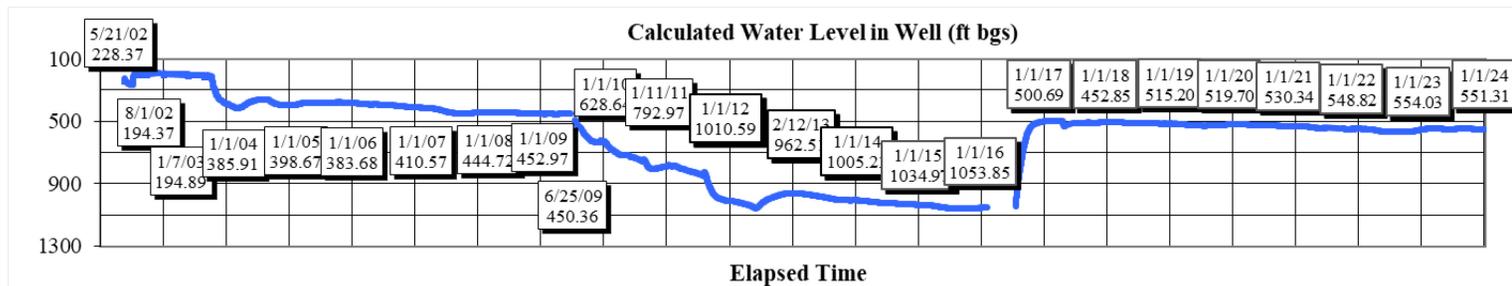
**Figure 2-8
Pressure Transducer Data Beaver Creek Ranch Well MW-35-6-17-1**

pressure regime. 2018-2023 pressure data demonstrates that following this bleed-off the wellhead pressure has remained depressed at approximately 30 psi and relatively stable but slightly increasing pressure trend. This is likely because the water head pressure of approximately 1000 feet (430 psi) is effectively preventing significant gas build-up at the wellhead.

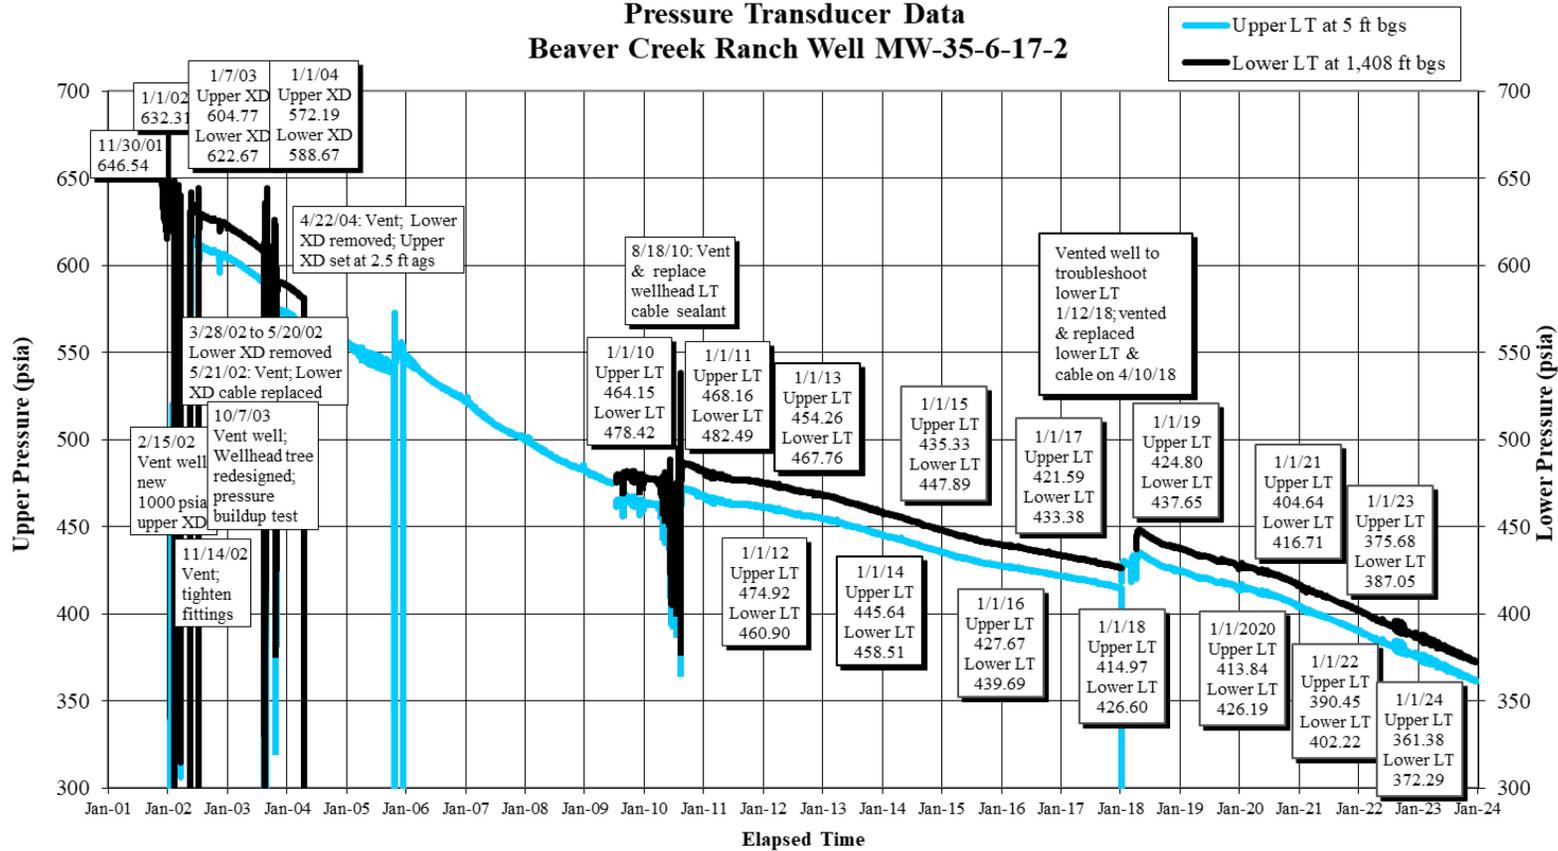
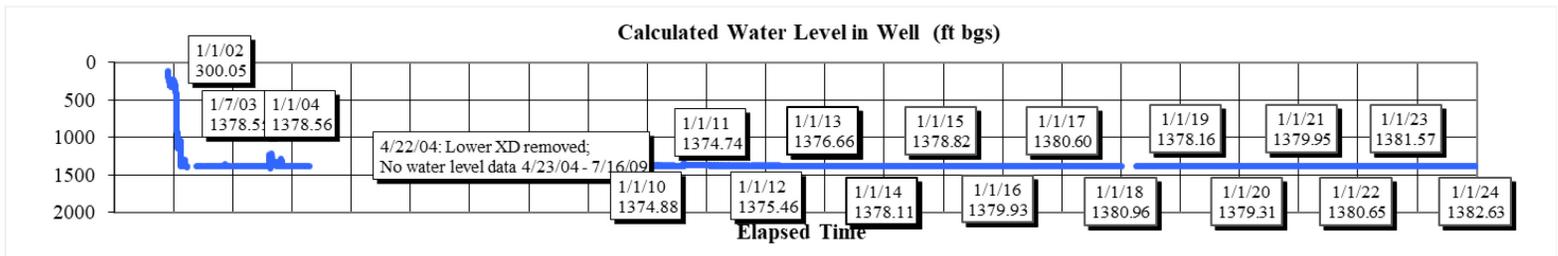
**Figure 2-9
Pressure Transducer Data Beaver Creek Ranch Well MW-35-6-17-2**

Figure 2-9 shows the well pressure in a declining trend for the entire period record. There is a notable shift in the well pressure curve following the installation of Level Troll instruments on July 17, 2009, followed by erratic well pressure fluctuations associated with incomplete shut-in through August 17, 2010. After the well was vented August 18, 2010 to replace the Level Troll cable fitting sealants, there was a steady build-up of well pressure through early September 2010 followed by a return to a declining trend through the period of record.

The 2023 data indicates the well is on a continued generally linear trend of gas pressure decrease since 2018.

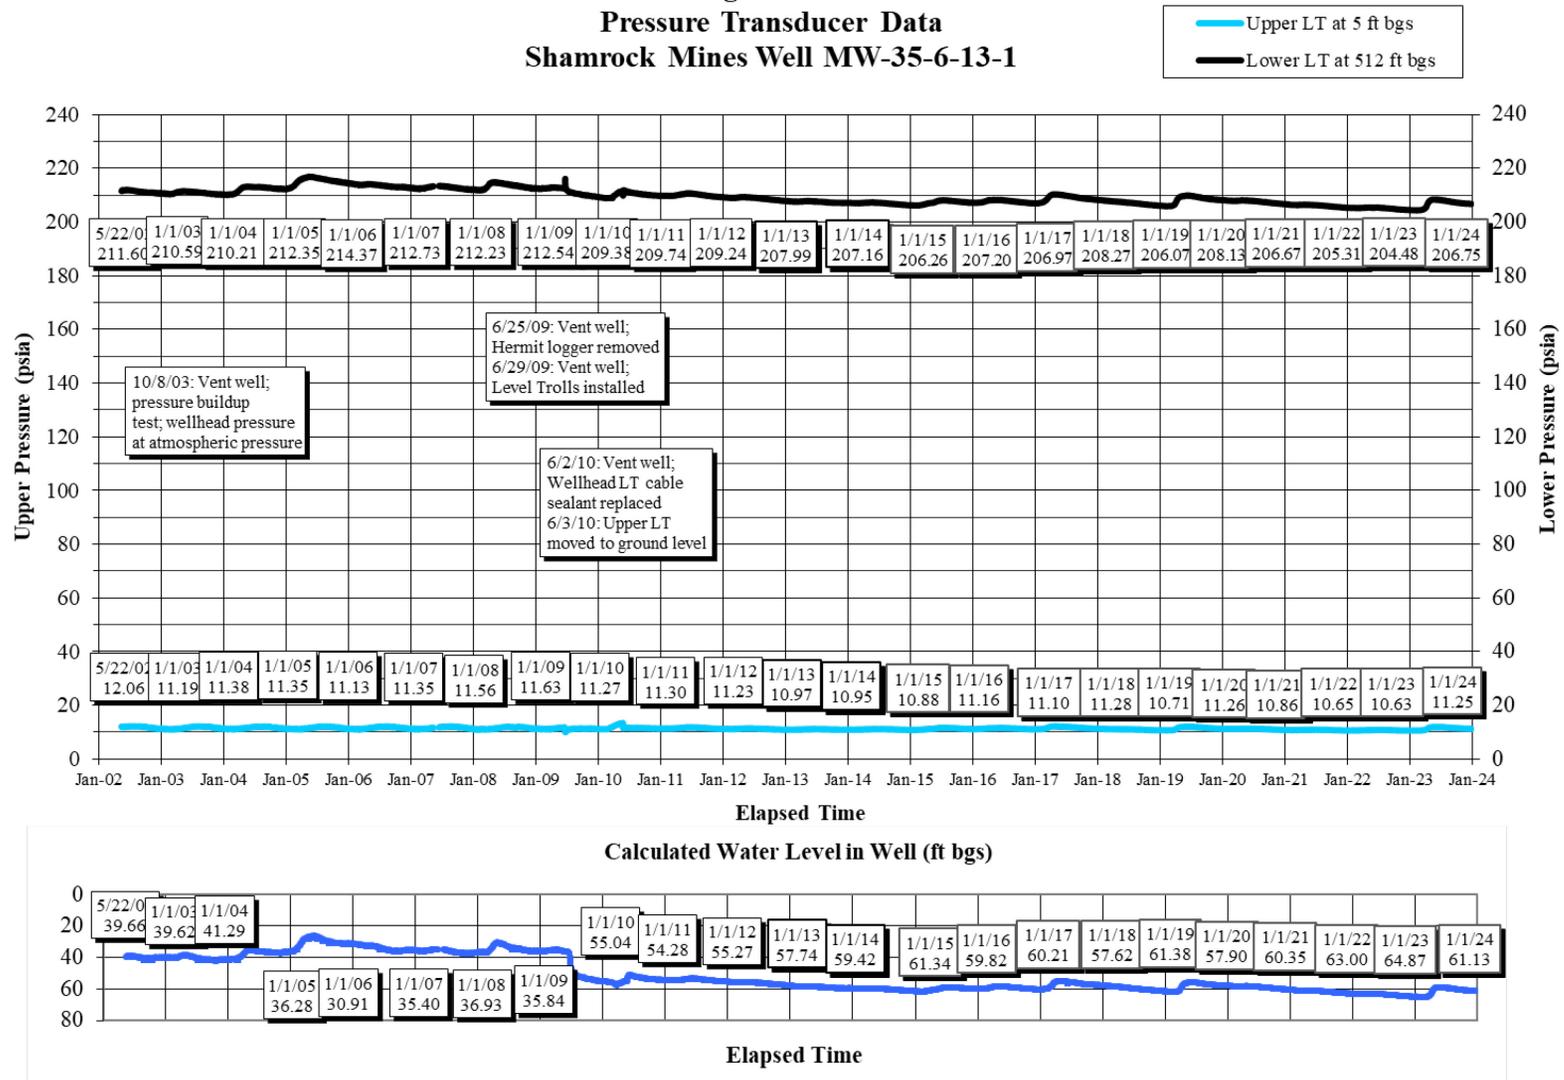
Figure 2-10
Pressure Transducer Data Shamrock Mines Well MW-35-6-13-1

Figures 2-10 shows the wellhead pressure regime continues to be at atmospheric pressure and fluctuates within a range of 2 psi (between 10 psia and 12 psia). During the months of April and May 2010, the wellhead pressure steadily increased to around 13.4 psia. Wellhead pressure returned to the historic atmospheric pressure trend after the Level Troll wellhead cable sealants were replaced on June 2, 2010.

Figure 2-10 also shows the downhole pressure and calculated water level in the well continued to exhibit an overall declining well pressure trend for the period of record since April 2005. With wellhead pressure equal to atmospheric pressure, fluctuation of downhole pressure is associated with the fluctuation of the water level in the well. Downhole pressure and corresponding calculated water levels have documented seasonal groundwater recharge events following the wet winters of 2007-2008, 2009-2010, 2016-2017, 2018-2019, and 2022-2023.
