Colorado Energy & Carbon Management Commission

**Monitor Wells Summary Report
2023**

**4M Project Monitoring Program
Archuleta and La Plata Counties
Colorado**

June 10, 2024

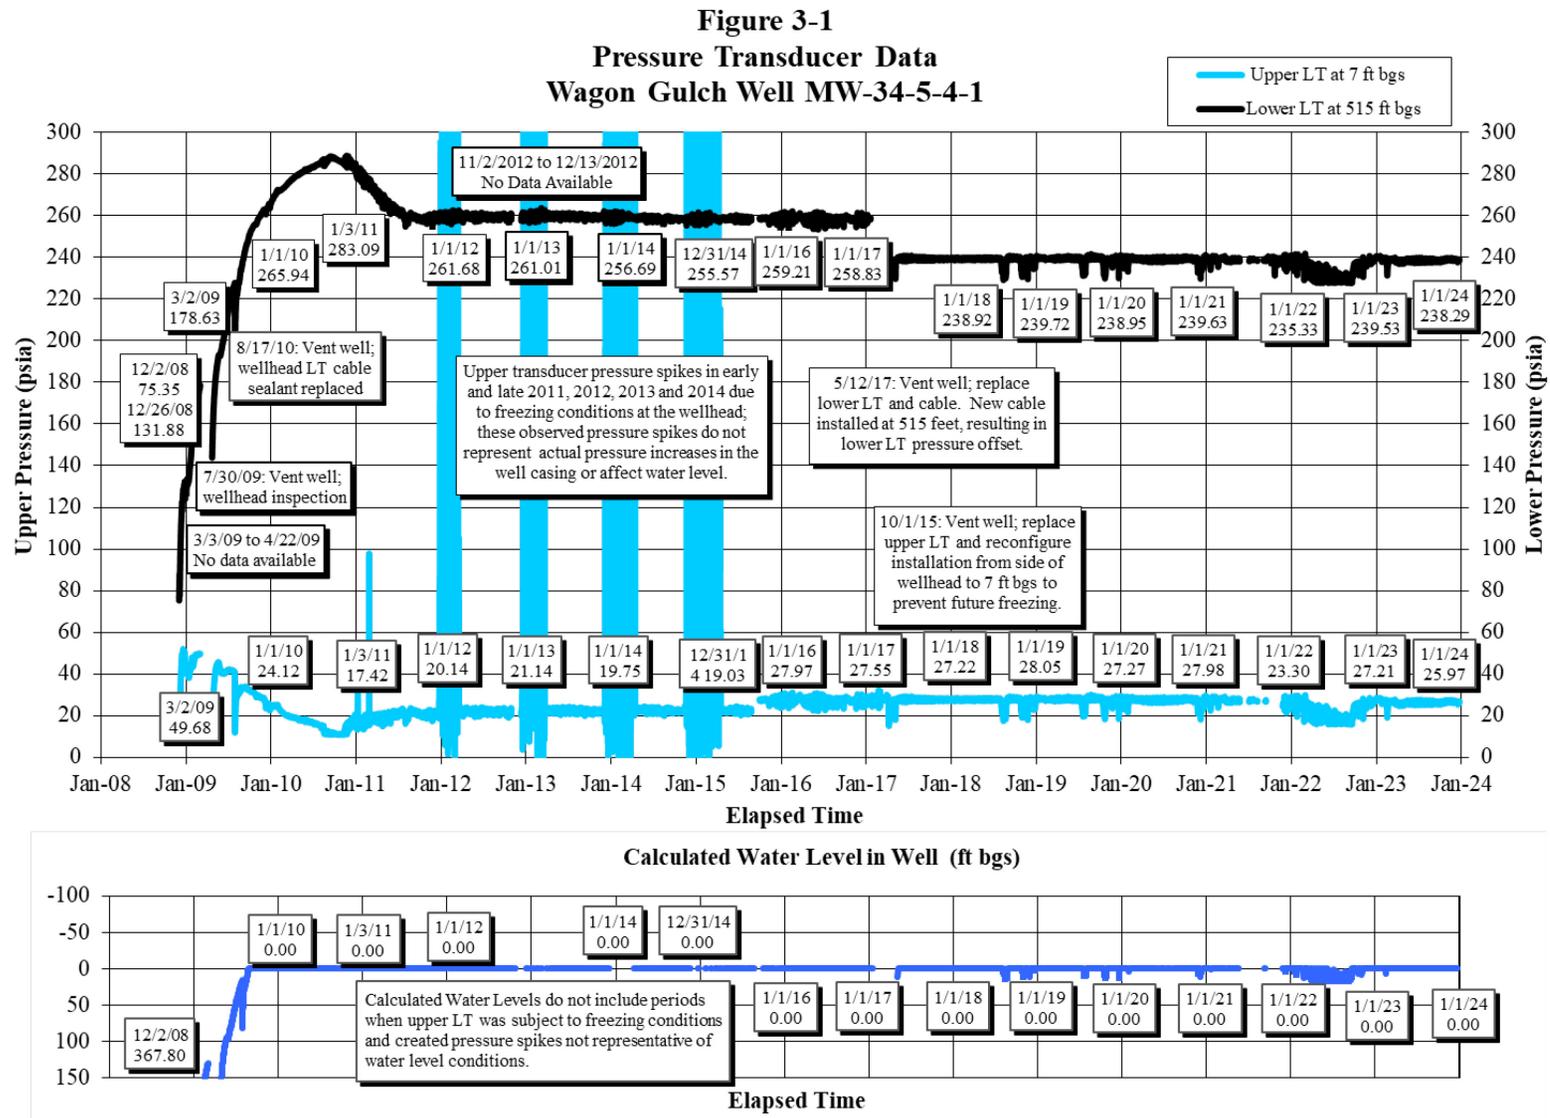
**Figure 3-1
Pressure Transducer Data Wagon Gulch Well MW-34-5-4-1**

2008. Figure 3-1 shows the trend of rising water level with corresponding increasing downhole pressure continued in 2010 until the trend reversed in mid-September 2010. This may have been related to the transducer cable sealant being changed on August 17, 2010 and possibly eliminating a partial shut-in condition. No leaks were detected during the site inspections in 2012-2014. Between October 1, 2010 and December 31, 2010, Figure 3-1 shows the water level decreased about 21.2 feet while the downhole pressure decreased about 2.7 psia.

During the winters of 2011-2012, 2012-2013, 2013-2014 and 2014-2015 pressure spikes in the upper transducer occurred due to the pressure transducer freezing within its deployment location in the wellhead 2.3 feet above ground surface. These are not actual increases in gas pressure within the well casing, but rather caused when the air volume next to the transducer inlet is trapped and then compressed by expanding frozen water condensate. When the 2011 well inspection was conducted at MW 34-5-4-1 the well was vented to ensure that the transducer would return to atmospheric pressure; this test successfully showed that the transducer continued to function properly and was not damaged. The transducer recovered after surface temperatures warmed each spring. The transducer was inspected for damage in each subsequent site visit since this problem began in 2011 until the 2015 site inspection when the Level Troll was replaced and lowered into the well to 7 ft bgs. As evidenced by the winter 2015 data shown in Figure 3-1, the condensate freezing problem in this location has been corrected by lowering the Level Troll below the ground surface.

Several pressure decreases on the order of 10 psi were observed by both the upper and lower transducers in the second half of 2018, 2019, and 2020, and then fairly consistently during 2021, 2022, and 2023. The duration of each event was on the order of days to weeks and full recovery to static pressure conditions occurred after each event.

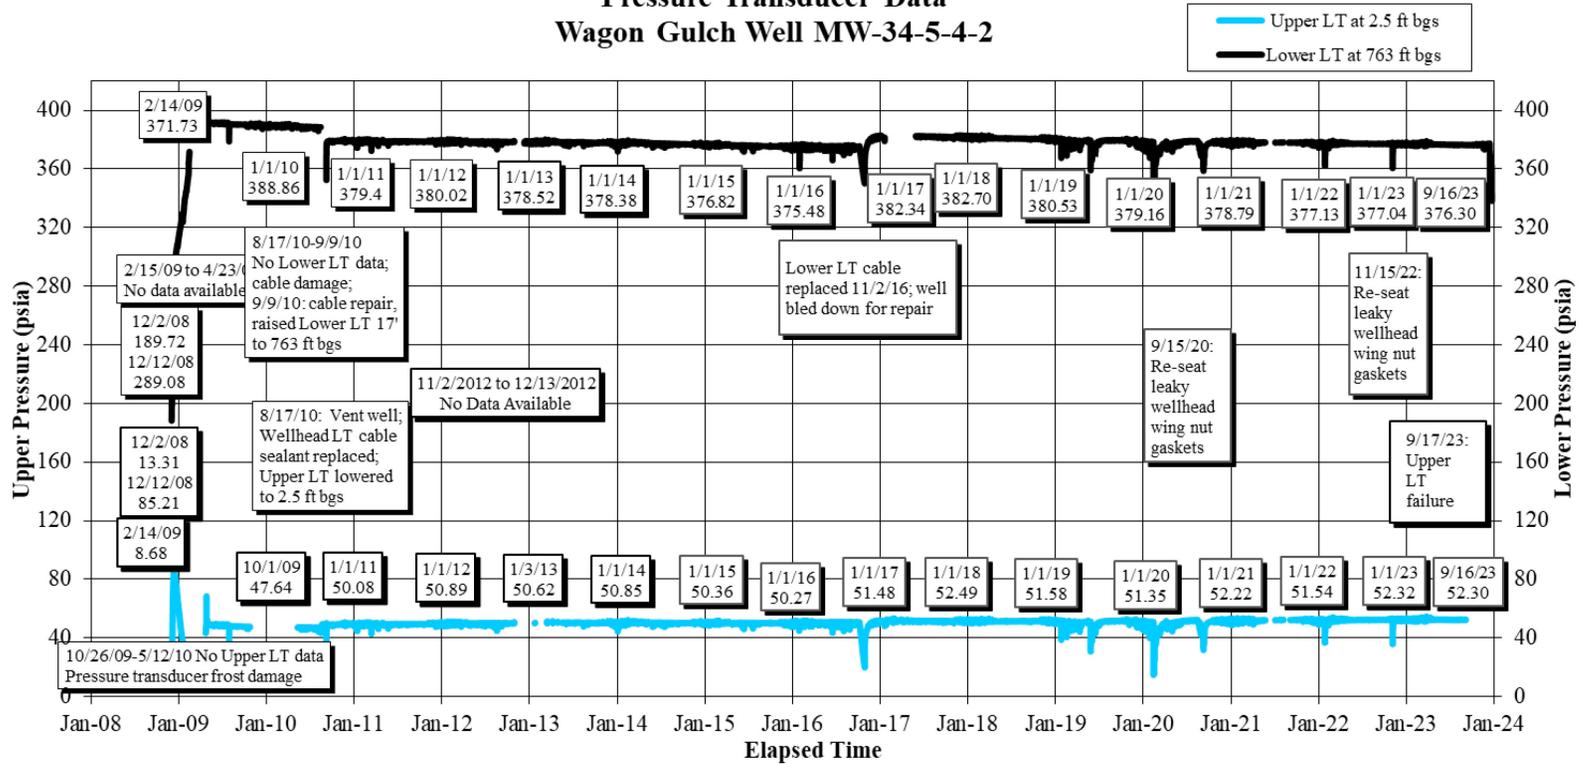
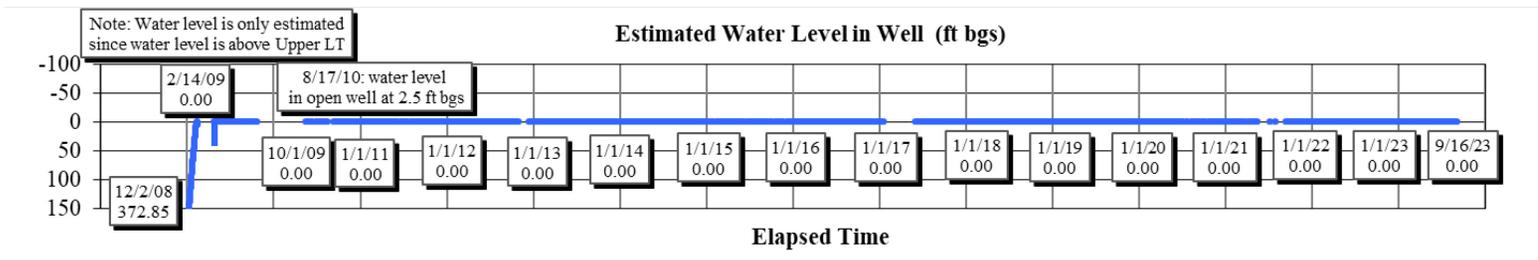
**Figure 3-2
Pressure Transducer Data Wagon Gulch Well MW-34-5-4-2**

Figure 3-2 shows a relatively constant wellhead pressure of about 47 to 48 psia between April 24, 2009 and October 25, 2009. An erratic pressure spiking pattern between October 26, 2009 and May 12, 2010 suggested wellhead Level Troll pressure sensor freeze damage, so the data were omitted from Figure 3-2. Between May 13, 2010 and August 16, 2010, the wellhead pressure remained fairly constant at around 47 psia.

Freeze damage to the upper Level Troll pressure transducer sensor was confirmed after the well was vented on August 17, 2010. As noted on Figure 3-2, the water level inside the open wellhead was at a height of about 2.5 feet above ground level. The new upper Level Troll was changed from an external mount to an internal depth setting of 2.5 ft bgs on August 17, 2010 to protect the transducer sensor from freezing conditions. After well shut-in on August 17, 2010, Figure 3-2 shows a relatively rapid return of wellhead pressure to an average constant pressure of about 50 psia.

The lower Level Troll cable was damaged during replacement of Level Troll wellhead cable sealants on August 17, 2010. Cable repair performed on September 9, 2010 included raising the Level Troll 17 feet from 780 ft bgs to 763 ft bgs. As a result of this change, Figure 3-2 shows a shift in the downhole pressure curve to a corrected constant downhole pressure regime of 378 to 379 psia.

As noted above, the water level was inside the open wellhead at a height of about 2.5 feet above ground level on August 17, 2010. The wellhead pressure build-up after shut-in may reflect water and/or gas pressure build-up. For charting purposes, the water level in the shut-in well is estimated to be at or near ground surface above the upper Level Troll (set at 2.5 ft bgs). However, there is a possibility that the observed build-up in wellhead pressure is from gas pressure, which could result in a downward displacement of the water in the well to some level below the upper Level Troll.

The pressure regime observed in 2023, as well as for the full period of record since post-completion stabilization in 2009, has been quite stable with an overall minor decreasing trend. The exception is apparent multiple drawdown cycles observed in 2019, 2020, 2022, and 2023 which are likely observed interference effects from nearby groundwater production.

Future routine work will consist of periodic field checks of each monitoring system and remote retrieval of recorded pressure measurement data using the In-Situ Inc. TROLL[®] Link telemetry system and ISI Data Center. ECMC staff will schedule an inspection and testing of all wellhead components and instruments during 2024 when all monitoring well sites are safely accessible and replacement equipment, as needed, has been procured. Specifically, all site instrumentation enclosure desiccants will be replaced, as required annually. Also, to regain data collection after malfunctions, the lower pressure transducers and cables at Basin Creek #1 and Fosset Gulch #1 and #2 will be replaced, and the upper pressure transducer and cable will be replaced at Wagon Gulch #2.

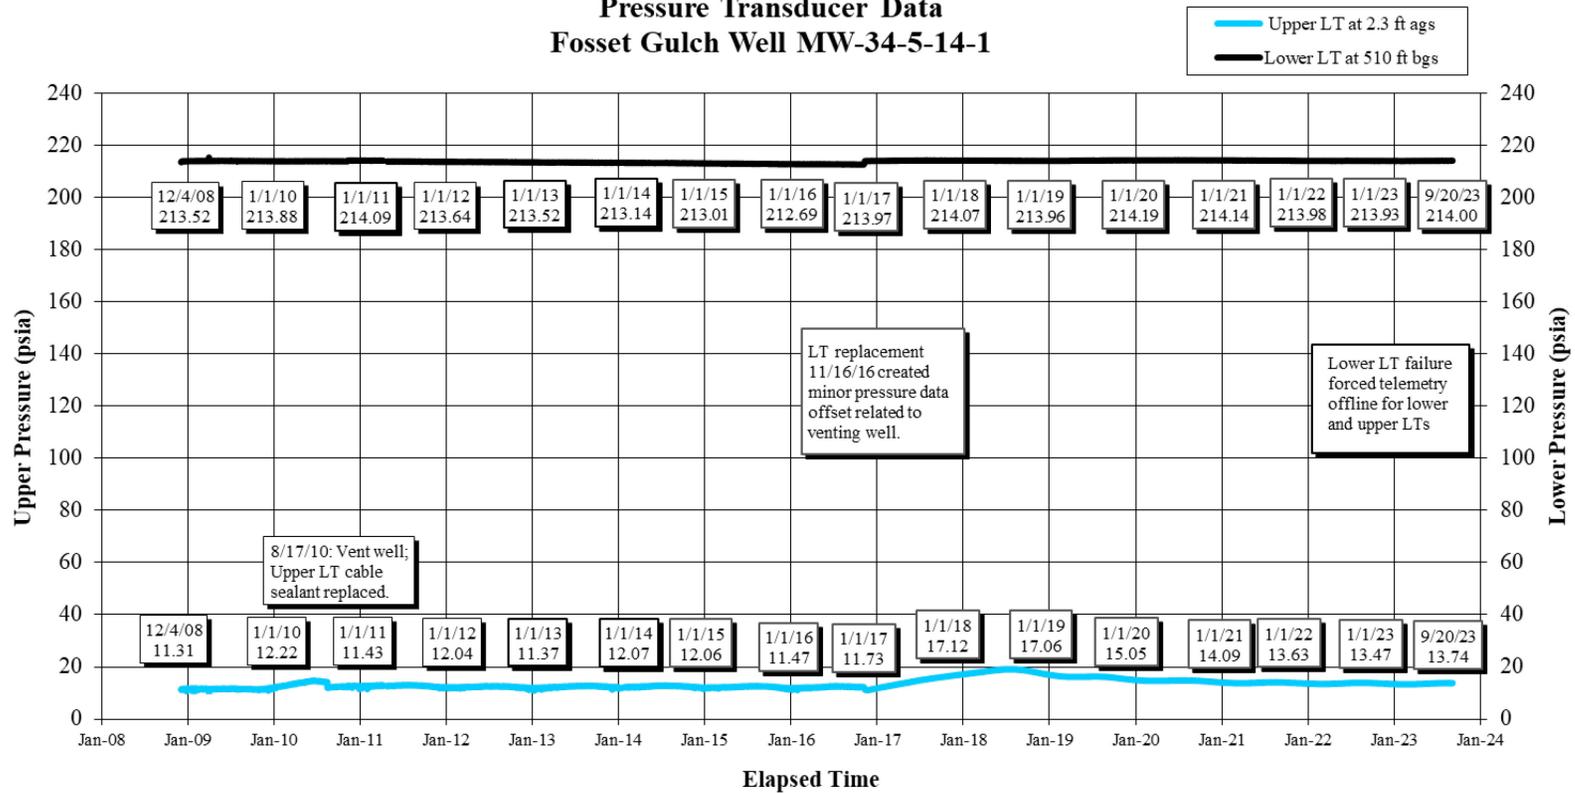
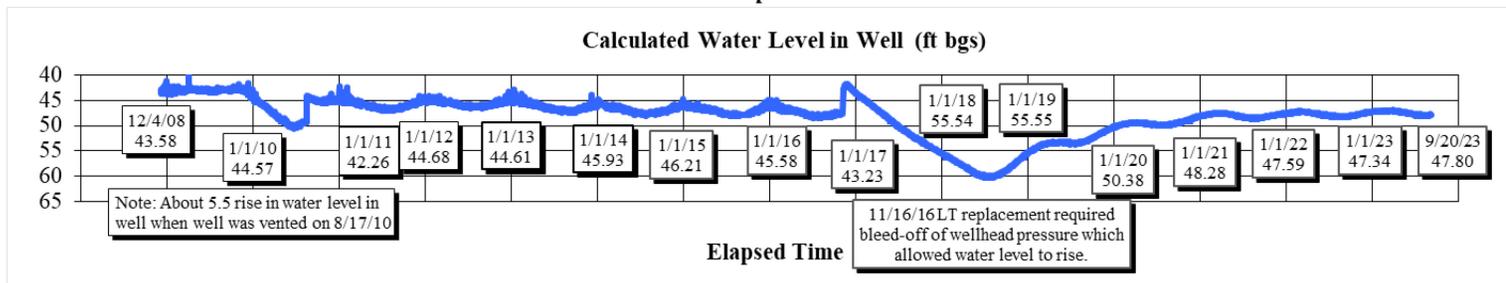
**Figure 3-3
Pressure Transducer Data Fosset Gulch Well MW-34-5-14-1**

Figure 3-3 charts the upper and lower pressure transducer data and the calculated water level in the well. Table 3-2 and Figure 3-3 show the wellhead pressure at atmospheric pressure prior to 2010 followed by a gradual increase in pressure through August 16, 2010 to 14.19 psia. Following the August 17, 2010 well maintenance event including venting, the wellhead pressure has remained relatively constant within a normal atmospheric pressure range through November 16, 2016. At that time, upper transducer replacement required venting the wellhead. Following the maintenance, the wellhead pressure increased slowly until July 2018 when it began to trend down. This is likely a response to gas production stimulation that occurred when the well was vented. Figure 3-3 shows a stable downhole pressure trend (213.52-214.19 psia) for the entire period of record. Figure 3-3 also shows a stable water level averaging 43.0 ft bgs until November 2009, followed by a gradually declining water level trend through July 1, 2010 (50.13 ft bgs). The water level increased to 49.28 ft bgs until the well was vented on August 17, 2010. The water level immediately rose to 44.36 ft bgs when the well was vented on August 17, 2010 but has since followed apparent gentle seasonal fluctuation until November 16, 2016. At that time, the well was vented to replace the upper pressure transducer. Upon replacement, the pressure measured at the wellhead has steadily increased from approximately 12.20 psi to 17 psi on January 1, 2019 and then changed to a decreasing pressure trend which has now generally stabilized to about 2 psi above atmospheric pressure. As such, the calculated water level was in steady decline during this time period as gas pressure has apparently

depressed it. Likewise, with the 2018 reversal of the wellhead gas pressure increase trend to a decreasing trend, the calculated water level is now shown to be increasing through the available data in 2023 superimposed over seasonal fluctuations to return to the trend of 2011 to 2016.

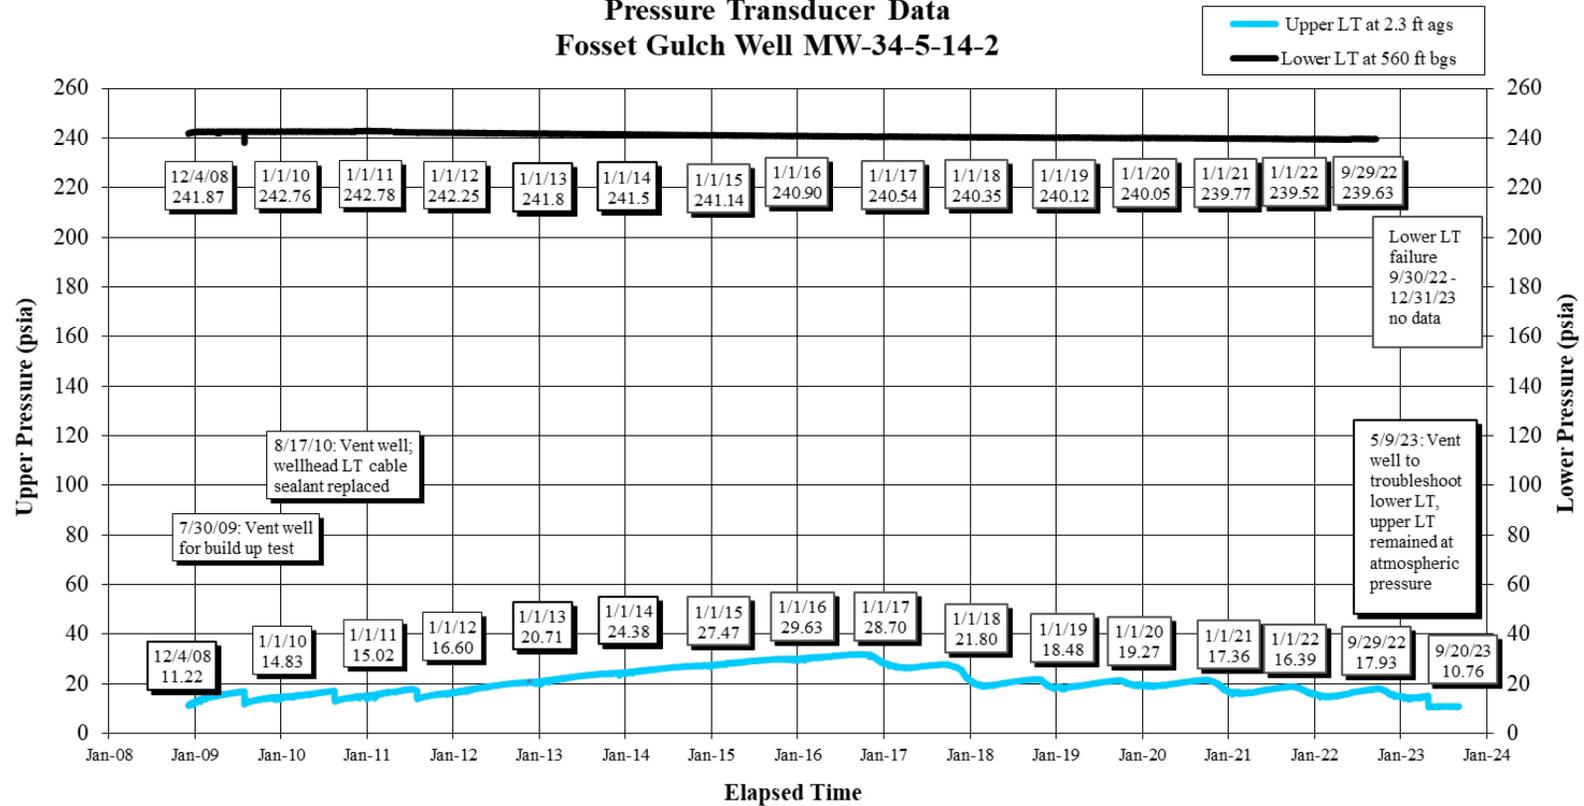
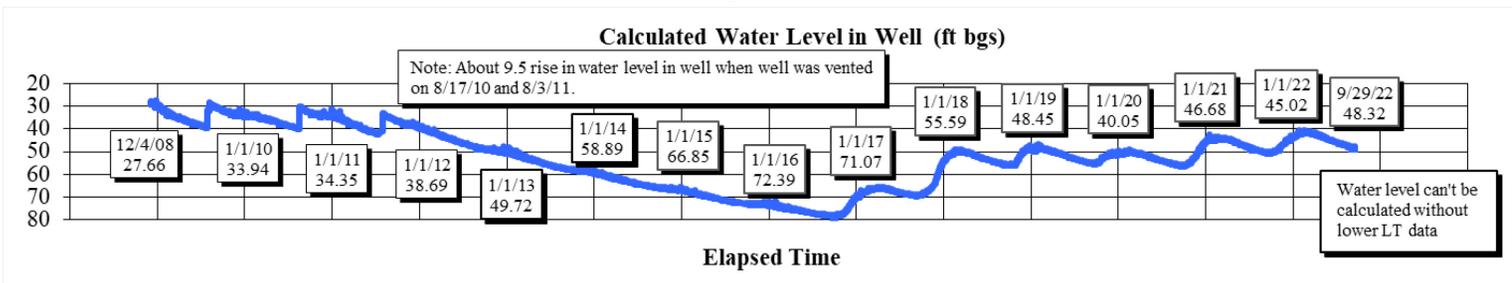
**Figure 3-4
Pressure Transducer Data Fosset Gulch Well MW-34-5-14-2**

Figure 3-4 plots the upper and lower pressure transducer data and the calculated water level in the well. Although the well was shut in for monitoring on December 4, 2008, wellhead pressure did not stabilize at about 17 psia until July 2009. Table 3-2 and Figure 3-4 show a net increase of 6.58 psi in wellhead pressure for the period of record between December 4, 2008 (11.35 psia) and September 29, 2022 (17.93 psia). After that date, the lower Level Troll failed and so no data is available for the remainder of 2022 or 2023. Figure 3-4 shows a stable but slightly declining downhole well pressure trend for the entire period of record, with fluctuations ranging between a minimum pressure of about 239.52 psia to a maximum pressure of 242.78 psia. The downhole pressure was 239.63 psia on September 29, 2022, a new low as the pressure trend has been very slightly decreasing over 14 years of monitoring.

Table 3-2 indicates a net water level drop of 3.02 feet in the well as of September 29, 2022. However, Figure 3-4 shows that the wellhead pressure and water level in the last five years has apparently shown an effect of venting MW 34-5-14-1 for maintenance on 11/16/16. This would suggest some amount of hydraulic connection between the two wells. Although there is an immediate drop in wellhead pressure and corresponding rise in the water level each time the well is vented to the atmosphere in the past, Figure 3-4 also shows the build-up in wellhead pressure takes approximately 12 months to return to the pressure exhibited prior to each venting event so unless required for servicing the instrumentation, the well will not be vented in attempt to determine the static wellhead pressure.

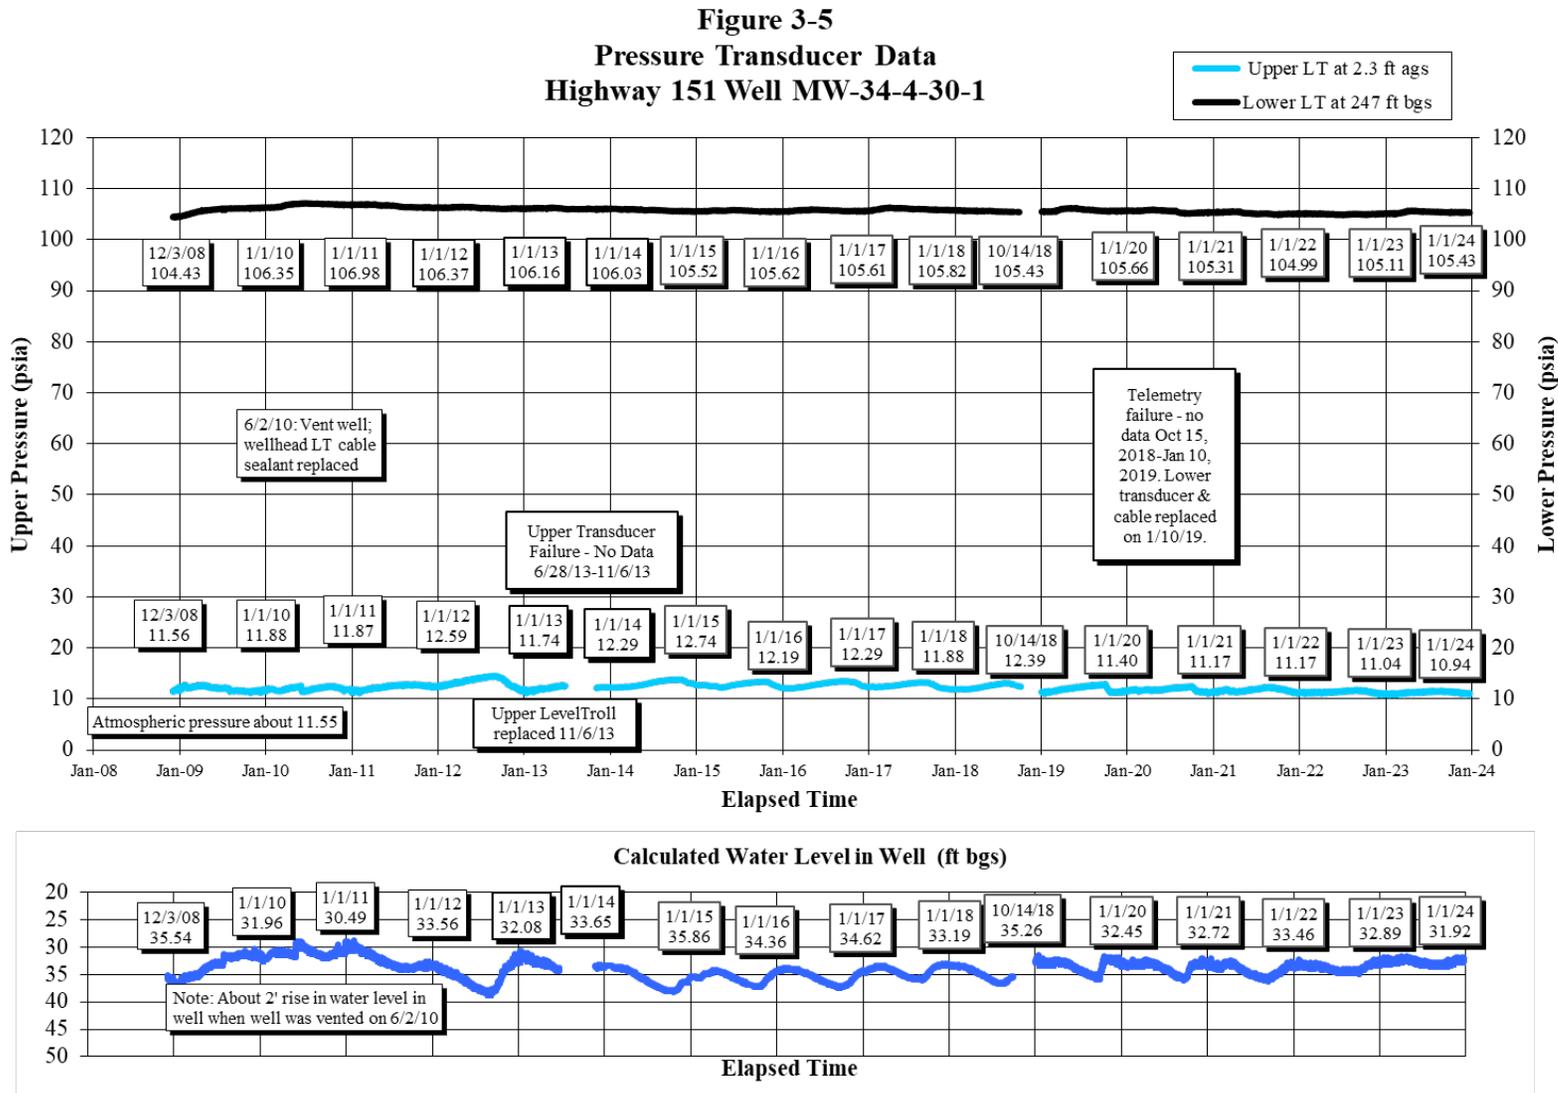
**Figure 3-5
Pressure Transducer Data Highway 151 Well MW-34-4-30-1**

Figure 3-5 charts the upper and lower pressure transducer data and the calculated water level in the well. Table 3-3 and Figure 3-5 show a relatively stable well pressure regime with a stable wellhead pressure trend at atmospheric pressure, a stable downhole pressure trend of about 104-107 psia, and a fluctuating water level trend of 30-39 ft bgs since August 2009. Sharp fluctuations in both wellhead pressure and the calculated water level shown on Figure 3-5 correspond to the immediate loss of pressure when the well is vented (e.g., June 2, 2010), followed by a gradual return to the well pressure regime exhibited prior to venting the well.

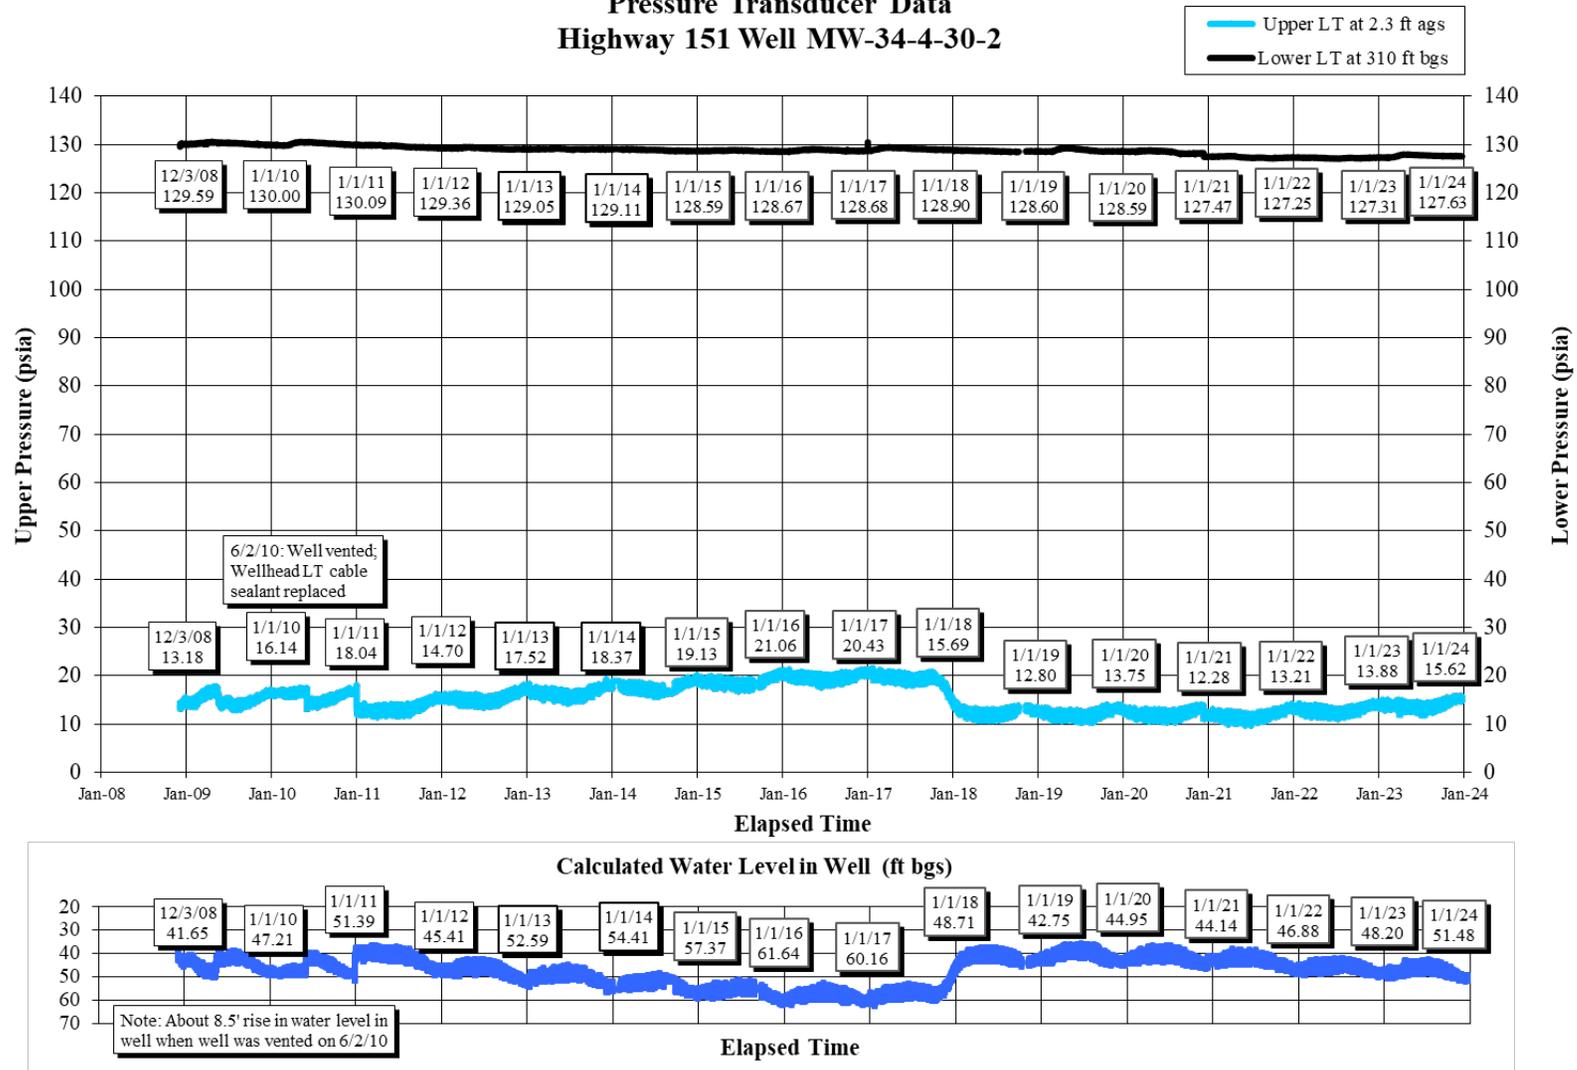
**Figure 3-6
Pressure Transducer Data Highway 151 Well MW-34-4-30-2**

Figure 3-6 charts the upper and lower pressure transducer data and the calculated water level in the well. Table 3-3 and Figure 3-6 shows a stable downhole pressure trend with 2.28 psi change from 129.59 psia on December 3, 2008 to 127.63 psia on January 1, 2024. In addition, there was a net wellhead pressure decrease of 2.44 psi with a corresponding net water level decline of 9.83 feet for the entire period of record from December 3, 2008 to January 1, 2024. However, the wellhead pressure decreased slowly in the fourth quarter of 2017 with a loss measured at approximately 4.3 psi in 3 months. The pressure then stabilized at atmospheric pressure and has remained in that range through 2022. The well was inspected in 2019 during routine maintenance and no wellhead pressure leaks were found. A seasonal water level fluctuation trend has continued superimposed over a long-term trend of approximately 0.5 feet of water level decline per year.

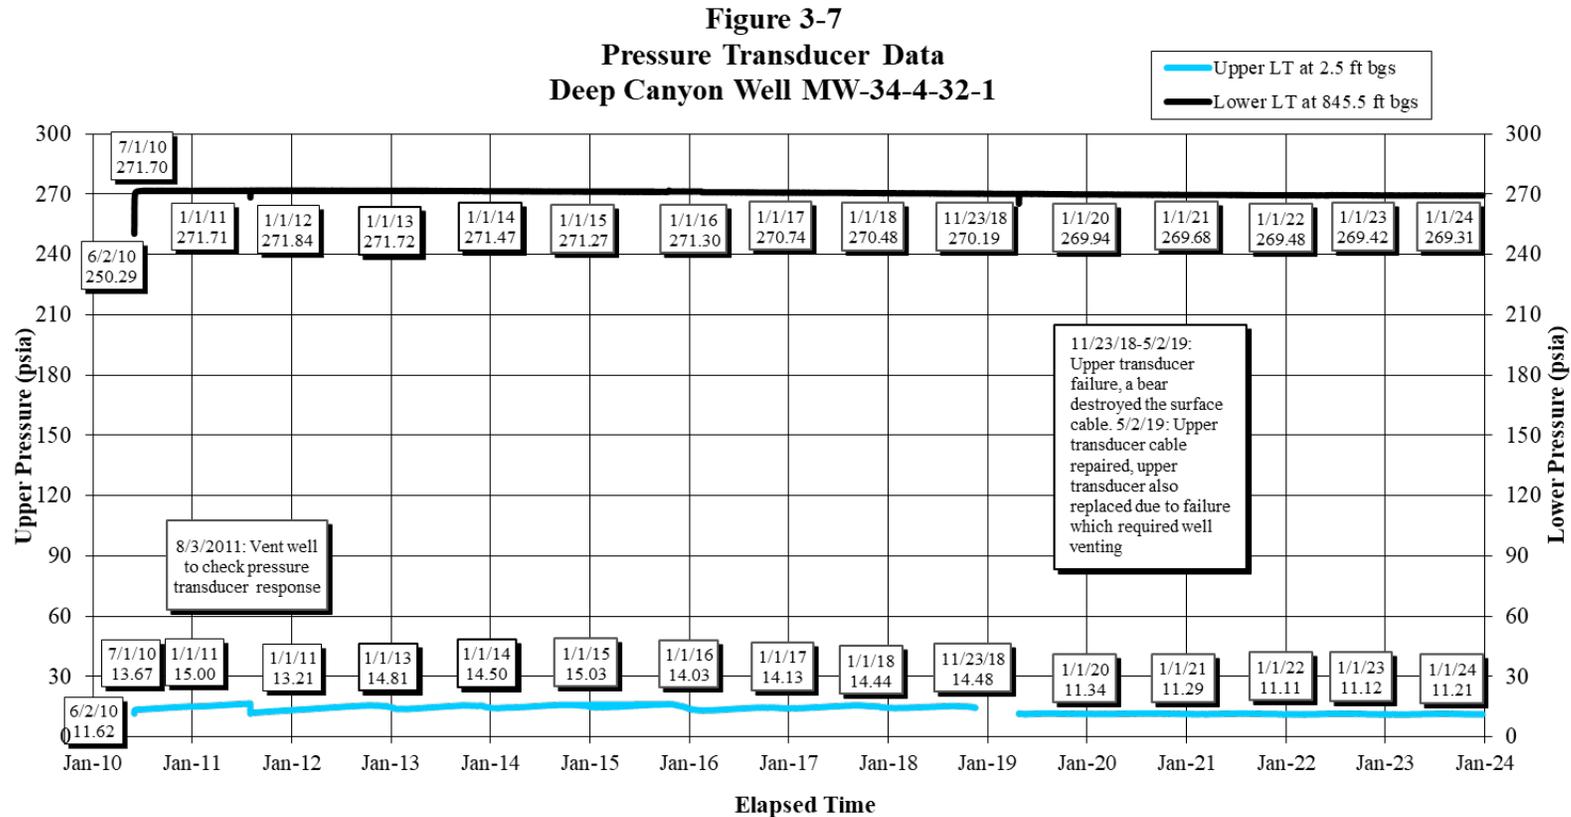
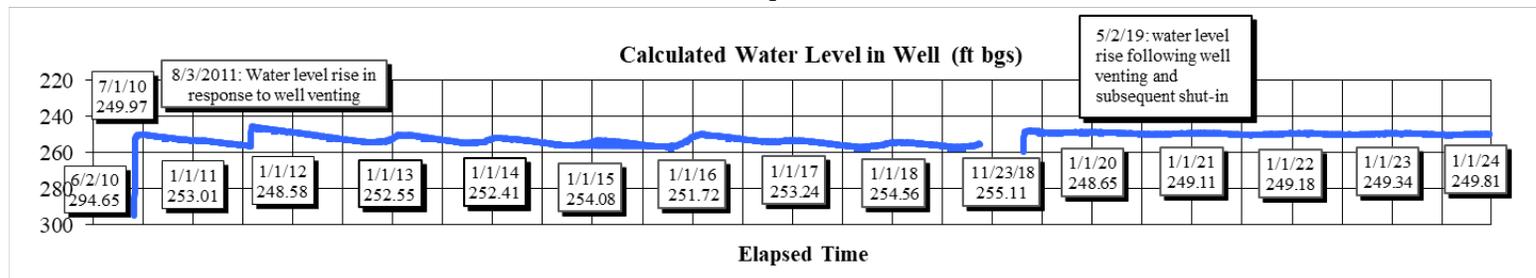
**Figure 3-7
Pressure Transducer Data Deep Canyon Well MW-34-4-32-1**

Figure 3-7 charts the upper and lower pressure transducer data and the calculated water level in the well. Table 3-4 and Figure 3-7 show the well pressure initially stabilized on June 8, 2010, six days after the well was shut in for monitoring on June 2, 2010. Table 3-4 and Figure 3-7 also show a relatively stable well pressure regime for the 13.5-year period of record through November 23, 2018 with only a slight increase in well pressure and a corresponding net water level decrease of 7.39 feet in the well. Data for this well is limited from November 23, 2018 to May 2, 2019 due to an upper Level Troll transducer failure. When investigated in early 2019 after the location was accessible following winter it was found that the surface cable for this Level Troll was damaged by what appeared to be a bear mauling of the telemetry station based on the type of cable damage and muddy paw prints on the telemetry instrumentation enclosure. At that time the cable was repaired, the Level Troll was replaced and full function has resumed. Since May 2, 2019, the upper and lower pressure transducer data has been stable, with corresponding stable calculated water levels which do not seem to demonstrate significant seasonal fluctuation.
