Colorado Energy & Carbon Management Commission

**Monitor Wells Summary Report
2024**

**4M Project Monitoring Program
Archuleta and La Plata Counties
Colorado**

June 10, 2025

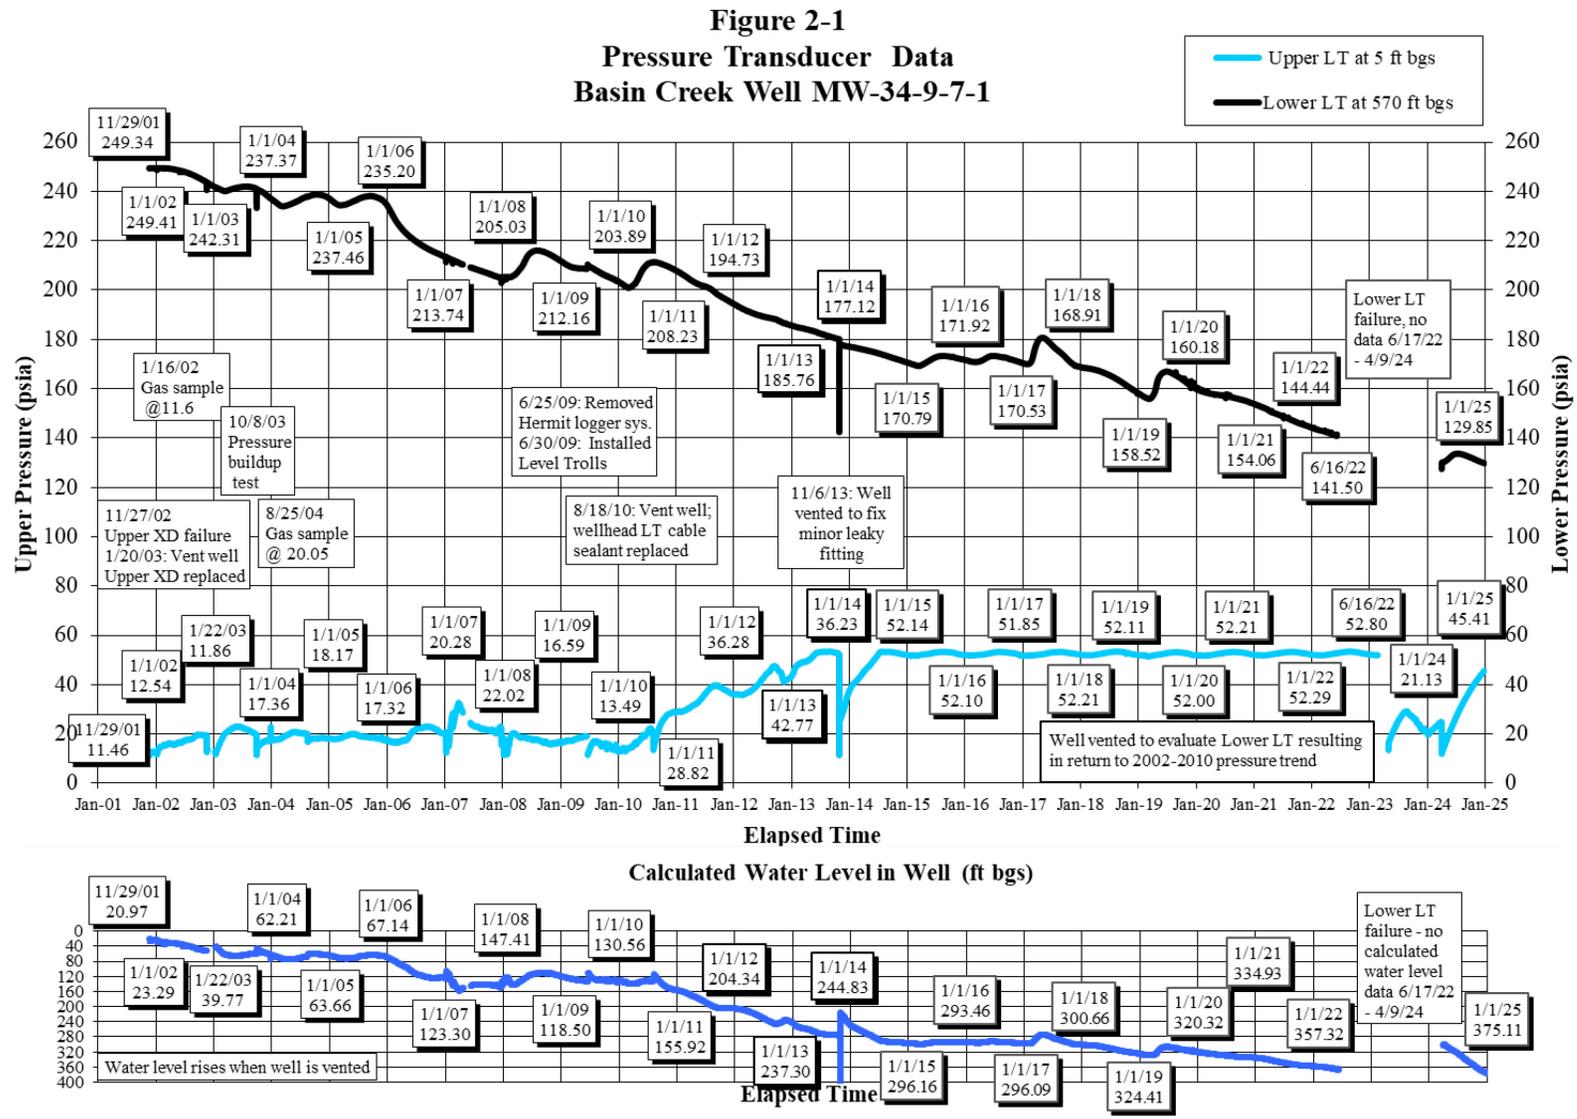
**Figure 2-1
Pressure Transducer Data Basin Creek Well MW-34-9-7-1**

Figure 2-1 charts the upper and lower pressure transducer data and the calculated water level in the well. Table 2-1 and Figure 2-1 show a net increase of 33.95 psi in wellhead pressure for the entire 23.5-year period of record from November 29, 2001 (11.46 psia) to January 1, 2025 (45.41 psia). The lower transducer stopped functioning on June 17, 2022, resulting in only a partial 2022 data set and no data in 2023. This lower transducer was replaced in 2024 and data collection has resumed. Figure 2-1 generally shows a pattern of minor seasonal fluctuations within an overall stable trend in wellhead pressure prior to wellhead cable gland seal replacement on August 18, 2010, followed by a rise in wellhead pressure to a recorded high of 53.42 psia on September 11, 2013. A very minor leak persisted so on November 6, 2013 the well was vented to allow a safe condition to repair leaking threads at the wellhead. Recovery of the

previous wellhead pressure occurred for about nine months following this wellhead venting. Since recovery in the second half of 2014, wellhead pressure has remained relatively stable. 2019 data demonstrated a groundwater recharge response to the very wet winter of 2018-2019; this effect was greater in magnitude than a similar pressure and water level response to the wet winters of 2007-2008, 2009-2010, 2016-2017. The venting of the well in January 2023 to evaluate the failed lower transducer apparently reset the pressure regime to that of 2001 through 2009 time period, but in 2024 it appears to be trending back to its previous 2014-2022 range.

In contrast to the wellhead pressure patterns, Table 2-1 and Figure 2-1 show a substantial net decline of 354.14 feet in the calculated well water level and a corresponding net decline in downhole pressure of 119.50 psi for the period of record through January 1, 2025. Figure 2-1 also shows a pattern of slight seasonal fluctuations within the overall declining trend in the water level and corresponding downhole pressure for the period of record.

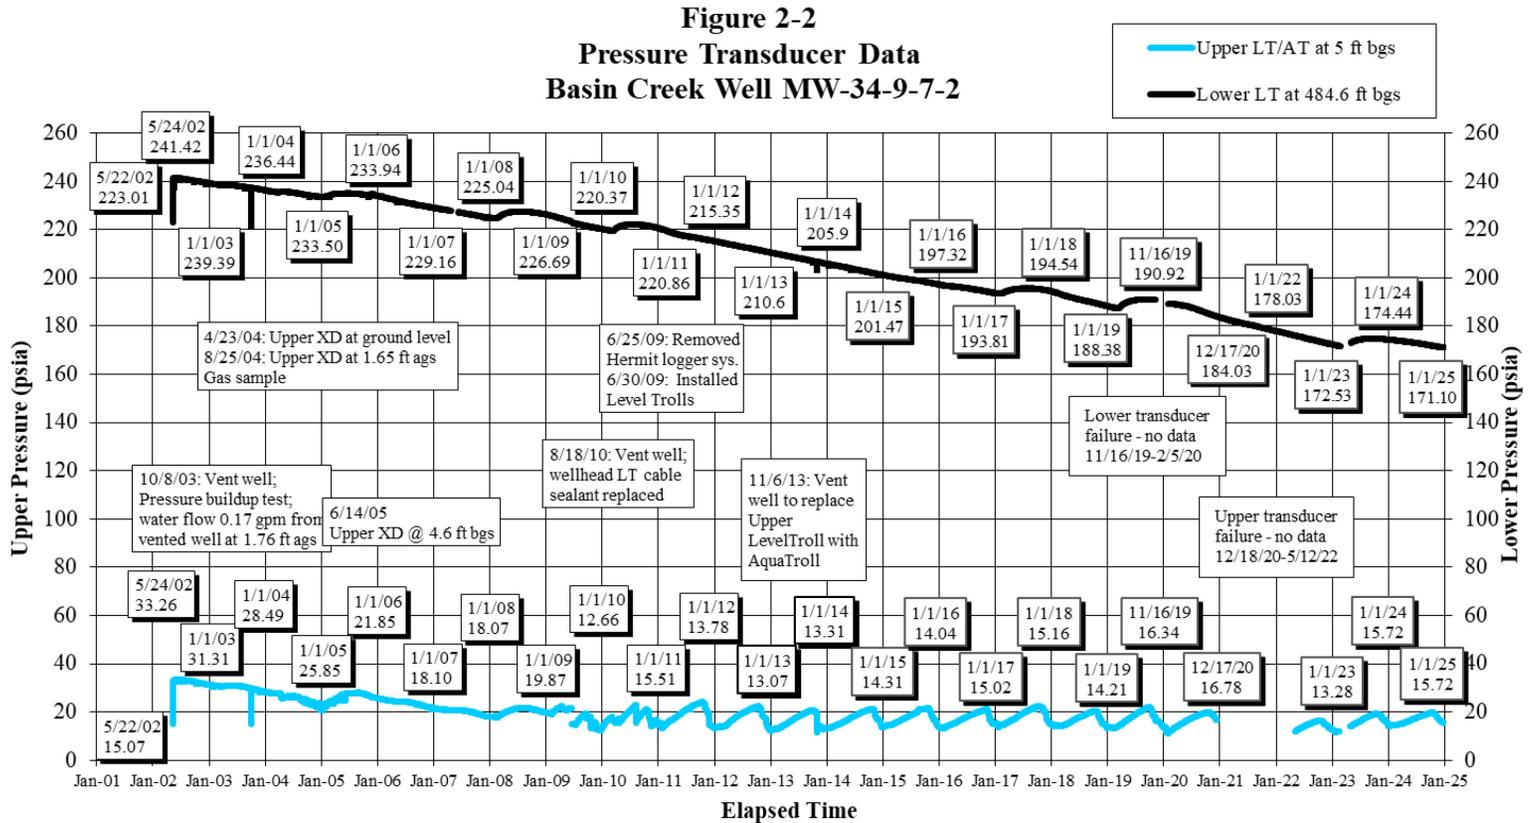
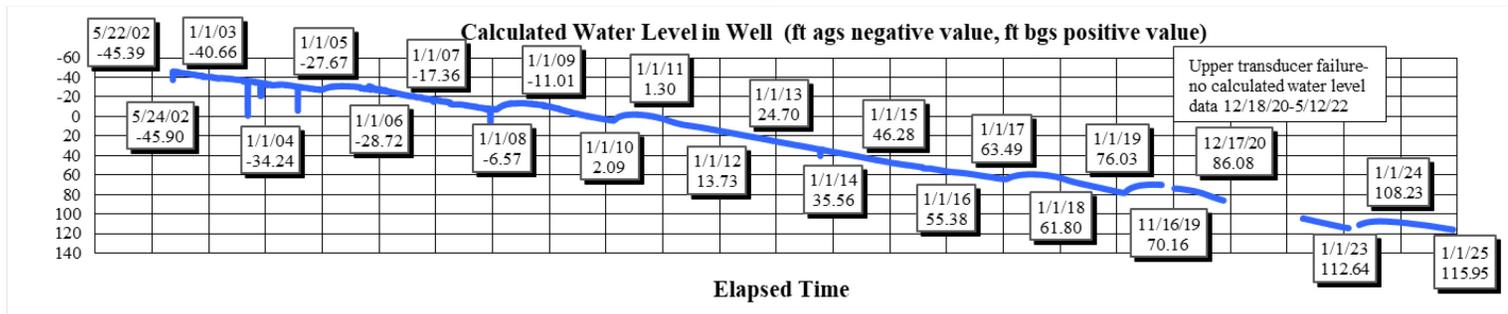
**Figure 2-2
Pressure Transducer Data Basin Creek Well MW-34-9-7-2**

A small amount of gas was released and artesian flow (~0.2 gpm) from the well consistently occurred each time the well was vented for maintenance during the period of record between 2002 and 2010. The pressure regime documented was relatively high pressure but low volume based on the head pressure versus artesian flow. Artesian flow from the well did not occur when the wellhead was vented on August 18, 2010 to replace the Level Troll wellhead cable Conax gland sealants. The final recorded upper transducer pressure in 2011 of 13.7 psi was very near atmospheric pressure indicating the well was essentially in hydrostatic balance. The pressure fluctuations since early 2009 suggest that ambient surface temperatures may be affecting the gas pressure as measured by the upper transducer. In order to attempt to distinguish water pressure versus gas pressure being recorded by the upper transducer, the Level Troll was replaced by an Aqua Troll, which records specific conductance (SC) in addition to pressure and temperature. The concept was that if water was present at the Aqua Troll, it would record an SC value greater than zero. If a value of zero was recorded for SC, then a pressure greater than atmospheric pressure would be gas pressure only. The Aqua Troll was installed on November 6, 2013, but it appears by this time the static water level in this well had dropped from the near-surface balance of 2009-2011. 2017 brought a change in trend of the downhole pressure; it increased slightly throughout the first half of 2017, plateaued and then continued to decrease in the linear trend followed since mid-2011. This was a similar trend as observed in 2010. 2023 data demonstrated a groundwater recharge response to the very wet winter of 2022-2023, similar to that observed after the wet winters of 2007-2008, 2009-2010, 2016-2017, 2018-2019. There was no groundwater recharge observed during 2024 with levels declining all year.

Substantial water level decline has been documented in this well, going from artesian flowing with a calculated shut-in head of approximately 45 feet above ground surface just after construction to 108.23 feet below ground surface on January 1, 2024. This calculated water level data set has been verified by a manual open-well water level measurement on November 6, 2013 of 40.20 ft bgs used as a calibration point for water level calculation using the lower Level Troll data within fifteen minutes on the same date of 40.46 feet below ground surface.

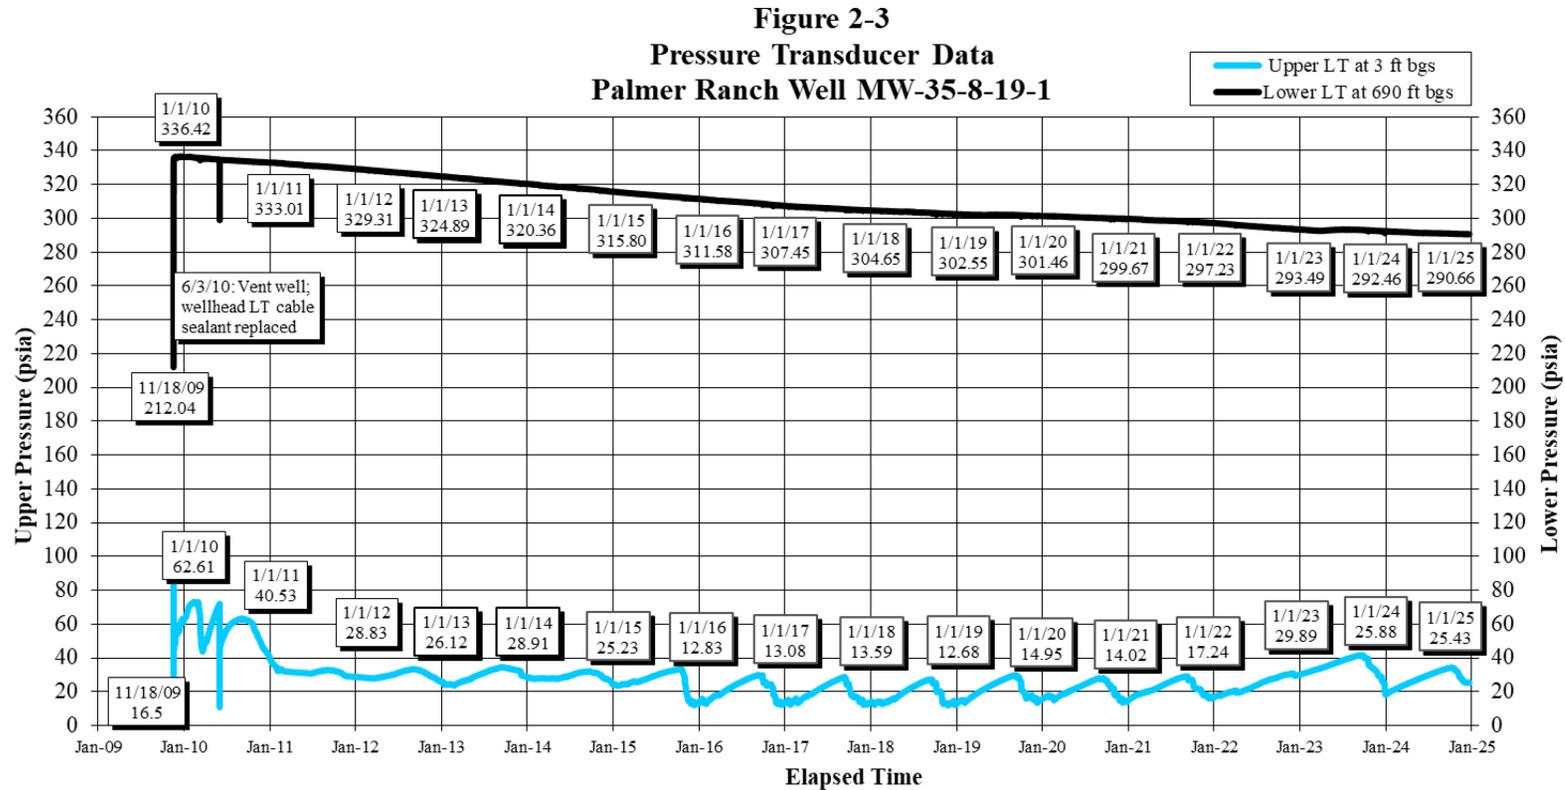
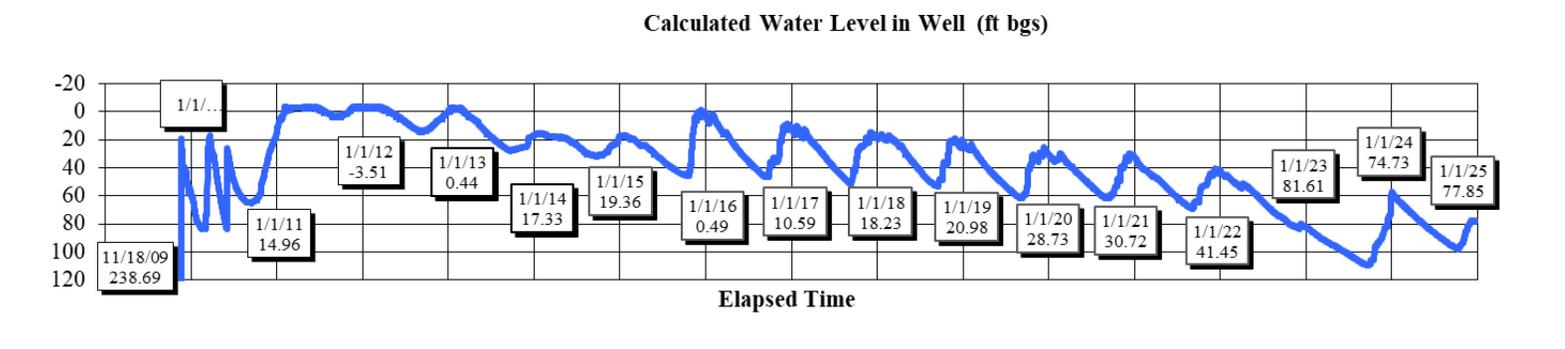
**Figure 2-3
Pressure Transducer Data Palmer Ranch Well MW-35-8-19-1**

In late October 2015, wellhead pressure apparently began dropping slowly from approximately 33 psi to approximately 12 psi in mid-December 2015. Wellhead pressure then was fairly stable through the winter and then slowly built up from late winter through late summer. The pressure trend appears to be similar but stronger seasonal trend that has been occurring since 2011. The trend repeated through 2022 and suggests the well has been demonstrating an apparent increased response to seasonal groundwater level

changes, increased local groundwater production effects or coal seam reservoir pressure fluctuations. The Florida River runs immediately adjacent to the well and flows are significantly impacted by agricultural irrigation schedules, which may have both direct and indirect effects on observed Fruitland coal seam reservoir pressure and water levels. In the winter of 2022-2023, the typical groundwater recharge event started several months later than typical, and was very short in duration to the point that groundwater level generally continued on the same near-linear decline trend in 2023 as 2022 until the irrigation season ended and significant seasonal groundwater recharge occurred through the end of 2023. 2024 seasonal groundwater decline and recharge appears to have returned to the trends of 2016 through 2021.

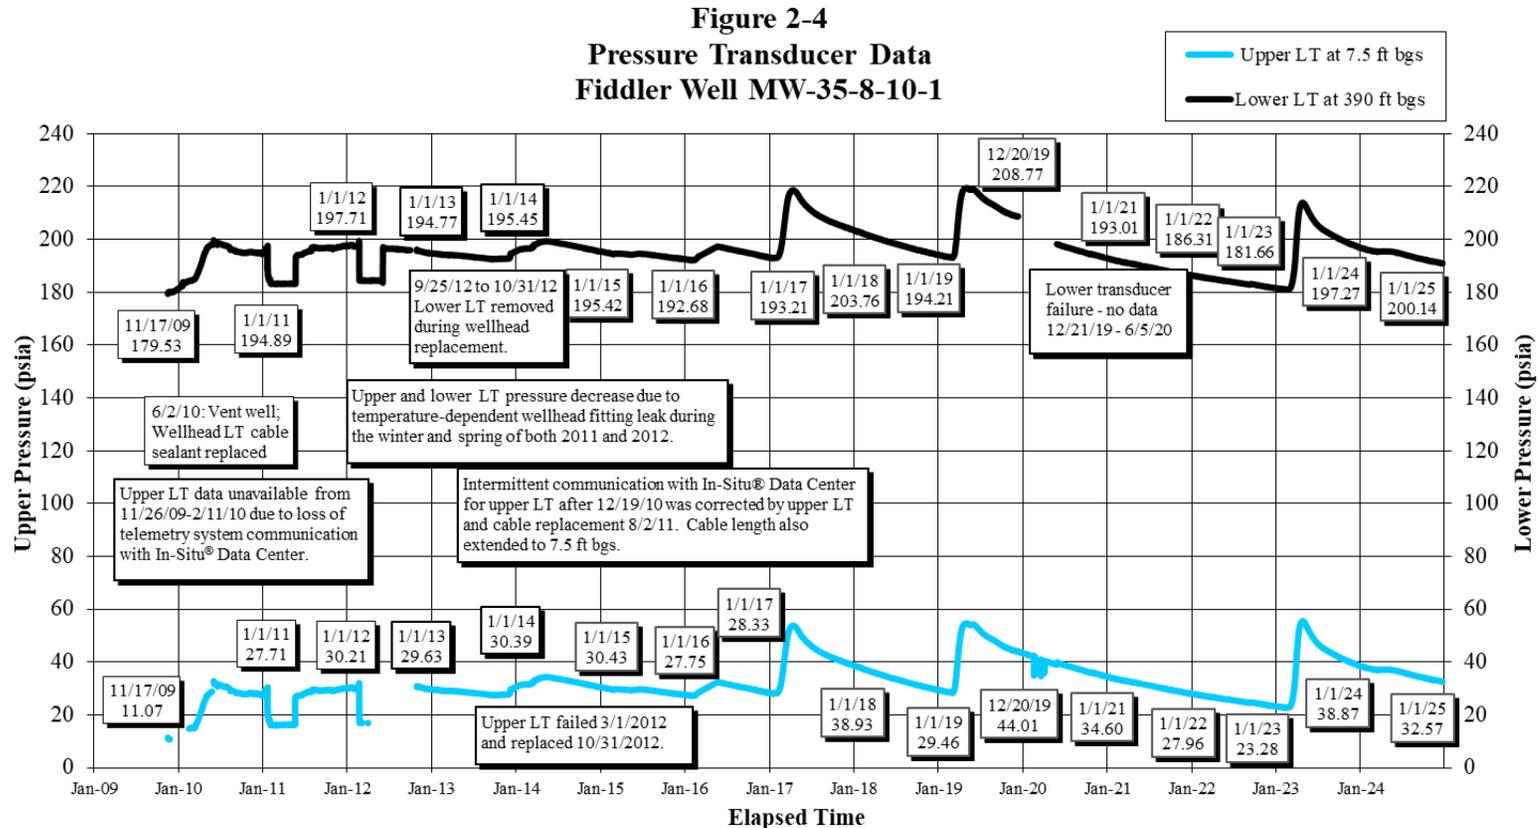
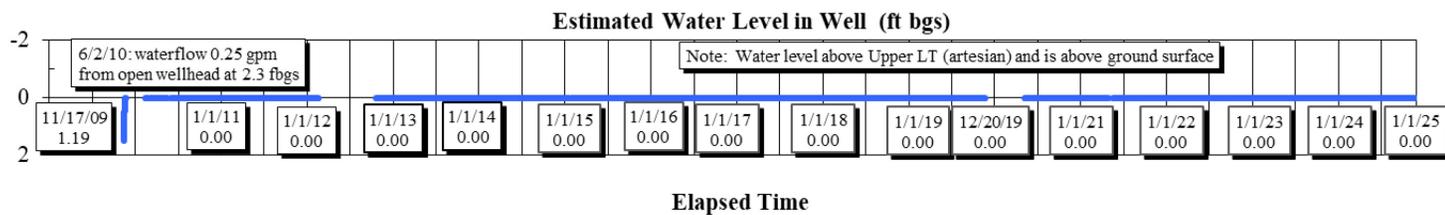
**Figure 2-4
Pressure Transducer Data Fiddler MW-35-8-10-1**

Monitoring data for MW 35-8-10-1 are plotted in Figure 2-4. The net change in wellhead pressure is 17.73 psi and the net change in downhole pressure is 15.84 psi for the 15-year period of record. As Figure 2-4 shows, both the wellhead pressure and downhole pressure steadily increased from installation on November 17, 2009 to early June, 2010. This well has seen moderate fluctuation in the pressure regime, however instrumentation problems and wellhead leakage occurred until 2013. These issues are discussed below.

As noted on Figure 2-4 the lower Level Troll was removed during wellhead maintenance on September 25, 2012 and reinstalled on October 31, 2012. A net water level change was not calculated because the upper transducer is below the water level in the well. Figure 2-4 documents a natural flow rate from the well at a rate of 0.25 gallons per minute (gpm) when the well was vented for maintenance on June 2, 2010. At the time of the well inspection on October 31, 2012, the flow rate was measured at 0.14 gpm. For charting purposes, the water level in the shut-in well is estimated to be at or near ground surface above the upper pressure transducer (set at 7.5 ft bgs).

Also noted on Figure 2-4, telemetry system communication with the In-Situ[®] Data Center for the upper transducer was lost from November 26, 2009 through February 11, 2010 due to cable connection problem and was intermittent from December 19, 2010 to January 1, 2011. The upper transducer and cable were replaced during the 2011 well inspection and the cable length was extended from 3 ft bgs to 7.5 ft bgs. Additionally, a wellhead fitting leak during the winter and spring of 2011 through the summer of 2012 caused a pressure decrease observed on both the upper and lower transducers. Related to the freeze-thaw cycles, the upper transducer failed again March 1, 2012. Inspection of the wellhead on June 6, 2012

revealed the minor water leak at an estimated flow rate of 0.1 to 0.2 gpm. Evidence of the wellhead freezing and then popping the wellhead seal is observed by the minor pressure spiking on both transducers in January 2011 and February 2012. The tubing head threading was cleaned in an attempt to achieve a pressure tight seal at the mandrel head, but both the rubber seals and threading had deteriorated significantly. Documentation was conducted for a later wellhead replacement. Souder Miller Associates supervised installation of the new wellhead on September 25, 2012, which required removal of all instrumentation from the well. Rather than reset the instrumentation at that time, it was planned to remain out of service until the well inspection conducted by ECMC, Norwest and In-Situ, Inc. on October 31, 2012. During that well inspection the upper transducer was replaced with a new 100 psia Level Troll. Also, as planned, the lower transducer and cable was reset, however the new set depth was approximately 15 feet deeper than the previous set depth, so the proper offset has been incorporated into the lower transducer data in Figure 2-4.

Since mid-2014, the Fiddler monitoring well showed a fairly steady decline in bottom-hole and wellhead pressure of approximately 6 psi through January 1, 2016. However, bottom hole and wellhead pressure measurements show a steady increase of approximately 5 psi from late February 2016 through May 2016. This could have been a response related to temporary shut-in of one or more nearby coal bed methane production wells, but based on the time of year, it was likely relatively minor seasonal groundwater recharge.

2017 demonstrated a substantial pressure build-up measured on both the upper and lower transducers. It appears to represent significant groundwater recharge to at least one, if not all of the five Fruitland coal seams monitored in the Fiddler well following the wet winter of 2016-2017. This effect is observed again with similar magnitude following the very wet winter of 2018-2019. In 2023 the pressure regime returned to the fall-off trend as seen in 2019 following that previous wet winter. In 2024 there was a very muted seasonal groundwater recharge event followed by typical pressure decline for the remainder of the year.

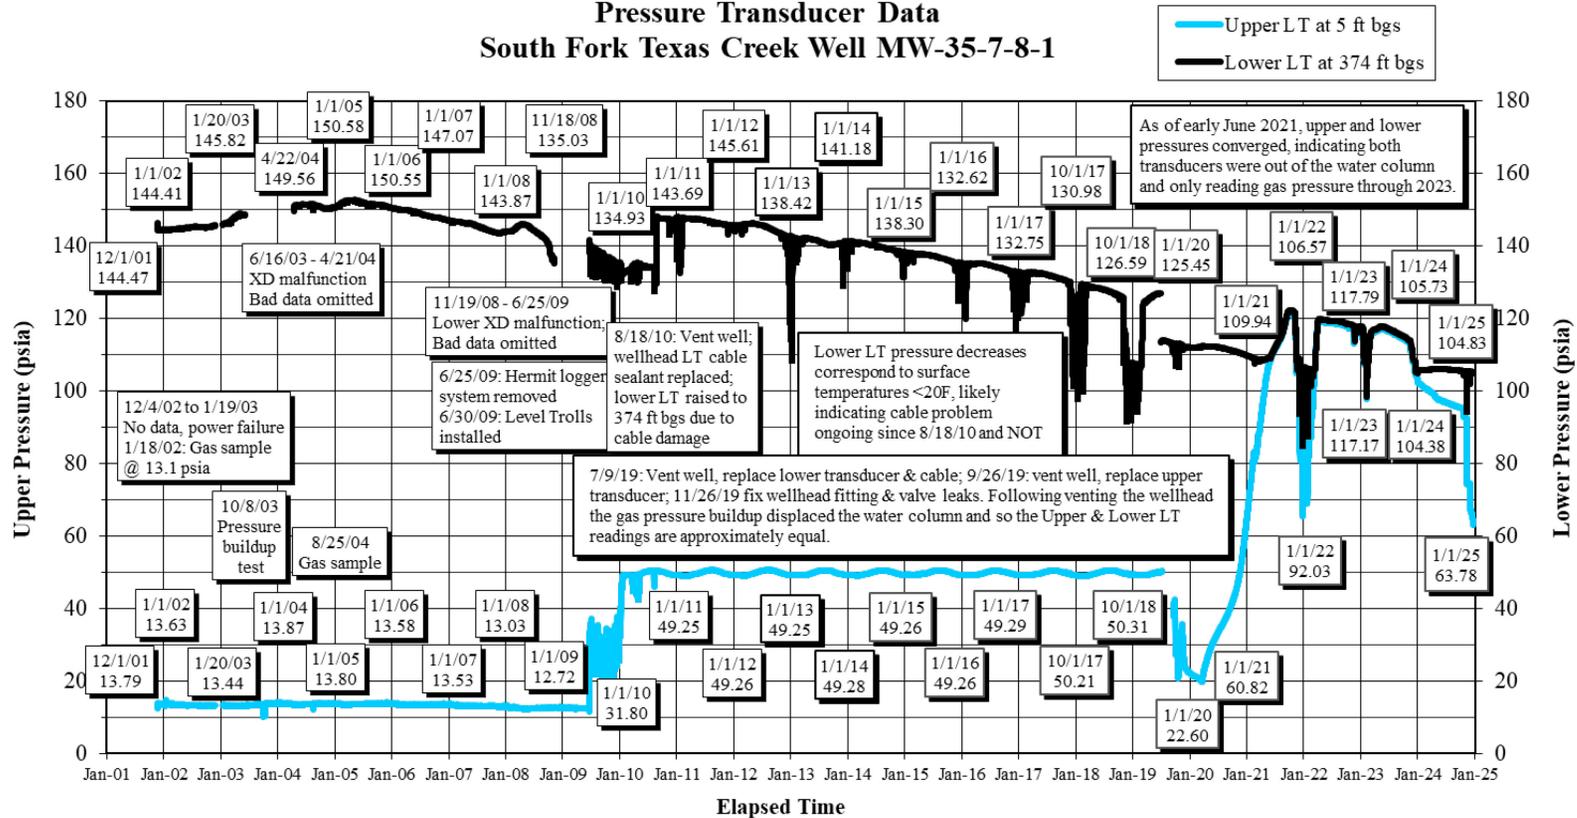
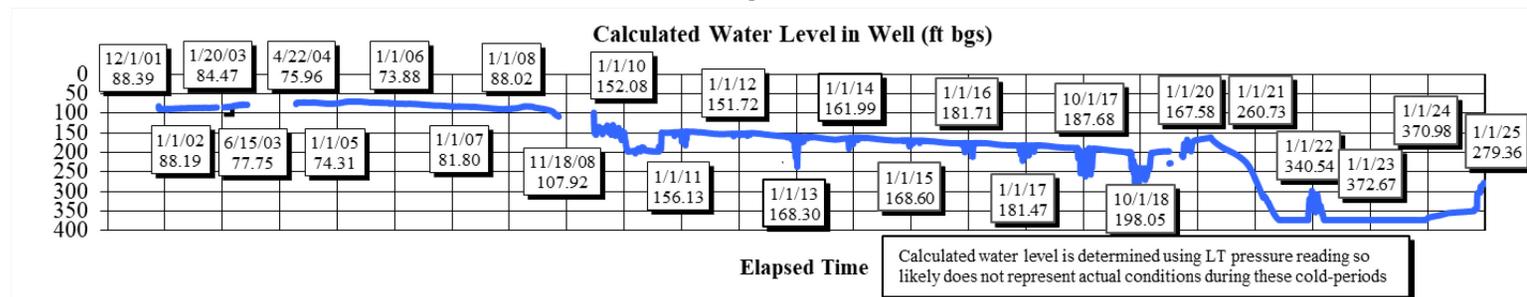
**Figure 2-5
Pressure Transducer Data South Fork Texas Creek Well MW-35-7-8-1**

of record during winter (cold) periods. In the summer of 2019, the lower transducer and cable were replaced as planned to address the cold weather pressure spikes. The upper transducer was replaced due to failure. Following those repairs and during the subsequent shut-in, the wellhead pressure declined for a period of several months until April 1st of 2020. At that time there was a significant, fairly steady wellhead pressure increase of over 100 psi through September of 2021, which may relate to decrease of groundwater production and thus an increase of reservoir gas pressure in the vicinity, or an intrawell pressure regime transition created by the first venting of this well since 2010. The difference in pressure readings between the upper and lower Level Trolls since June 2021 is only about 0.6 psi (1.4 feet) and demonstrates that the lower Level Troll is now only submerged by 1.4 feet of water, or more likely, the lower Level Troll is no longer submerged and the difference in readings is simply due to accuracy differences between the two Level Trolls. The corresponding calculated water level has decreased approximately 208 feet since the 2019 wellhead venting and instrumentation repairs, but as discussed previously, the water level may be lower given a total well depth of 463 feet below ground surface and a lower Level Troll set depth of 374 feet below ground surface. In 2024, the water level appeared to recover as wellhead pressure decreased, which resulted in a pressure regime that may be returning to that of the pre-2021 period when the water level was high enough to submerge the lower Level Troll.

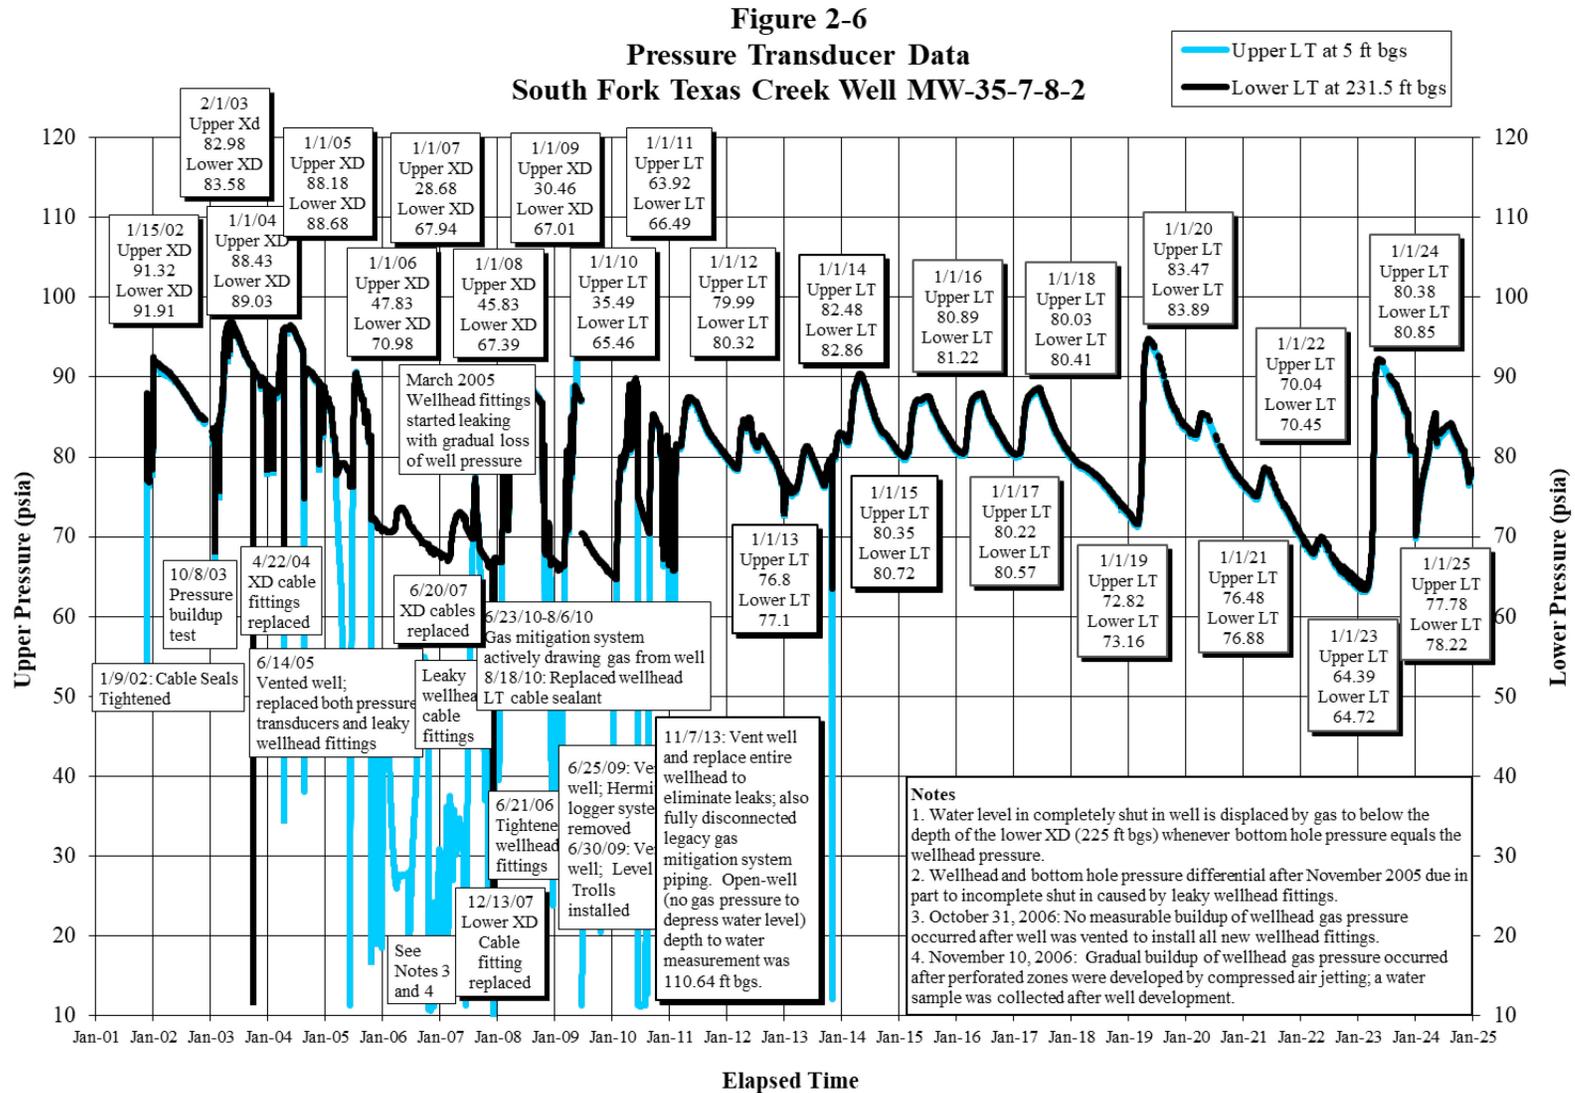
**Figure 2-6
Pressure Transducer Data South Fork Texas Creek Well MW-35-7-8-2**

Figure 2-6 charts the pressure data for well MW 35-7-8-2. Figure 2-6 shows nearly equal wellhead and downhole pressures for the period of record when the well is completely shut in with no leaks. For example, wellhead and downhole pressures recorded on January 1, 2025 were 77.78 psia and 78.22 psia respectively under shut-in conditions.

Figure 2-6 shows a fairly rapid increase in well pressure after the well was shut in on August 18, 2010. The peak build-up pressure of about 85 psia on September 28, 2010 was followed by an erratic decline in well pressure. The inspection of the well in 2013 documented a minor fitting leak at that time; this was a consistent leak on a pipe fitting that has been attempted to be tightened in the past years but required significant replacement of numerous wellhead fittings. The colder air temperatures occurring with early winter of 2012 and again in 2013 appeared to cause some erratic pressure fluctuations documented with the upper and lower transducers in Figure 2-6. This seemed to indicate that the leak was becoming more significant. On November 7, 2013 a site-specific follow-up trip was conducted to repair the leak that had been most recently documented on September 30, 2013. The well gas pressure was allowed to safely bleed down, with continuous gas detector monitoring. Both upper and lower Level Trolls were removed from the well and the wellhead was completely removed down to the 2-inch line pipe that is the well casing extending up from the cement pad. The threads were reconditioned with a hand-operated 2-inch pipe die. The wellhead was reconstructed using all new carbon steel pipe fittings, with the exception of

the Conax compression fittings secured around each Level Troll Rugged Cable, as they had not been documented as leaking. Several manual water level measurements were taken while the wellhead was open. Initially, the water level recovered fairly quickly as the gas pressure was vented. After approximately 2.5 hours open during the new wellhead installation, the water level was relatively stable and measured 110.64 ft bgs. This is the static water level when no gas pressure is allowed to depress the water column in the well. As can be seen in Figure 2-6, the upper and lower Level Troll pressure readings diverge at this time indicating that for the short period following well shut-in the lower Level Troll was actually submerged in water. The lower Level Troll pressure reading was approximately 63.6 psia, which calculates to 111.06 ft bgs. This gives good confidence in the calculated versus measured water level in this well, given error in the assumption of atmospheric pressure which is not currently recorded at this location. To prevent damage to the existing lower Level Troll cable, the Conax compression fitting was not adjusted to offset the new wellhead's increased height above ground surface of 0.25 feet, so the new set depth is 231.25 ft bgs. No leaks have been detected at this wellhead since the replacement.

A fairly consistent well pressure trend was observed for the previous years, 2014 – 2017, whereby the well pressure builds in the first two quarters of the year and then falls off during the second two quarters. This trend may be documentation of seasonal effects of groundwater recharge and discharge, natural or otherwise. As 2018 was documented with extreme drought conditions, it appears that the monitored interval did not receive the typical magnitude of recharge. The pressure trend continued to decrease during the usual recharge period of early 2018, with minimal superimposed recharge noted as a slight reversal in the pressure curve character. The excessively wet winter of 2018-2019 appears to have caused a substantial well pressure increase in the late winter and early spring of 2019, with the usual pressure fall-off occurring following for the remainder of the year. The pressure record appears to show that in 2022 the trend was similar to 2019-2021, which is an overall declining trend with an apparent minor seasonal recharge pattern. In 2023 another substantial well pressure increase and fall-off occurred following the very wet winter of 2022-2023. In the first quarter of 2024 a moderate apparent pressure build-up event of roughly half that of 2023 occurred, followed by a minor secondary pressure build-up event in mid-2024. A pressure fall-off for the remainder of 2024 showed a different character of curve than what has been typical.

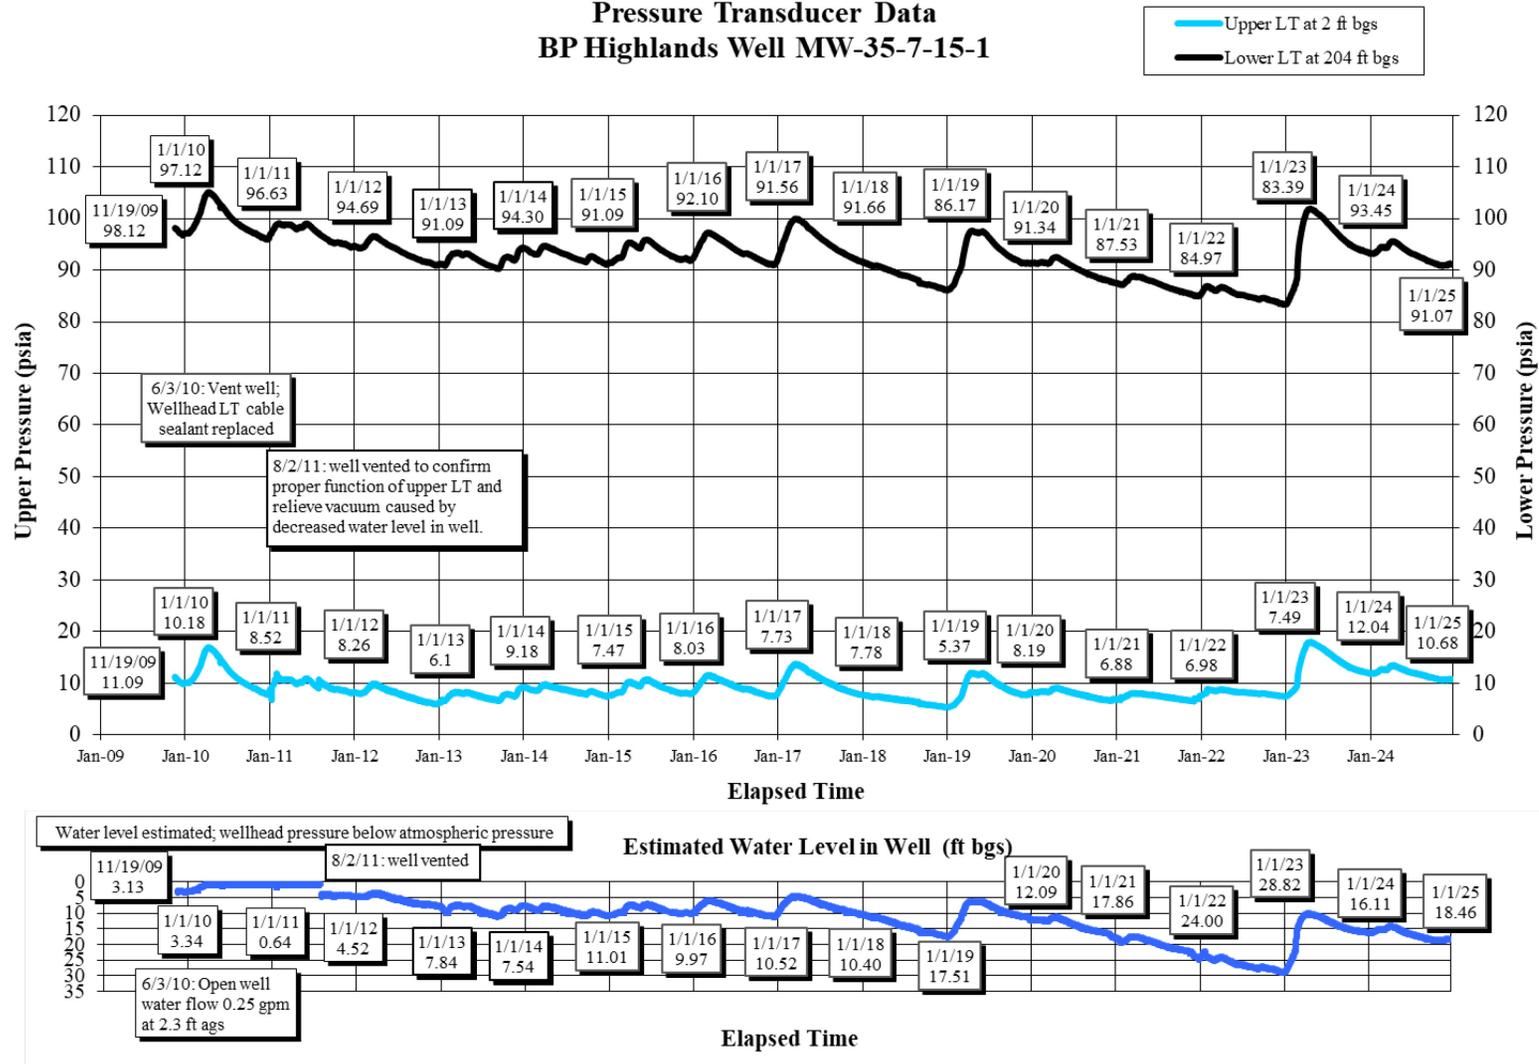
**Figure 2-7
Pressure Transducer Data BP Highlands Well MW-35-7-15-1**

Monitoring data for MW 35-7-15-1 are plotted in Figure 2-7. As summarized in Table 2-5 for the 15-year period of record, the net change in downhole pressure is a decrease of 7.05 psi. The well follows an overall decreasing pressure trend with seasonal variability dominated by late winter/early spring recharge. The net change in the calculated water level in the well is a decrease of 15.33 feet. The magnitude of this decrease was approximately doubled in 2018 due to extreme drought conditions and complete lack of observable recharge. This all but repeated again in 2020-2022, with a very muted recharge trend when compared to 2016 and 2017. 2023 showed a substantial pressure increase due to water level rise associated with groundwater recharge from the very wet winter of 2022-2023, which regained the level decline that started following the very wet winter of 2018-2019. As noted on Figure 2-7, water flowed from the well at a rate of 0.25 gallons per minute (gpm) when the well was vented for maintenance on June 3, 2010. For charting purposes, the water level in the shut-in well at that time was estimated to be slightly above ground surface with the upper transducer under water at 2 ft bgs.

The wellhead pressure started dropping below atmospheric pressure around August 12, 2010. This condition suggested either a potential problem with the upper transducer or a well pressure vacuum effect created in a completely shut-in well under declining water level conditions. A well instrumentation inspection and atmospheric pressure check conducted during each subsequent site visit through 2013 confirmed the proper function of the upper transducer. Venting the well allowed for physical confirmation that the well was under vacuum pressure conditions which have continued through January 1, 2025.

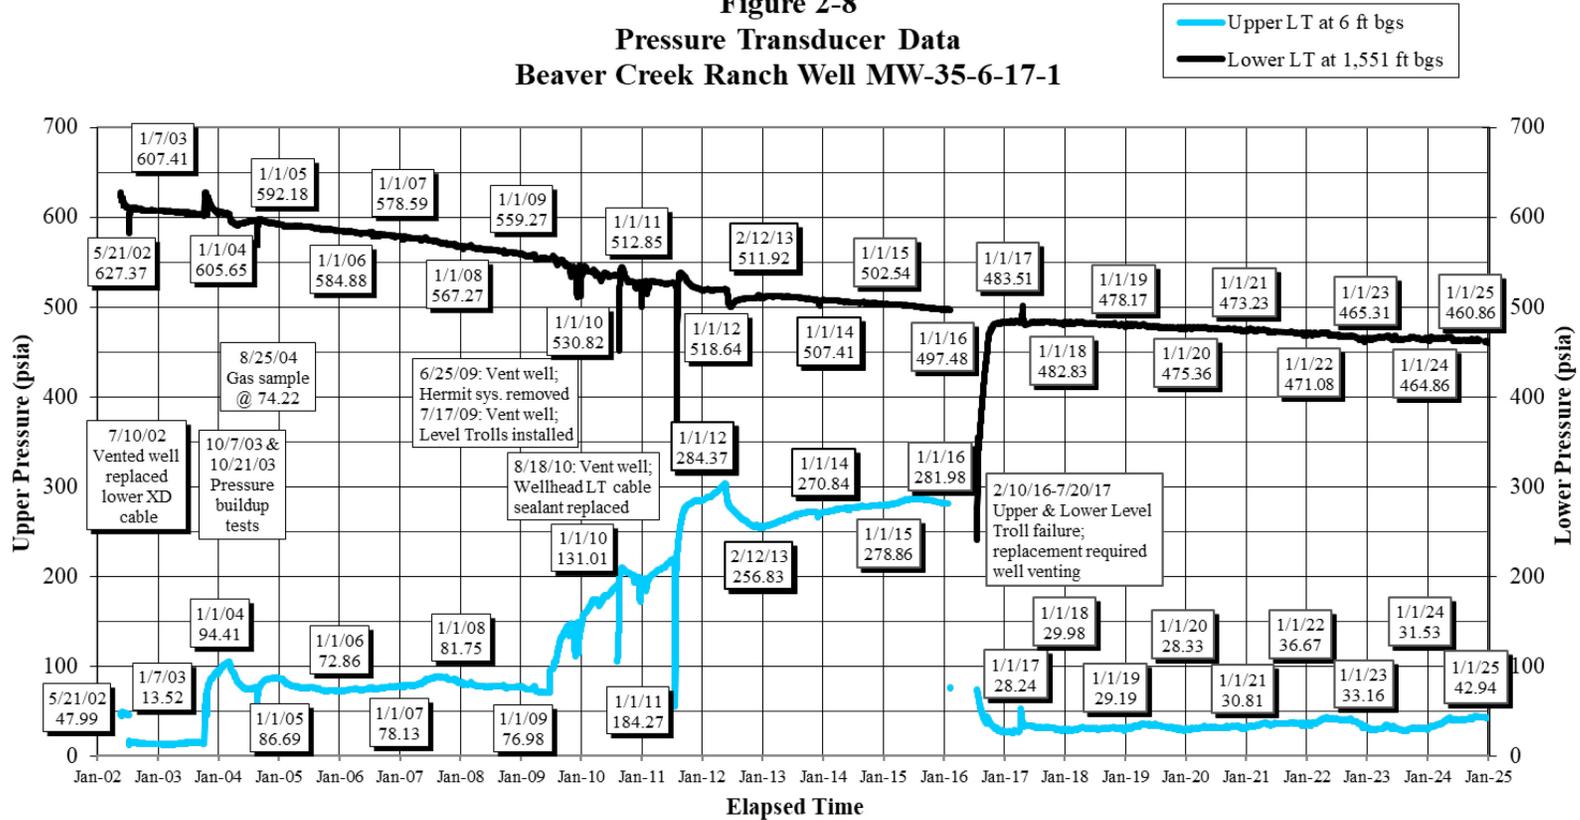
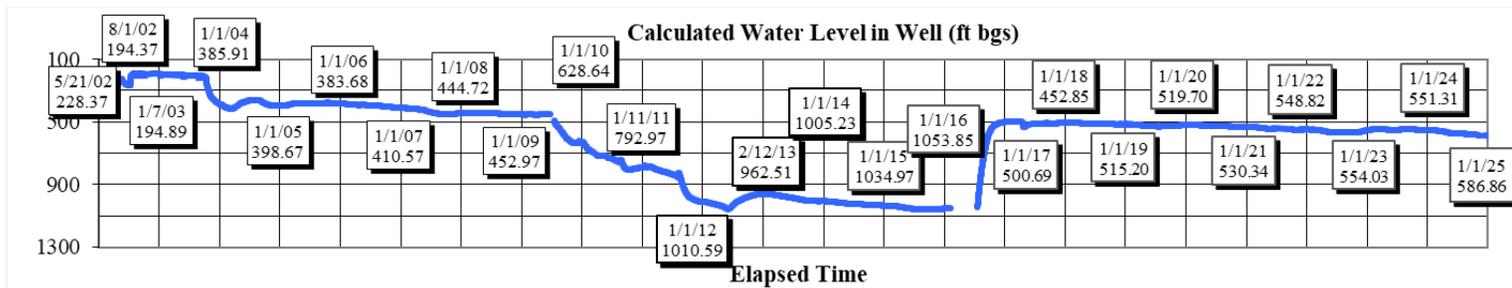
**Figure 2-8
Pressure Transducer Data Beaver Creek Ranch Well MW-35-6-17-1**

pressure regime. 2018-2024 pressure data demonstrates that following this bleed-off the wellhead pressure has remained depressed at approximately 30 psi and relatively stable but slightly increasing pressure trend. This is likely because the water head pressure of approximately 1000 feet (430 psi) is effectively preventing significant gas build-up at the wellhead.

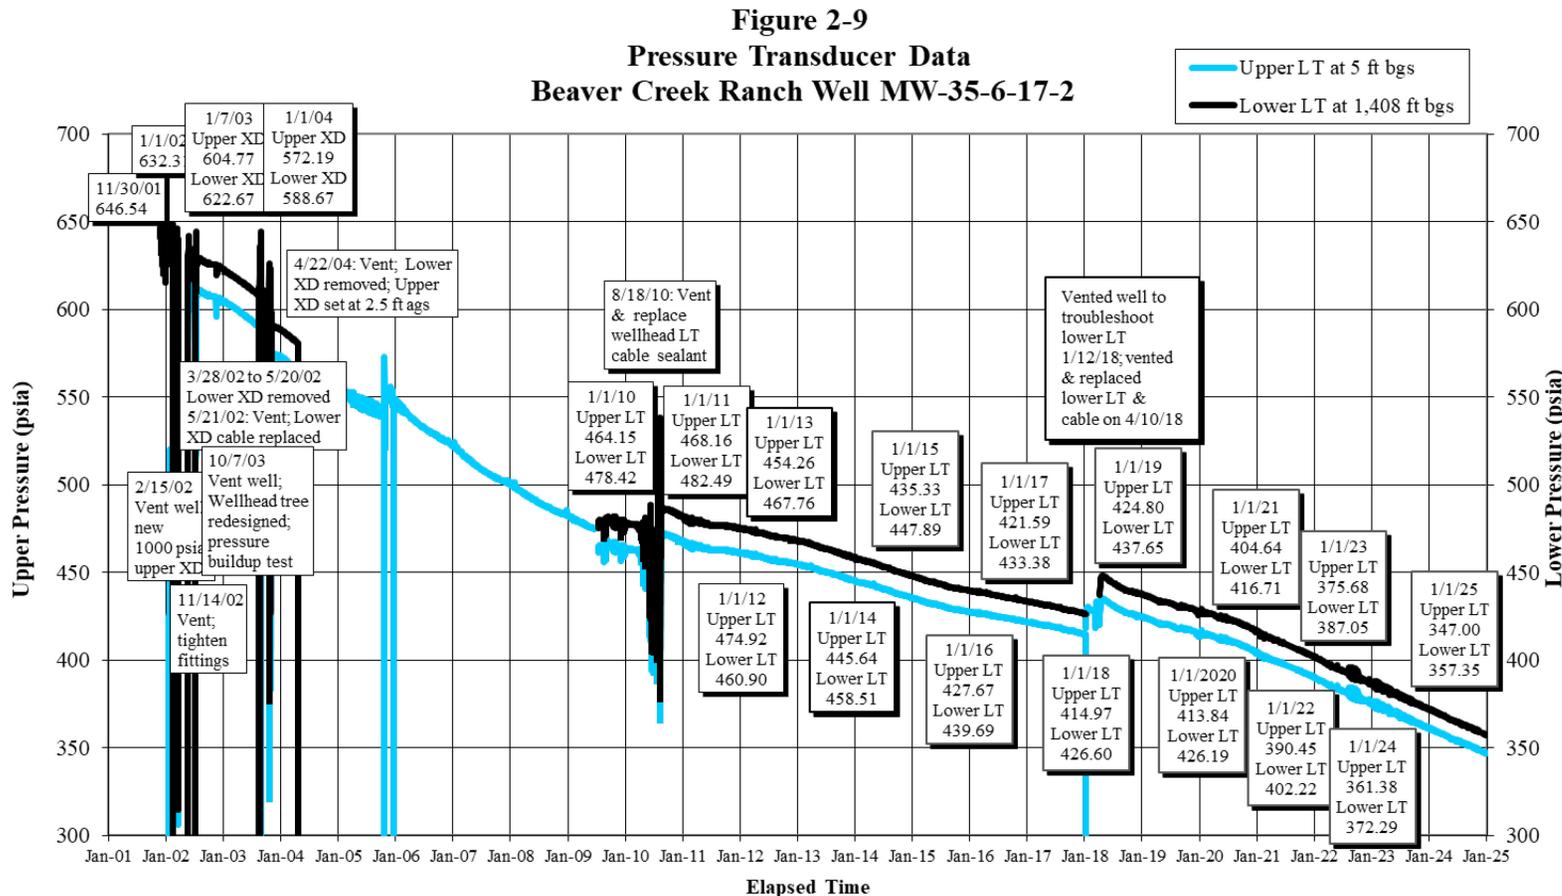
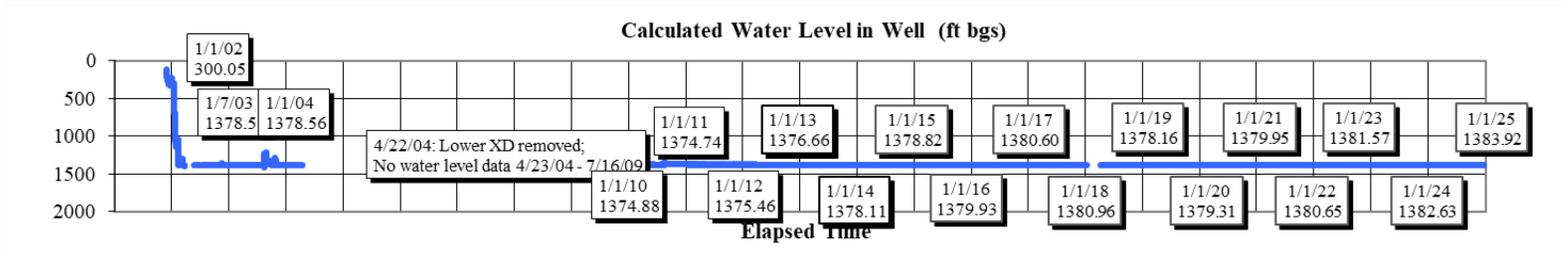
**Figure 2-9
Pressure Transducer Data Beaver Creek Ranch Well MW-35-6-17-2**

Figure 2-9 shows the well pressure in a declining trend for the entire period record. There is a notable shift in the well pressure curve following the installation of Level Troll instruments on July 17, 2009, followed by erratic well pressure fluctuations associated with incomplete shut-in through August 17, 2010. After the well was vented August 18, 2010 to replace the Level Troll cable fitting sealants, there was a steady build-up of well pressure through early September 2010 followed by a return to a declining trend through the period of record.

As shown on Figure 2-9, no water level data is available for the 6-year period of record when there was only one well pressure transducer, but based on prior and the significant later periods, it can be presumed that the water level was consistently near 1378 feet during that time. Well pressure data available after installation of wellhead and downhole Level Trolls on July 19, 2009 shows approximately 7.5 feet decline in the calculated water level and very little, if any seasonal influence on the overall well pressure regime.

The 2024 data indicate the well is on a continued generally linear trend of gas pressure decrease since 2018.
