Colorado Energy & Carbon Management Commission

**Monitor Wells Summary Report
2024**

**4M Project Monitoring Program
Archuleta and La Plata Counties
Colorado**

June 10, 2025

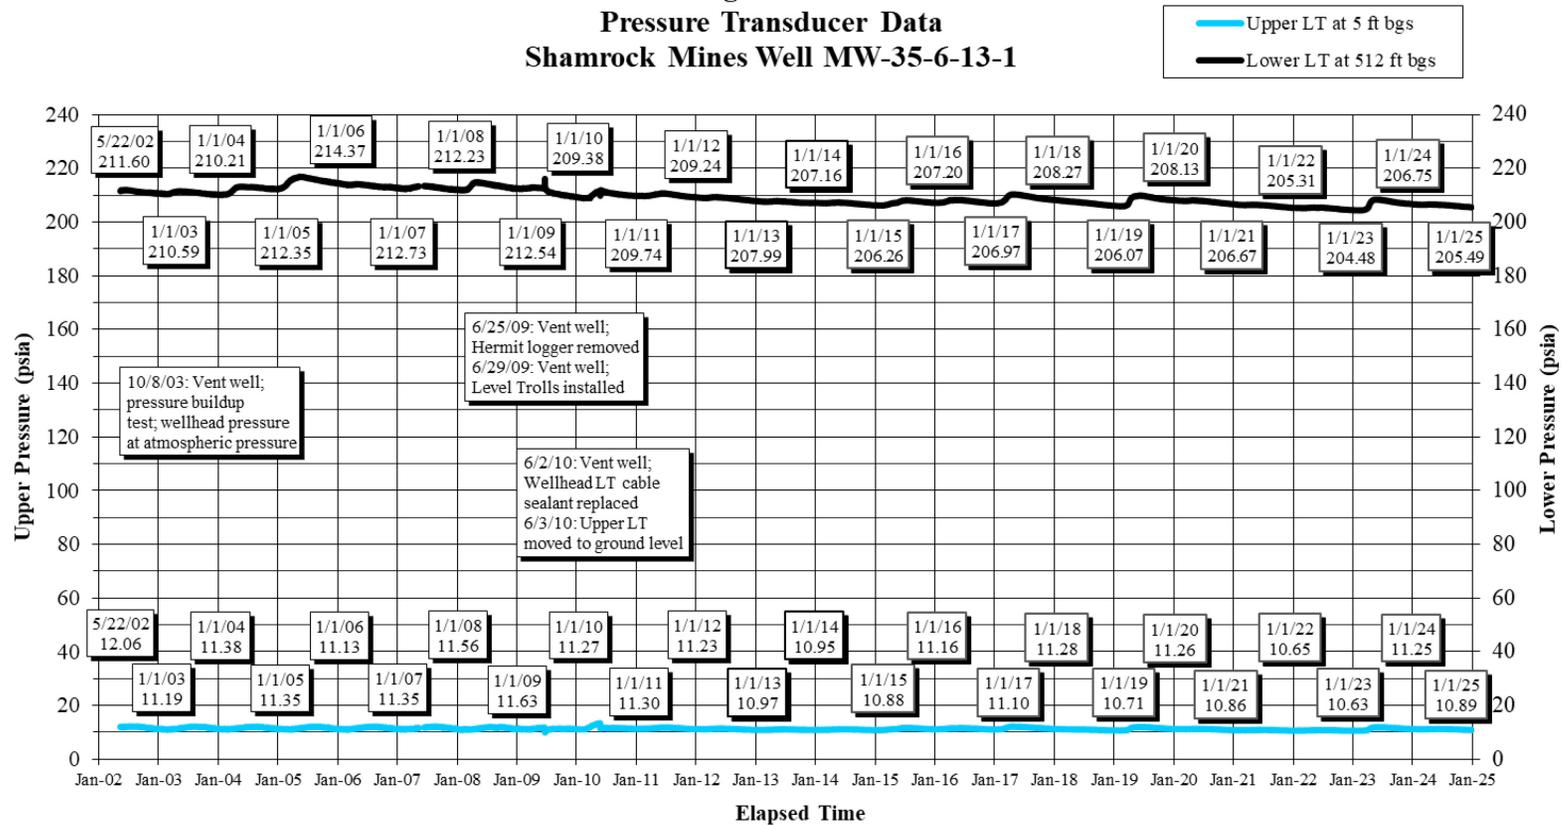
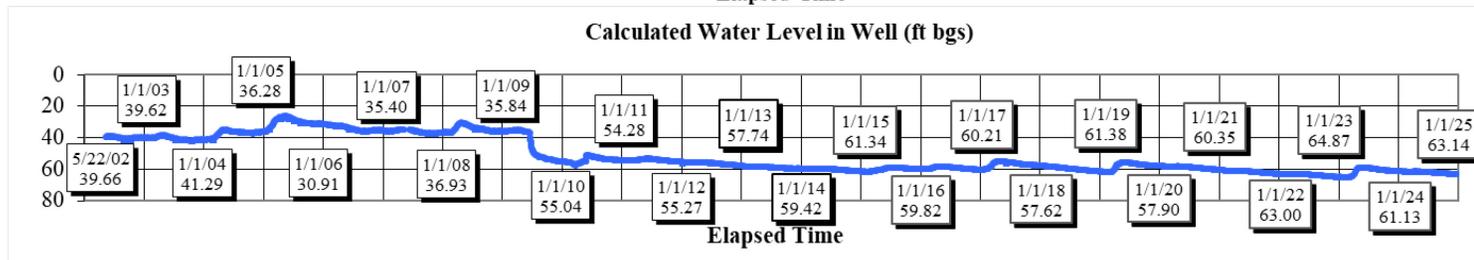
Figure 2-10
Pressure Transducer Data Shamrock Mines Well MW-35-6-13-1

Figures 2-10 shows the wellhead pressure regime continues to be at atmospheric pressure and fluctuates within a range of 2 psi (between 10 psia and 12 psia). During the months of April and May 2010, the wellhead pressure steadily increased to around 13.4 psia. Wellhead pressure returned to the historic atmospheric pressure trend after the Level Troll wellhead cable sealants were replaced on June 2, 2010.

Figure 2-10 also shows the downhole pressure and calculated water level in the well continued to exhibit an overall declining well pressure trend for the period of record since April 2005. With wellhead pressure equal to atmospheric pressure, fluctuation of downhole pressure is associated with the fluctuation of the water level in the well. Downhole pressure and corresponding calculated water levels have documented seasonal groundwater recharge events following the wet winters of 2007-2008, 2009-2010, 2016-2017, 2018-2019, and 2022-2023.

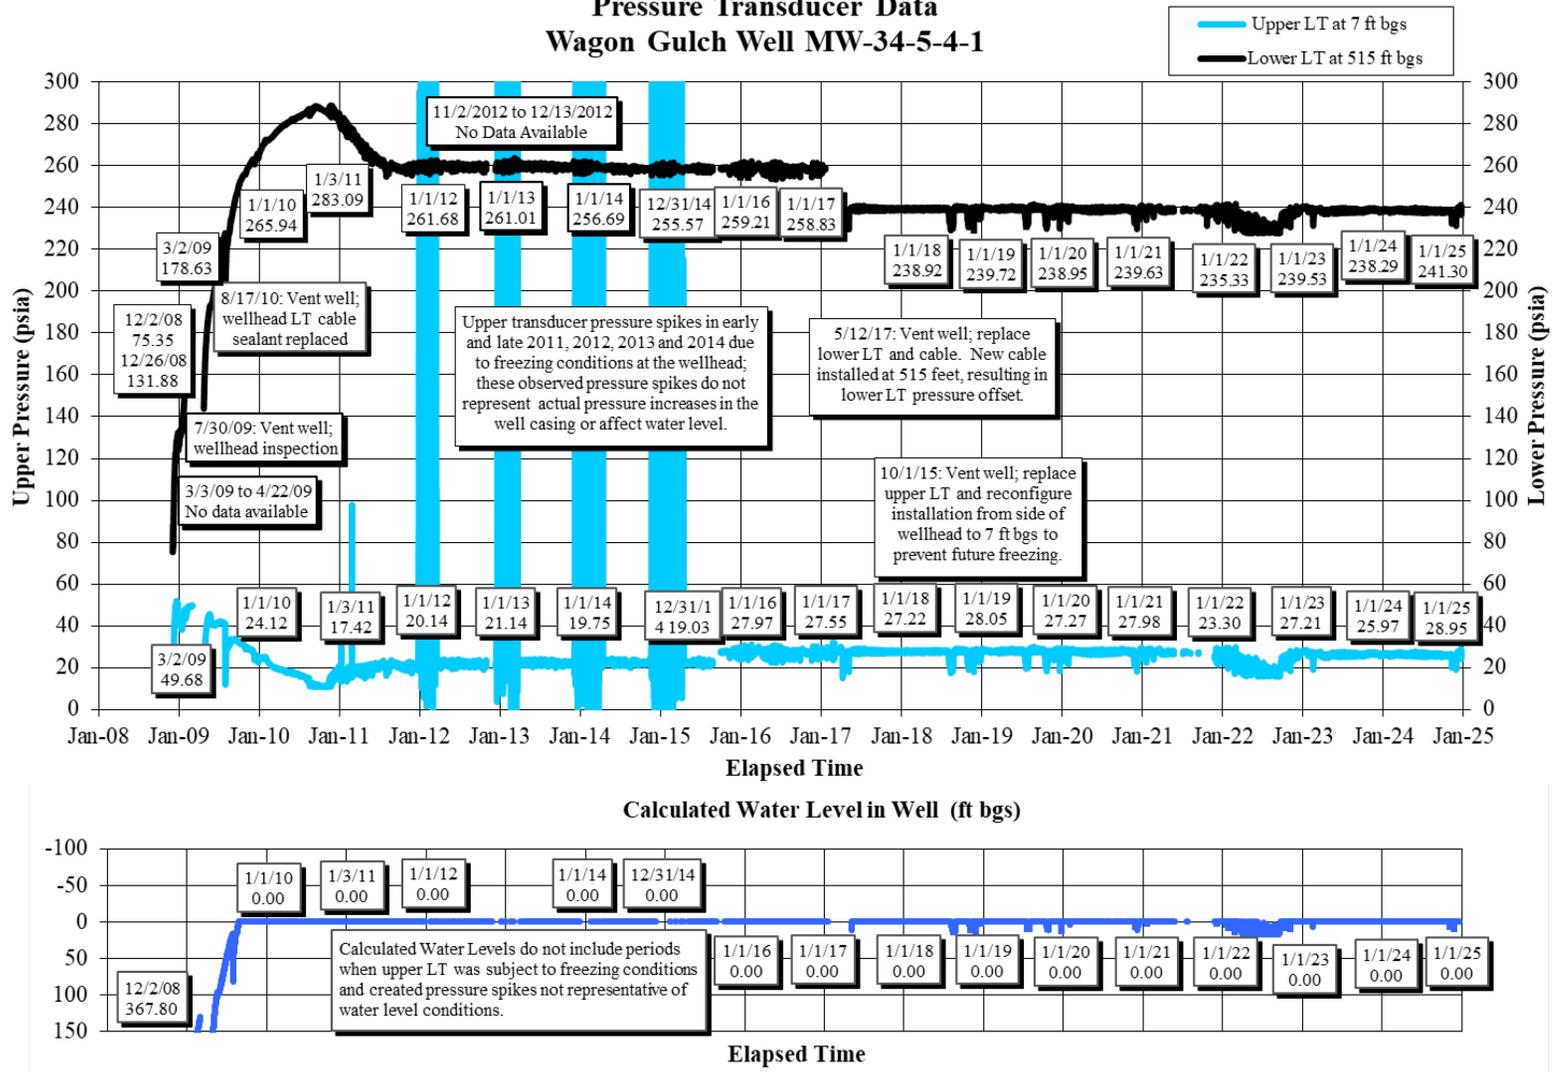
**Figure 3-1
Pressure Transducer Data Wagon Gulch Well MW-34-5-4-1**

2008. Figure 3-1 shows the trend of rising water level with corresponding increasing downhole pressure continued in 2010 until the trend reversed in mid-September 2010. This may have been related to the transducer cable sealant being changed on August 17, 2010 and possibly eliminating a partial shut-in condition. No leaks were detected during the site inspections in 2012-2014. Between October 1, 2010 and December 31, 2010, Figure 3-1 shows the water level decreased about 21.2 feet while the downhole pressure decreased about 2.7 psia.

During the winters of 2011-2012, 2012-2013, 2013-2014 and 2014-2015 pressure spikes in the upper transducer occurred due to the pressure transducer freezing within its deployment location in the wellhead 2.3 feet above ground surface. These are not actual increases in gas pressure within the well casing, but rather caused when the air volume next to the transducer inlet is trapped and then compressed by expanding frozen water condensate. When the 2011 well inspection was conducted at MW 34-5-4-1 the well was vented to ensure that the transducer would return to atmospheric pressure; this test successfully showed that the transducer continued to function properly and was not damaged. The transducer recovered after surface temperatures warmed each spring. The transducer was inspected for damage in each subsequent site visit since this problem began in 2011 until the 2015 site inspection when the Level Troll was replaced and lowered into the well to 7 ft bgs. As evidenced by the winter 2015 data shown in Figure 3-1, the condensate freezing problem in this location has been corrected by lowering the Level Troll below the ground surface.

Several pressure decreases on the order of 10 psi were observed by both the upper and lower transducers in the second half of 2018, 2019, and 2020, and then fairly consistently during 2021, 2022, 2023, and 2024. The duration of each event was on the order of days to weeks and full recovery to static pressure conditions occurred after each event.

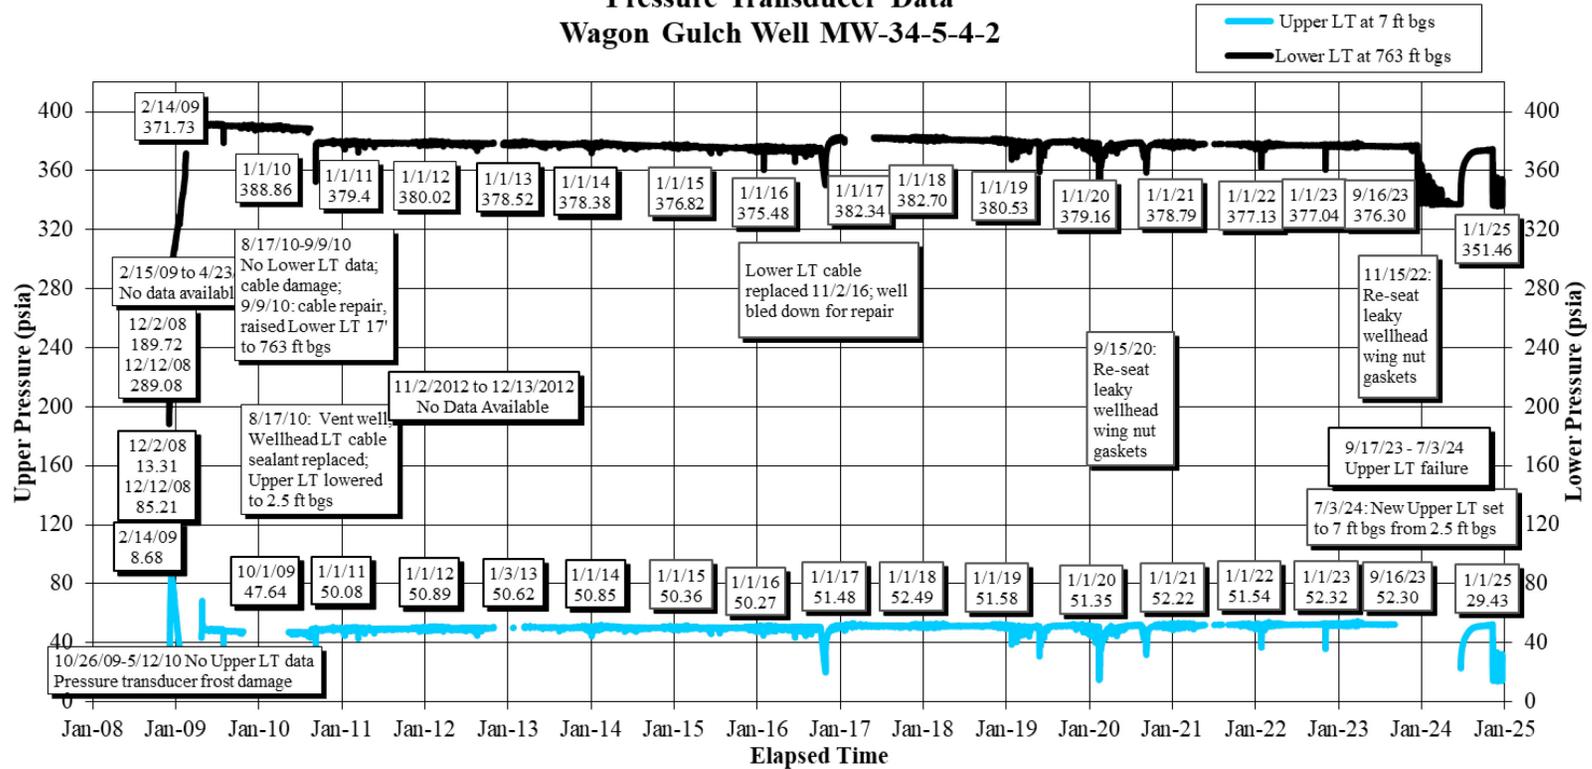
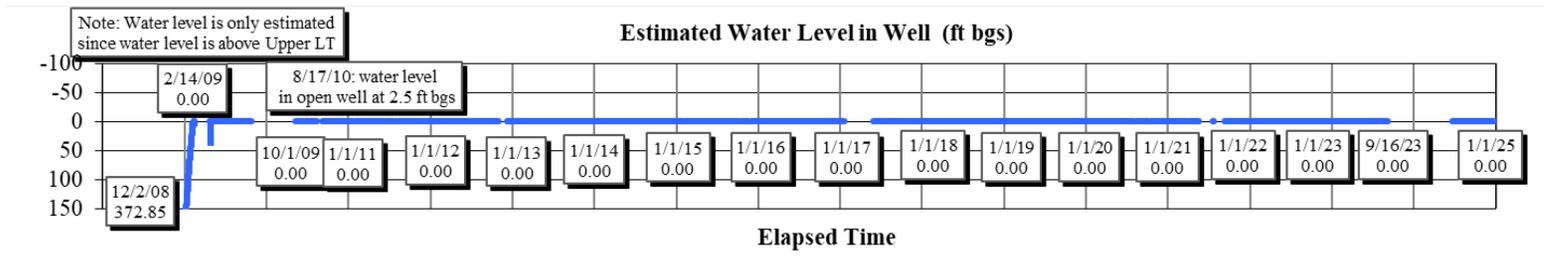
**Figure 3-2
Pressure Transducer Data Wagon Gulch Well MW-34-5-4-2**

Figure 3-2 shows a relatively constant wellhead pressure of about 47 to 48 psia between April 24, 2009 and October 25, 2009. An erratic pressure spiking pattern between October 26, 2009 and May 12, 2010 suggested wellhead Level Troll pressure sensor freeze damage, so the data were omitted from Figure 3-2. Between May 13, 2010 and August 16, 2010, the wellhead pressure remained fairly constant at around 47 psia.

Freeze damage to the upper Level Troll pressure transducer sensor was confirmed after the well was vented on August 17, 2010. As noted on Figure 3-2, the water level inside the open wellhead was at a height of about 2.5 feet above ground level. The new upper Level Troll was changed from an external mount to an internal depth setting of 2.5 ft bgs on August 17, 2010 to protect the transducer sensor from freezing conditions. After well shut-in on August 17, 2010, Figure 3-2 shows a relatively rapid return of wellhead pressure to an average constant pressure of about 50 psia.

The lower Level Troll cable was damaged during replacement of Level Troll wellhead cable sealants on August 17, 2010. Cable repair performed on September 9, 2010 included raising the Level Troll 17 feet from 780 ft bgs to 763 ft bgs. As a result of this change, Figure 3-2 shows a shift in the downhole pressure curve to a corrected constant downhole pressure regime of 378 to 379 psia.

As noted above, the water level was inside the open wellhead at a height of about 2.5 feet above ground level on August 17, 2010. The wellhead pressure build-up after shut-in may reflect water and/or gas pressure build-up. For charting purposes, the water level in the shut-in well is estimated to be at or near ground surface above the upper Level Troll (set at 2.5 ft bgs). However, there is a possibility that the observed build-up in wellhead pressure is from gas pressure, which could result in a downward displacement of the water in the well to some level below the upper Level Troll.

The pressure regime observed in 2023, as well as for the full period of record since post-completion stabilization in 2009, has been quite stable with an overall minor decreasing trend. The exception is apparent multiple drawdown cycles observed in 2019, 2020, 2022, and 2023 which are likely observed interference effects from nearby groundwater production. During the first half of 2024 there appears to be a significant lower Level Troll pressure decline which was related to a minor wellhead leak in frequent

freeze-thaw cycles. With the replacement of the upper Level Troll in July 2024, the well then was completely shut in evidenced by a distinct pressure buildup curve. It then appears in early winter 2024 that the minor leak resumed with the return of daily freeze-thaw cycles.

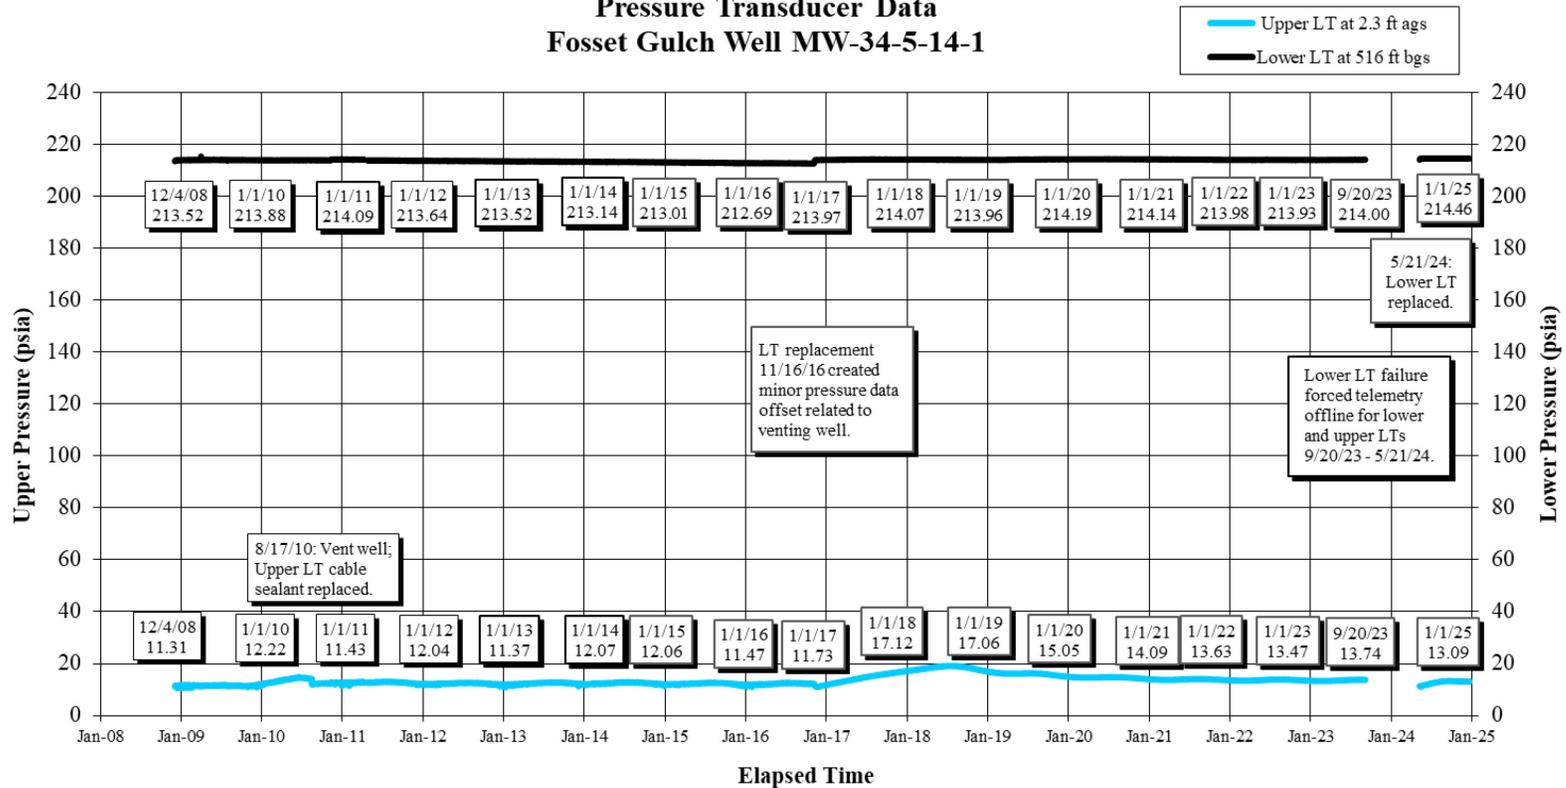
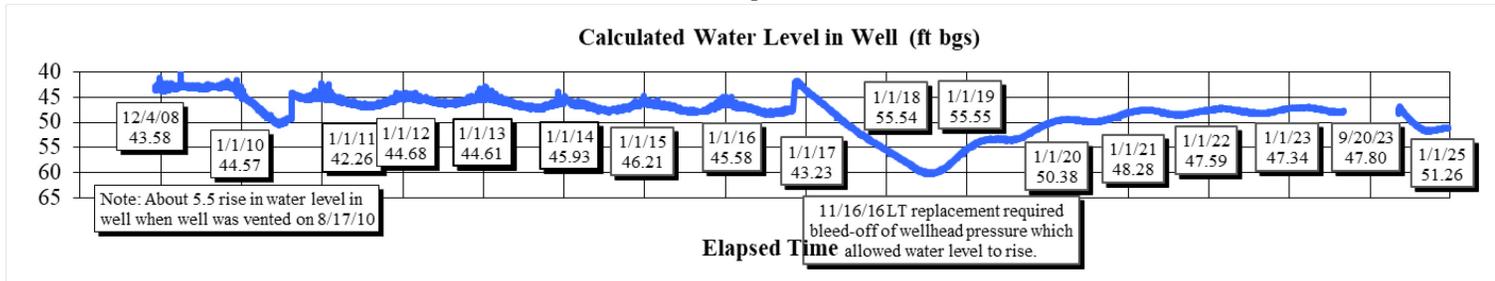
**Figure 3-3
Pressure Transducer Data Fosset Gulch Well MW-34-5-14-1**

Figure 3-3 charts the upper and lower pressure transducer data and the calculated water level in the well. Table 3-2 and Figure 3-3 show the wellhead pressure at atmospheric pressure prior to 2010 followed by a gradual increase in pressure through August 16, 2010 to 14.19 psia. Following the August 17, 2010 well maintenance event including venting, the wellhead pressure has remained relatively constant within a normal atmospheric pressure range through November 16, 2016. At that time, upper transducer replacement required venting the wellhead. Following the maintenance, the wellhead pressure increased slowly until July 2018 when it began to trend down. This is likely a response to gas production stimulation that occurred when the well was vented. Figure 3-3 shows a stable downhole pressure trend (213.52-214.19 psia) for the entire period of record. Figure 3-3 also shows a stable water level averaging 43.0 ft bgs until November 2009, followed by a gradually declining water level trend through July 1, 2010 (50.13 ft bgs). The water level increased to 49.28 ft bgs until the well was vented on August 17, 2010. The water level immediately rose to 44.36 ft bgs when the well was vented on August 17, 2010 but has since followed apparent gentle seasonal fluctuation until November 16, 2016. At that time, the well was vented to replace the upper pressure transducer. Upon replacement, the pressure measured at the wellhead has steadily increased from approximately 12.20 psi to 17 psi on January 1, 2019 and then changed to a decreasing pressure trend which has now generally stabilized to about 2 psi above atmospheric pressure. As such, the calculated water level was in steady decline during this time period as gas pressure has apparently

depressed it. Likewise, with the 2018 reversal of the wellhead gas pressure increase trend to a decreasing trend, the calculated water level increased through the mid-2024 before declining by approximately five feet.

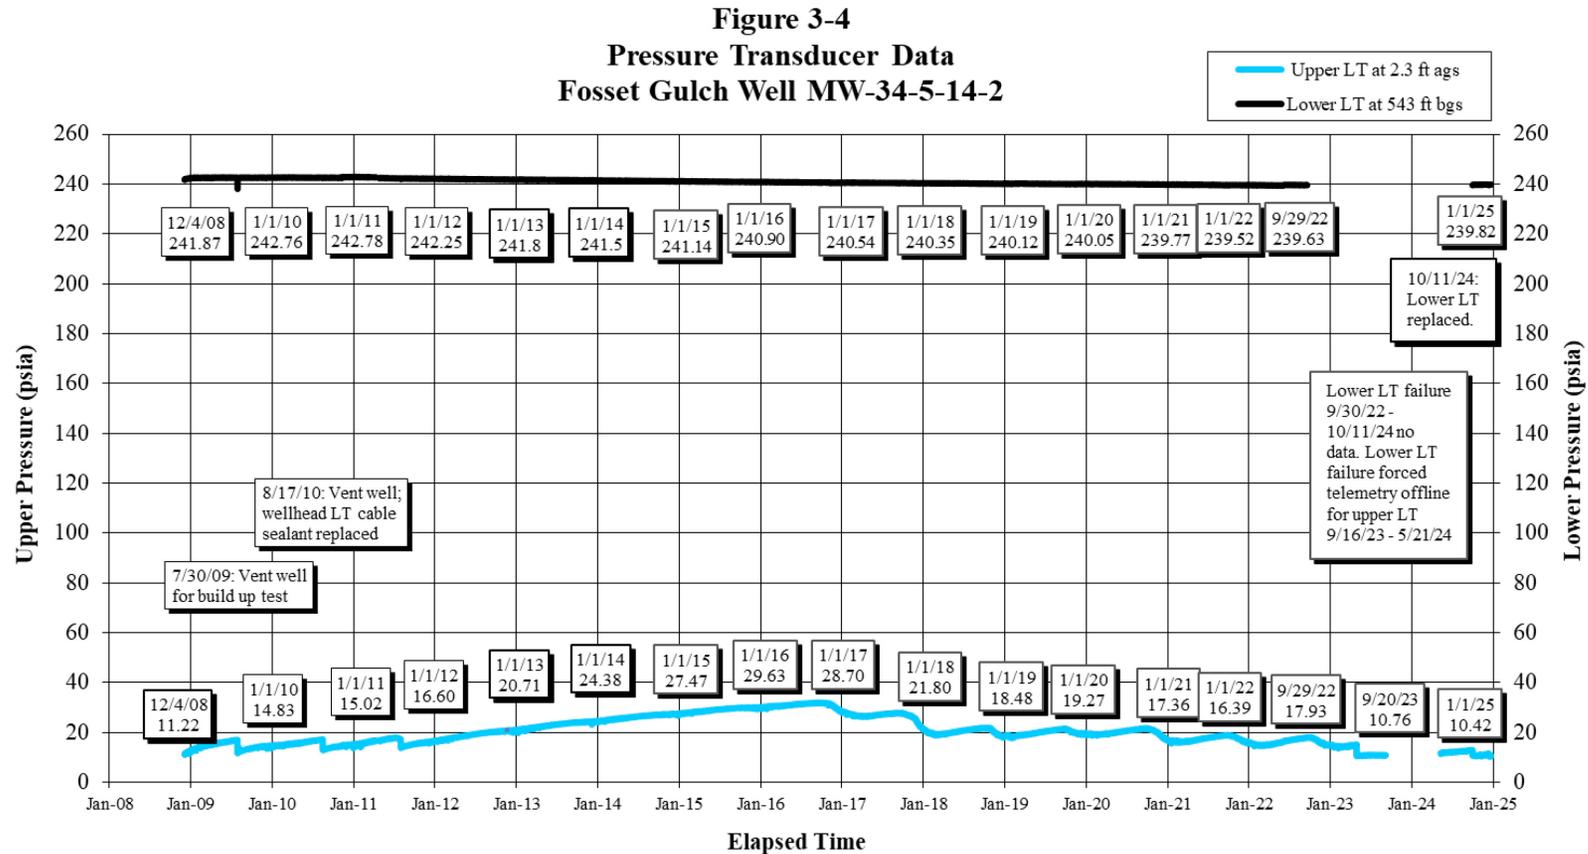
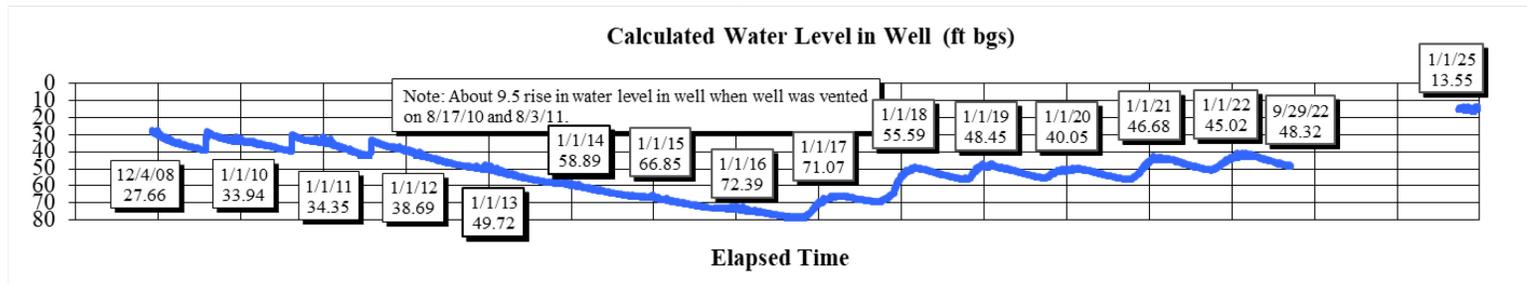
**Figure 3-4
Pressure Transducer Data Fosset Gulch Well MW-34-5-14-2**

Figure 3-4 plots the upper and lower pressure transducer data and the calculated water level in the well. Although the well was shut in for monitoring on December 4, 2008, wellhead pressure did not stabilize at about 17 psia until July 2009. Table 3-2 and Figure 3-4 show a net increase of 6.58 psi in wellhead pressure for the period of record between December 4, 2008 (11.35 psia) and September 29, 2022 (17.93 psia). After that date, the lower Level Troll failed and so no data is available for the remainder of 2022 or 2023. Figure 3-4 shows a stable but slightly declining downhole well pressure trend for the entire period of record, with fluctuations ranging between a minimum pressure of about 239.52 psia to a maximum pressure of 242.78 psia. The downhole pressure was 239.82 psia on January 1, 2025, a near-historic low as the pressure trend has been very slightly decreasing over 15 years of monitoring.

Table 3-2 indicates a net water level gain of 25.74 feet in the well as of January 1, 2025 although much of the documentation of this gain was lost while the upper and lower transducers were off-line for nearly 1.5 years. However, Figure 3-4 shows that the wellhead pressure and water level in the last five years has apparently shown an effect of venting MW 34-5-14-1 for maintenance on 11/16/16. This would suggest some amount of hydraulic connection between the two wells. Although there is an immediate drop in wellhead pressure and corresponding rise in the water level each time the well is vented to the atmosphere in the past, Figure 3-4 also shows the build-up in wellhead pressure takes approximately 12 months to return to the pressure exhibited prior to each venting event so unless required for servicing the instrumentation, the well will not be vented in attempt to determine the static wellhead pressure.

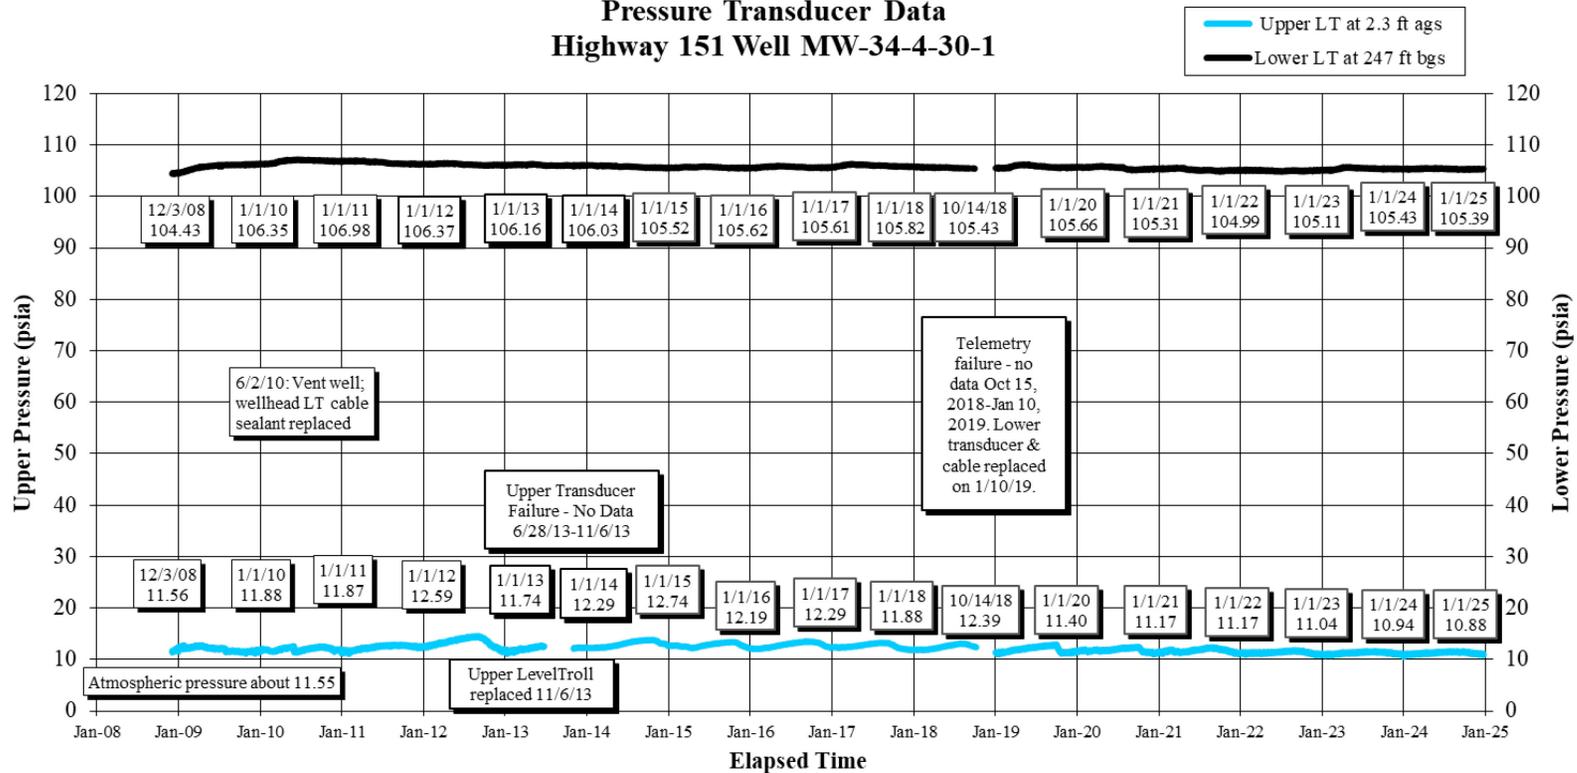
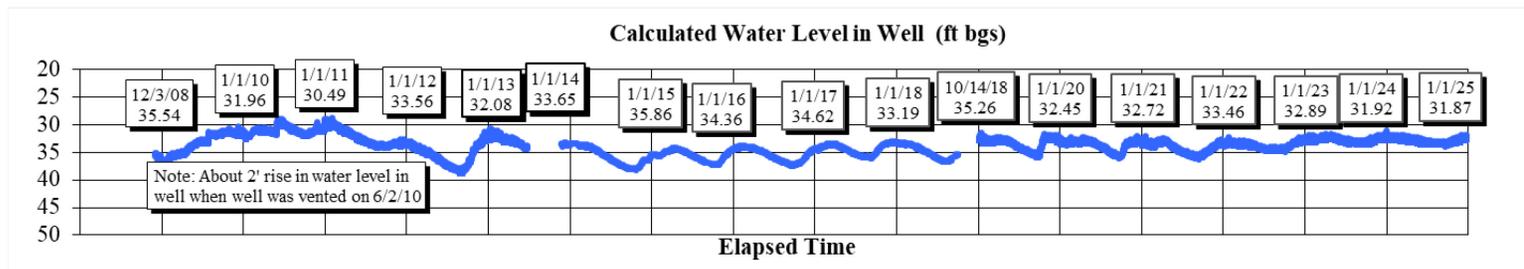
**Figure 3-5
Pressure Transducer Data Highway 151 Well MW-34-4-30-1**

Figure 3-5 charts the upper and lower pressure transducer data and the calculated water level in the well. Table 3-3 and Figure 3-5 show a relatively stable well pressure regime with a stable wellhead pressure trend at atmospheric pressure, a stable downhole pressure trend of about 104-107 psia, and a fluctuating water level trend of 30-39 ft bgs since August 2009. Sharp fluctuations in both wellhead pressure and the calculated water level shown on Figure 3-5 correspond to the immediate loss of pressure when the well is vented (e.g., June 2, 2010), followed by a gradual return to the well pressure regime exhibited prior to venting the well.

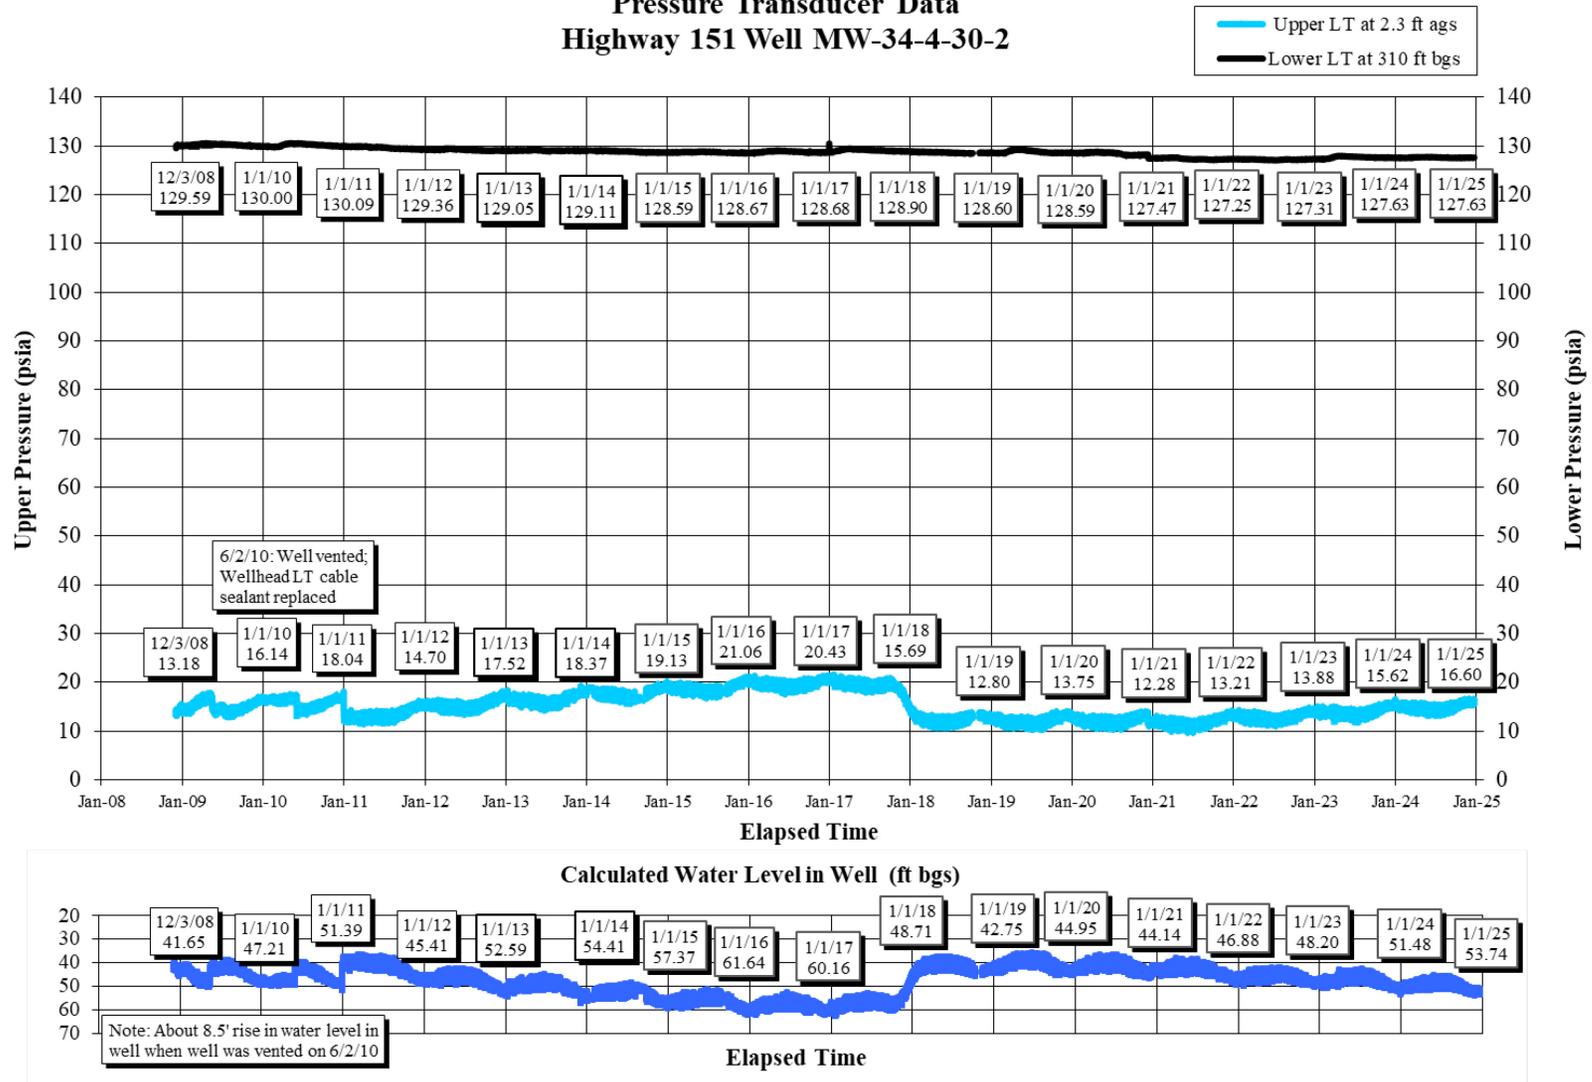
**Figure 3-6
Pressure Transducer Data Highway 151 Well MW-34-4-30-2**

Figure 3-6 charts the upper and lower pressure transducer data and the calculated water level in the well. Table 3-3 and Figure 3-6 shows a stable downhole pressure trend with 1.96 psi change from 129.59 psia on December 3, 2008 to 127.63 psia on January 1, 2025. In addition, there was a net wellhead pressure decrease of 3.42 psi with a corresponding net water level decline of 12.09 feet for the entire period of record from December 3, 2008 to January 1, 2025. However, the wellhead pressure decreased slowly in the fourth quarter of 2017 with a loss measured at approximately 4.3 psi in 3 months. The pressure then stabilized at atmospheric pressure and has remained in that range through 2022. The well was inspected in 2019 during routine maintenance and no wellhead pressure leaks were found. A seasonal water level fluctuation trend has continued superimposed over a long-term trend of approximately 0.5 feet of water level decline per year.

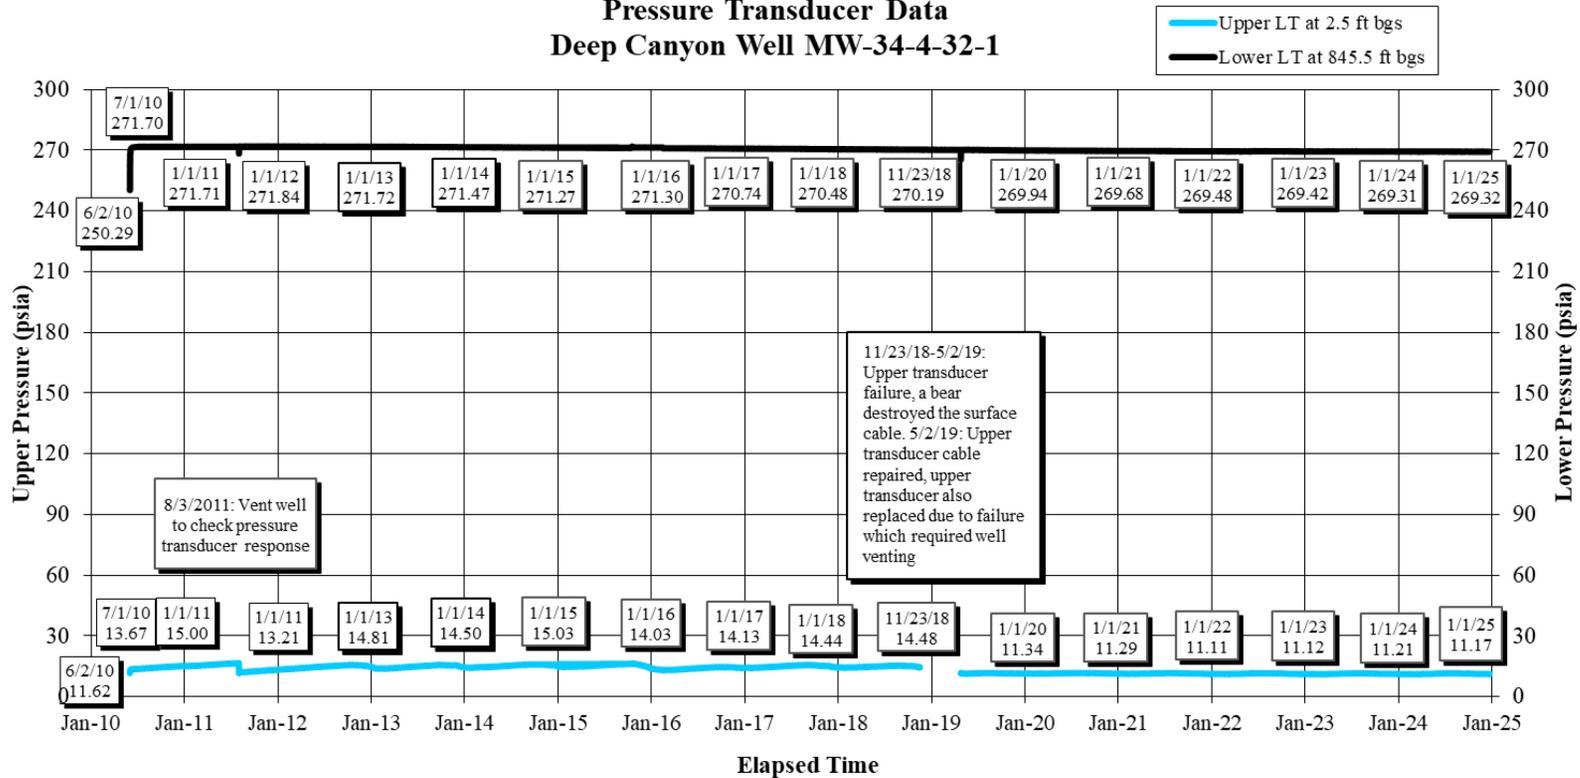
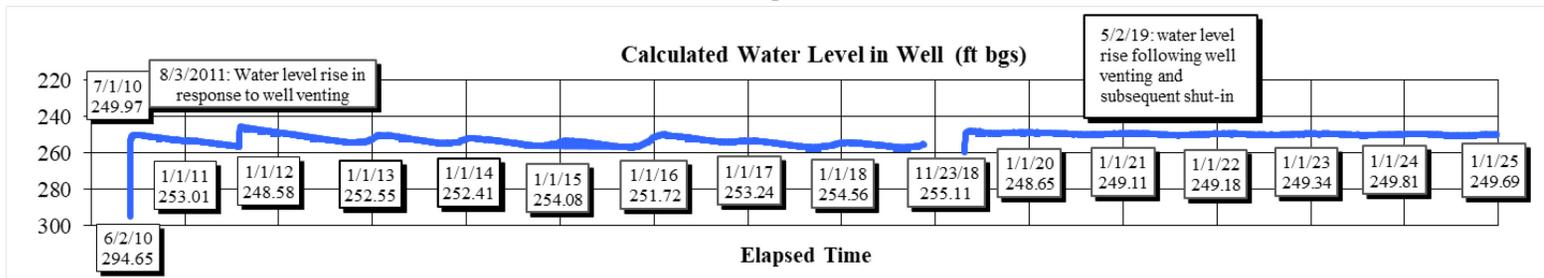
Figure 3-7
Pressure Transducer Data Deep Canyon Well MW-34-4-32-1

Figure 3-7 charts the upper and lower pressure transducer data and the calculated water level in the well. Table 3-4 and Figure 3-7 show the well pressure initially stabilized on June 8, 2010, six days after the well was shut in for monitoring on June 2, 2010. Table 3-4 and Figure 3-7 also show a relatively stable well pressure regime for the 14.5-year period of record through January 1, 2025 with only a slight decrease in well pressure and a corresponding net water level increase of 1.52 feet in the well. Data for this well is limited from November 23, 2018 to May 2, 2019 due to an upper Level Troll transducer failure. When investigated in early 2019 after the location was accessible following winter it was found that the surface cable for this Level Troll was damaged by what appeared to be a bear mauling of the telemetry station based on the type of cable damage and muddy paw prints on the telemetry instrumentation enclosure. At that time the cable was repaired, the Level Troll was replaced and full function has resumed. It appears there is less wellhead pressure observed since that time and thus less calculated water level fluctuation since that time.
