## **Colorado Oil and Gas Conservation Commission**

# Monitor Wells Summary Report 2021

# 4M Project Monitoring Program Archuleta and La Plata Counties Colorado

May 26, 2022

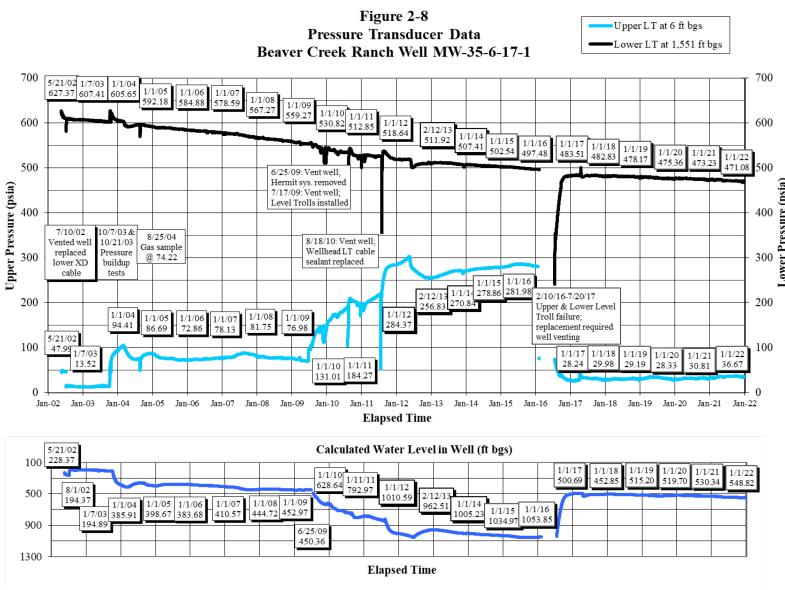
Figure 2-8
Pressure Transducer Data Beaver Creek Rach Well MW-35-6-17-1

Monitoring data for well MW 35-6-27-1 are charted on Figure 2-8. As shown in Table 2-6, the pressure regime for this well is different than the regime exhibited by well MW 35-6-17-2.

Table 2-6 and Figure 2-8 show a net increase of 21.23 psi in wellhead pressure, a net decline of 138.47 psi in downhole pressure and a corresponding net decline of 354.45 feet in the water level in the well for the entire approximate 18.5-year period of record. Figure 2-8 also shows a steady decline in the bottomhole pressure curve for the period of record, while the wellhead pressure curve shows two notable increases in the well pressure regime. Both increases in wellhead pressure suggest stimulation of gas flow into the well with corresponding declines in the water level occurred in response to venting the well in July 2003, June and July 2009 and August 2011. However, the most substantial cause for gas pressure increase during the period of record was the replacement of monitoring equipment and minimization of fittings leakage in July 2009. A significant leak was again repaired during the 2011 well inspection. In 2016 a failure of both LevelTrolls occurred requiring complete bleed-off of the well to install replacements. The pressure response shows that while the lower pressure regime appears to have returned to the previous trend, the wellhead pressure shows fall-off since the LevelTroll was replaced. This indicates that with the release of the wellhead pressure of nearly 300 psi during the well bleed-off, water was allowed to substantially flow to the well and disrupt the previous pressure regime. 2018-2021 pressure

2021 4M Project Monitor Wells Summary Report - Final	COGCC
data demonstrates that following this bleed-off the wellhead pressure has remained approximately 30 psi and relatively stable. This is likely because the water head pressure of 500 feet (215 psi) is effectively preventing significant gas build-up at the wellhead.	
2-22
